SAN JACINTO RIVER AUTHORITY

Inspection Report

By: JODY IGUESS

PUMP STATION AND LAKE INTAKE INSPECTION

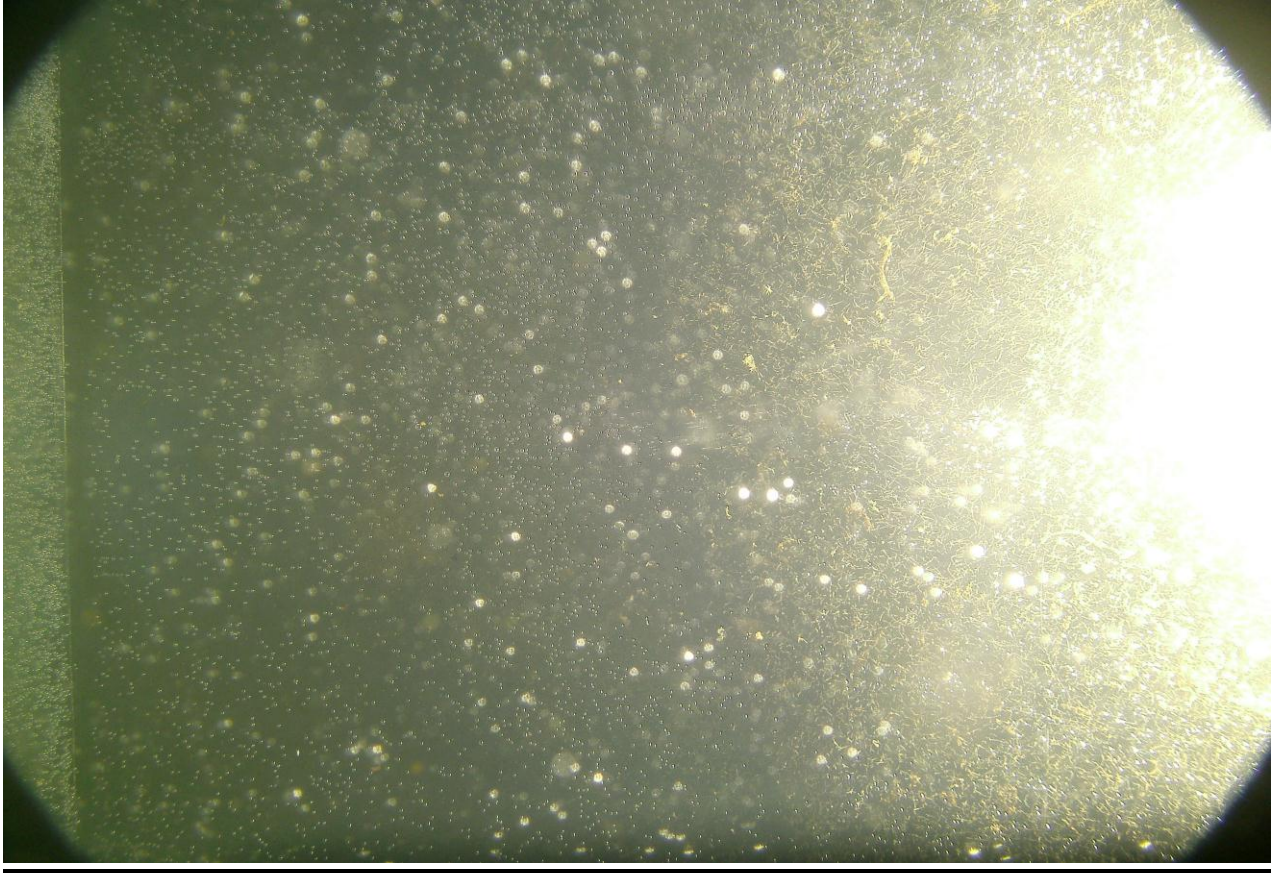
All flange bolts were in place and in good condition. The pump coating appeared to be in good condition with no visible deterioration to the coating and to the pump. The pump had minor marine growth of algae from 1-1.5 inches The U/T readings are on the chart provided in this report. (See APPENDIX B) The pump shaft has 3 flanges, and the first one is located at water line and then the next one is at 8 feet and the third one is at 18 feet and the pump bell housing is bolted to the last section of the pump, and all flanges had their bolts and nuts and were in good condition with no visible damage.

#4 PUMP SHAFT - LIGHT MARINE GROWTH
SHOWING NO CORROSION & GOOD COATING
TYPICAL OF ALL PUMP SHAFTS

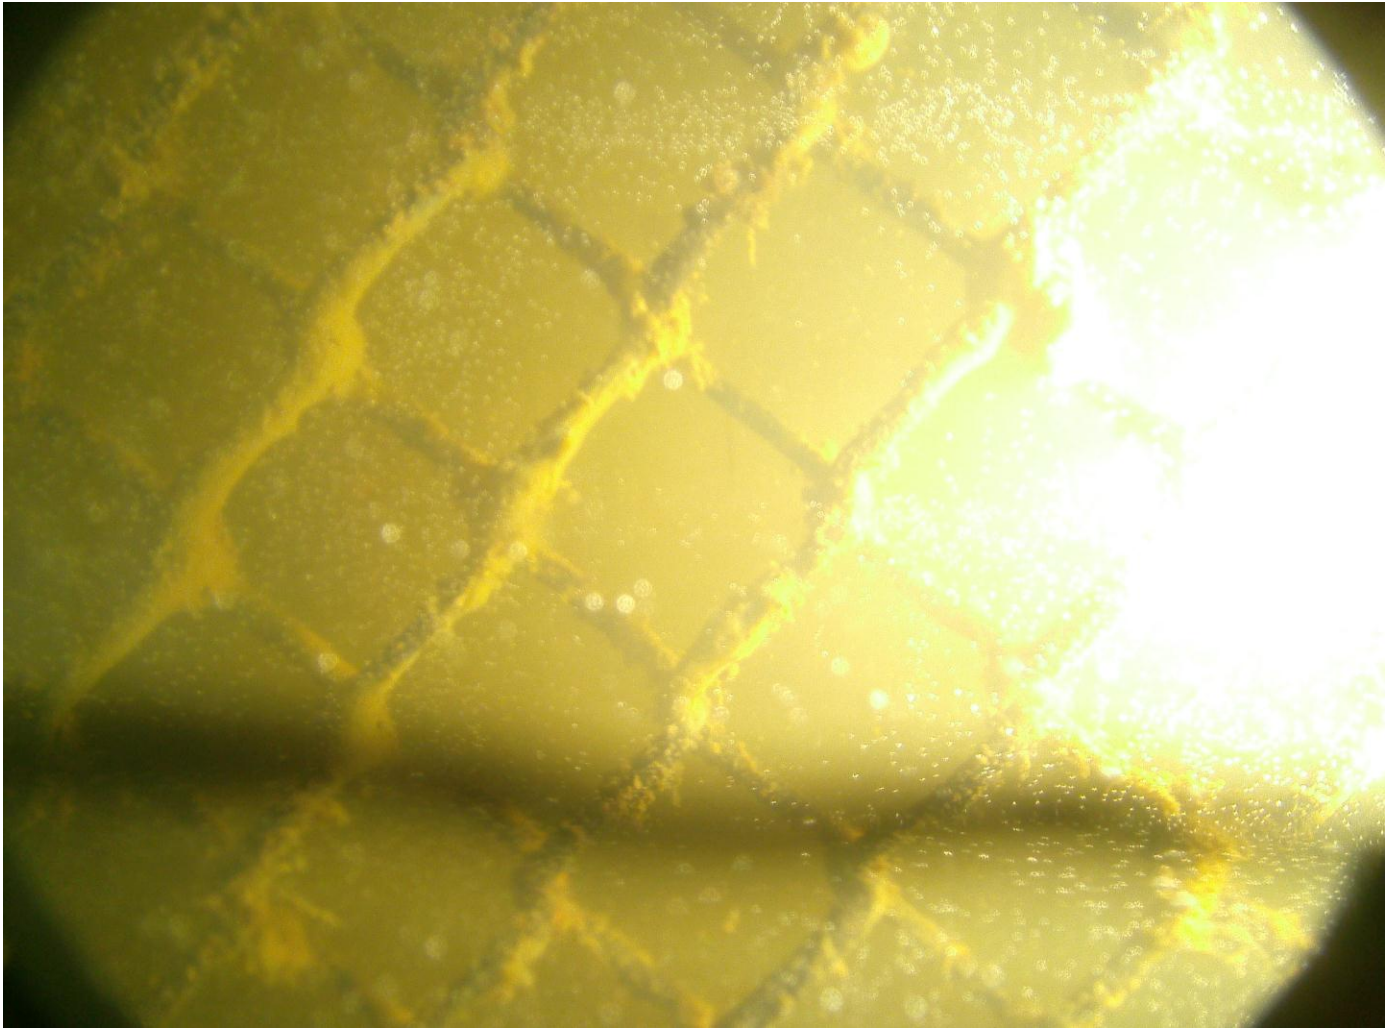
The trash screen (fencing) in bay 4 have light marine growth and appear to be in good shape with all the mounting hardware that secure the screen to the frame. The screens in all bays are the same configuration with no damage to the screens. Small debris was found in the bays but nothing to interfere with pump operations.

#4 WET WELL SCREEN - WITH LIGHT MARINE GROWTH

TYPICAL OF ALL TRASH SCREENS (FENCING)

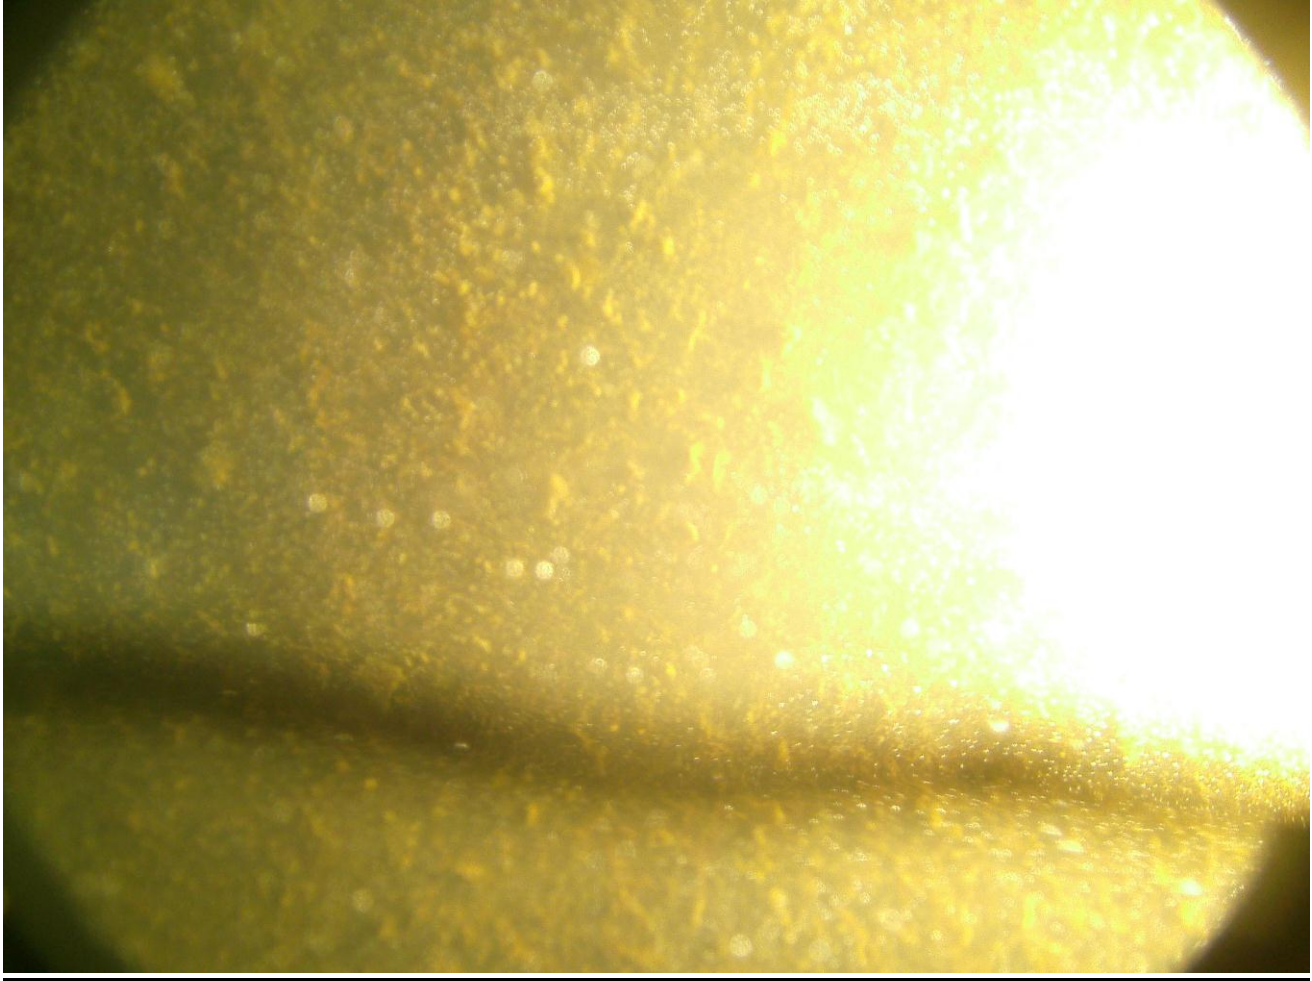
Wet well 4 had the most mud build up on the bay floor with 3-4 feet of mud in the whole bay, and directly under the bell housing of the pump shaft divers reported 6 inches of mud. Divers inspected the concrete walls and found no visual damage or spalling and reported that there was light marine growth of 1-2 inches (algae) on the walls. Pictures were taken in this bay of the walls and screens as well as the pump shaft which are typical of all bays. The pump shaft has the same flange set up as the other 3 bays but the flanges sections are 2' deeper, all flanges are in good condition and have all bolts and mounting hardware that appear to be in good condition.

#4 WET WELL - WALL ABOVE THE SCREEN - LIGHT MARINE GROWTH

TYPICAL OF ALL CONCRETE & CONDUIT WALLS

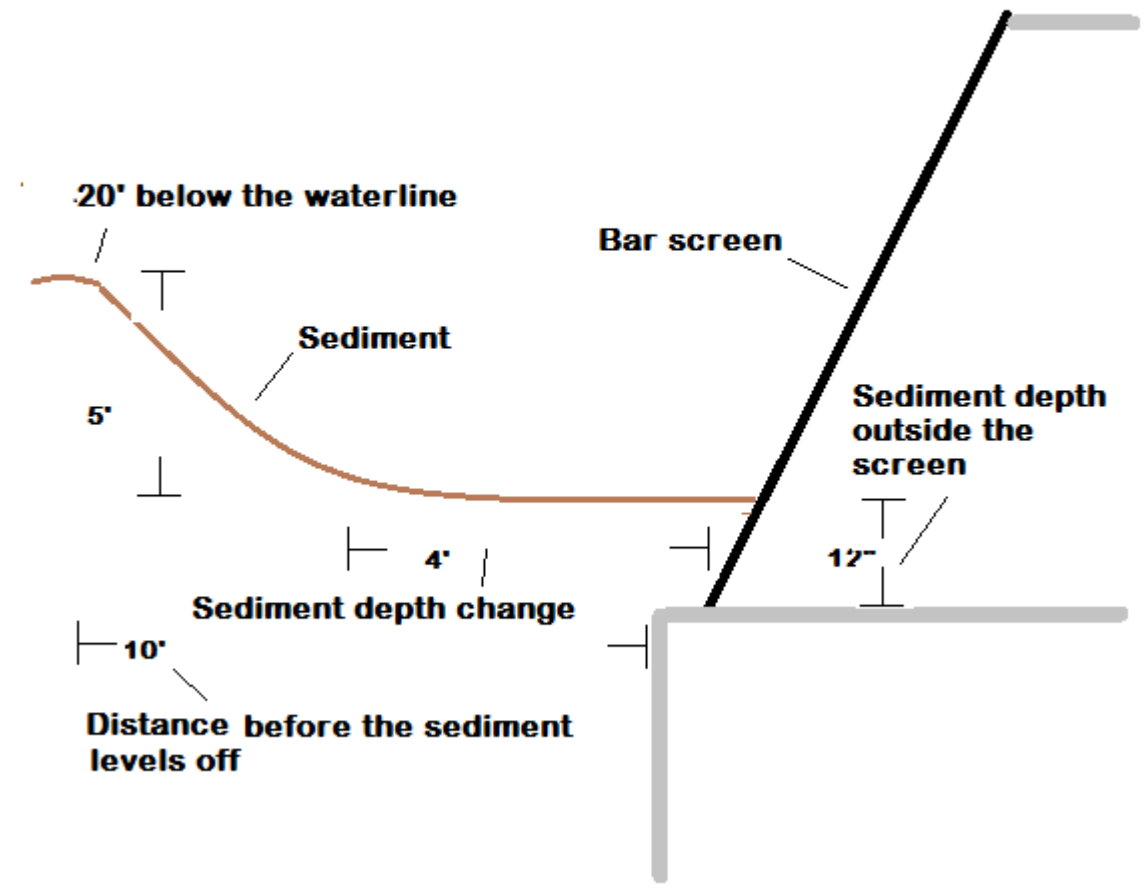
Bar Screen 1 is the southernmost bar screen and is the screen that pump 1 draws from. Divers took depth reading to identify the elevation of the top of the bar screen, the bottom of the bar screen and the top of the mud line. During the inspection of the bar screen the diver relayed that the bars appeared to be T shaped and have 5 bars per screen. It is unknown if this is the original shape of the bar or if they had original been H beam bars, if so the outer flange has deteriorated away on all of the bars. The existing bars have a flange bolted to the top and bottom of the conduit and a web that protrudes outward towards the lake. Due to the length of the bars and the lack of cross supports the bar have flexed to the north and the south slightly causing the spacing between bars to vary between 19 and 17 inches. (See diagram) The top of the bar screen is 18 feet below the water line. The bottom of the bar screen is 27 feet below the waterline and the mud line was 25feet below the waterline. Sediment depths averaged 12 to 24 inches and the diver located some small debris in front of the screen that he was able to move to the south away from the screens consisting of large limbs and branches.

The bar screens were found to be in very poor condition. The diver removed corrosion from some of the bar screens to identify the thickness of the heavily corroded metal. The diver attempted to find a section of bar screen that had minimal corrosion in order to define a base of material dimensions. The least corroded section of bar material was found in bar screen 4. The dimensions of the T bar that was used as a base had a flange width of 5 inches and a web width of 6 inches. The same section had a flange thickness of 3/8 inch and a web thickness of 1/4 inch. Since we were not provided with details of the bar this moderately corroded section of T bar is the only indication of what the original dimensions of the bar was. The average dimension of the T bar at Bar Screen 1 had a flange width of 2 inches, a web width of 2 inches a flange thickness of 1/4 inch and a web thickness of 1/8 inch. Due to the heavy corrosion in material Bar Screen 1 was giving rating of poor. Moving out from the bar screen 4 feet the mud bottom increases 3 to 5 foot in depth.

Conduit bar screens are in **POOR CONDITION** showing extreme deterioration in the vertical bars and attaching hardware. Also bar screen spacing is about 18 inches on average which is extremely wide compared to others we have inspected. We recommend that new bar screens be fabricated and installed due to the extreme deterioration and wide spacing.

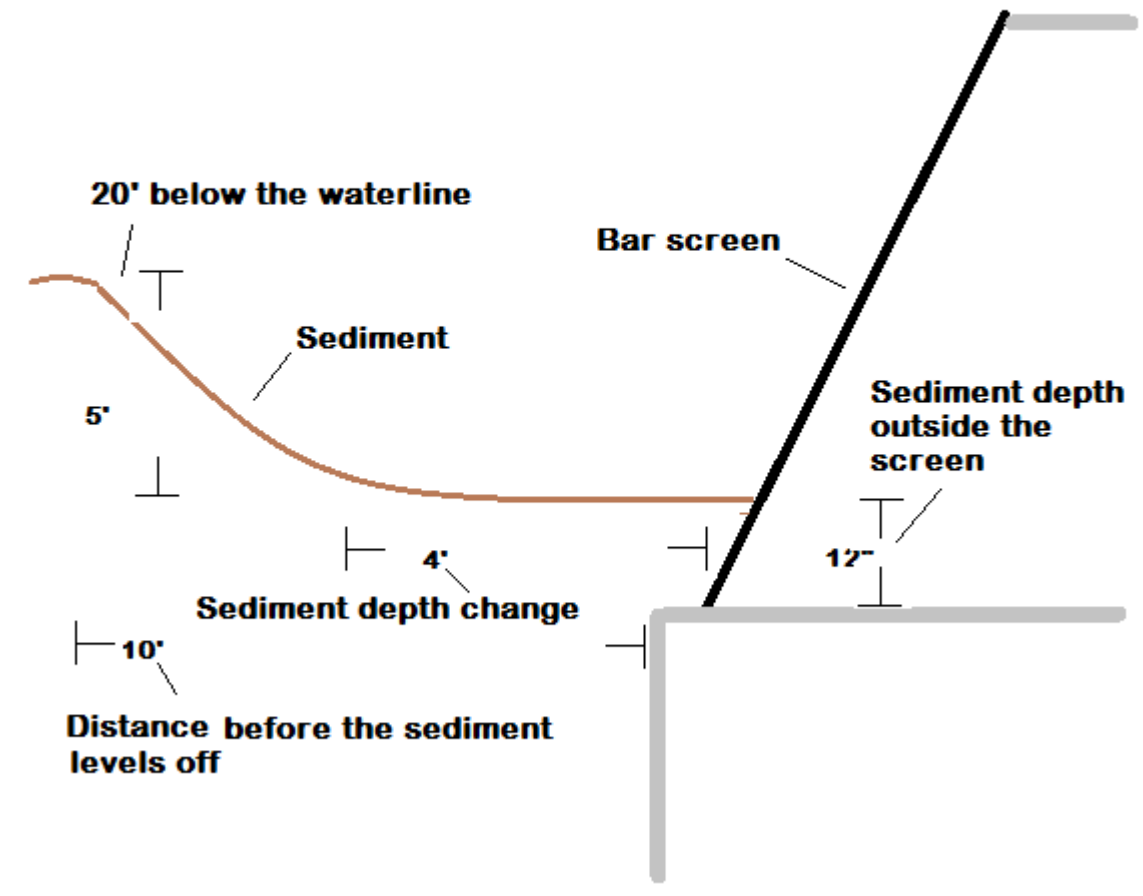
Bar Screen 2 is the bar screen that pump 2 draws from. The top of the screen was 18 foot below the waterline the bottom of the screen was 26 foot below the water line and the mud line was 25 foot below the waterline. Sediment depths averaged 12 inches. Due to the length of the bars and the lack of cross supports the bar have flexed to the north and the south slightly causing the spacing between bars to vary between 19 and 17 inches. The average dimension of the T bar at BS2 had a flange width of 4 inches, a web width of 3 inches a flange thickness of $\frac{1}{4}$ inch and a web thickness of $\frac{1}{8}$ inch. Due to the heavy corrosion BS2 was giving rating of poor.

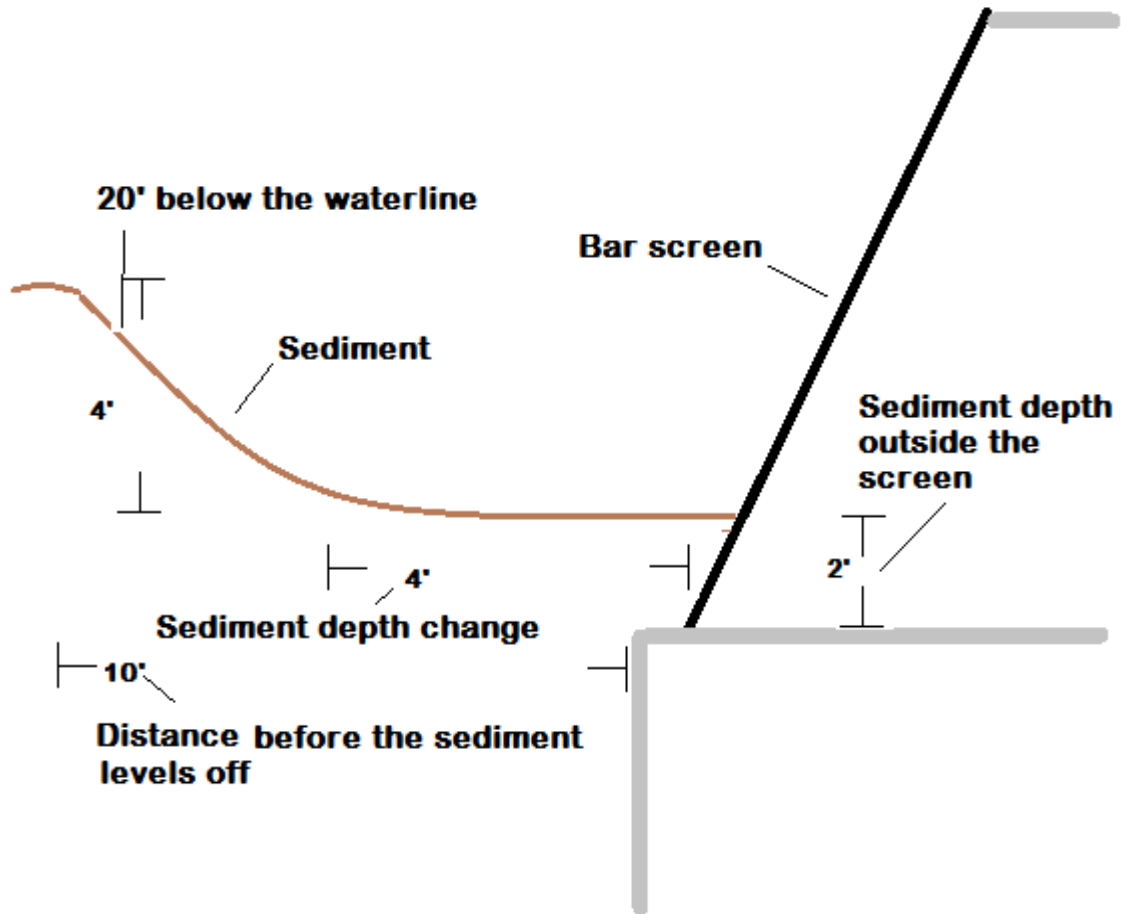
Bar Screen 3 is the bar screen that pump 3 draws from. The top of the screen was 18' below the waterline the bottom of the screen was 26 foot below the water line and the mud line was 24 foot below the waterline. Sediment depths averaged 24 inches. Due to the length of the bars and the lack of cross supports the bar have flexed to the north and the south slightly causing the spacing between bars to vary between 17 and 19 inches. The average dimension of the T bar at BS2 had a flange width of 2 inches, a web width of 2 inches a flange thickness of $\frac{1}{4}$ inch and a web thickness of $\frac{1}{8}$ inch. Due to the heavy corrosion BS3 was giving rating of poor.

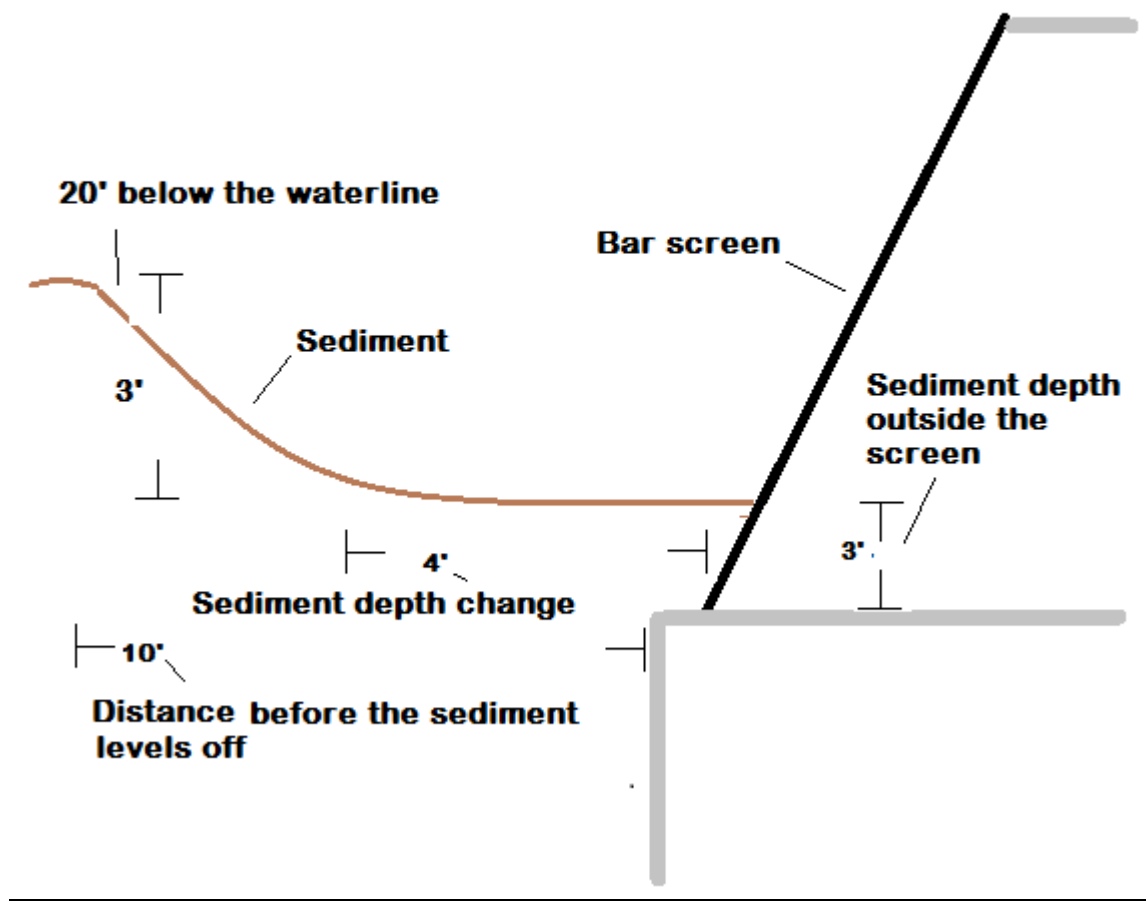
Bar Screen 4 is the bar screen that pump 4 draws from. The top of the screen was 18 foot below the waterline the bottom of the screen was 26 feet below the water line and the mud line was 23 foot below the waterline. Sediment depths averaged 3 inches. Due to the length of the bars and the lack of cross supports the bar have flexed to the north and the south slightly causing the spacing between bars to vary between 17 and 19 inches. The average dimension of the T bar at BS2 had a flange width of 4.5 inches, a web width of 4 inches, a flange thickness of $\frac{1}{4}$ inch and a web thickness of $\frac{1}{8}$ inch. The diver found the most north bar is broken in half and was unable to locate the top half. It is believed that the missing section is below the mud line. Due to the heavy corrosion and the broken screen bar BS4 was giving rating of poor.

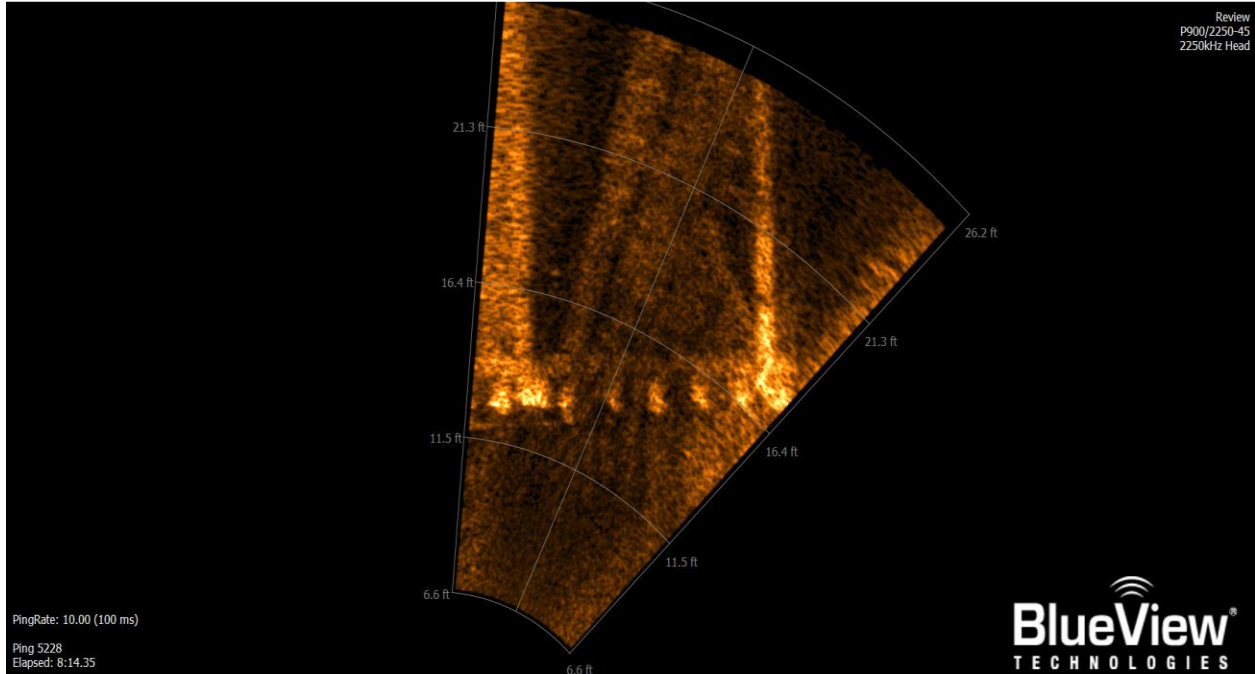
Intake Structure #1
Bar Screen and
conduit

Images are looking down at the bar screens and showing the tops of the conduit pipe. This is due to the mud build up in front of all the screens. The Blueview Tri-pod was at the mud depth of 20 feet and the base of the bar screen is at 27 feet. This condition applies to all (4) Bar Screen locations. The sonar distance from the bar screen is approximately 13 feet. A direct head on shot was not able to taken due to the mud build up in front of the bar screen.

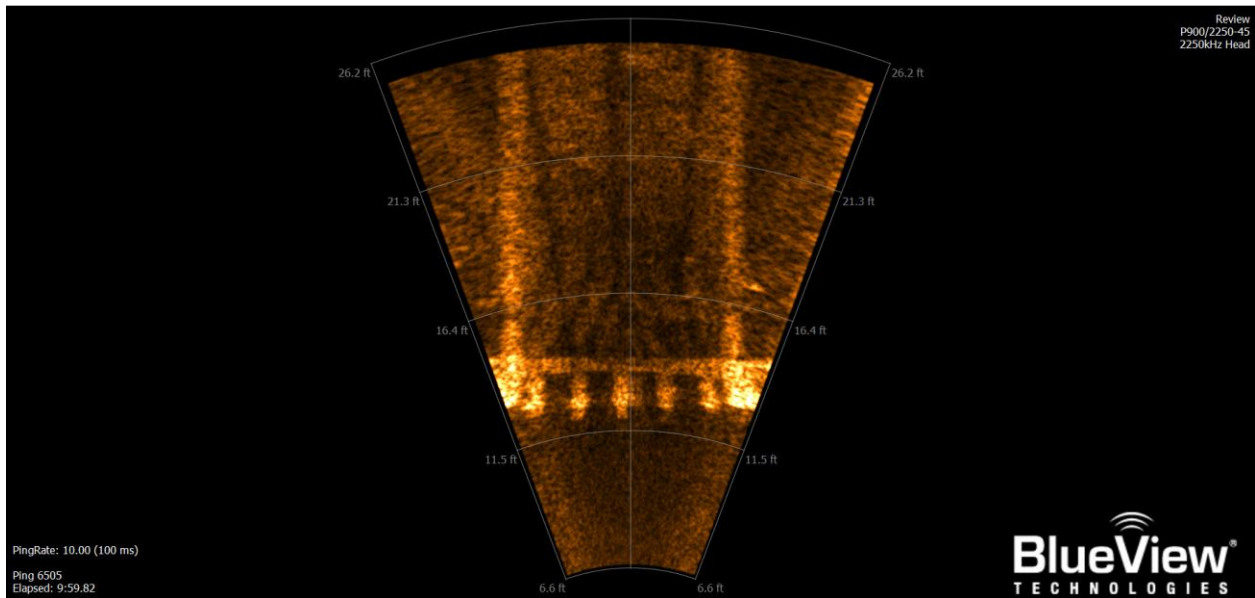
Intake Structure #2 Bar
Screen and conduit

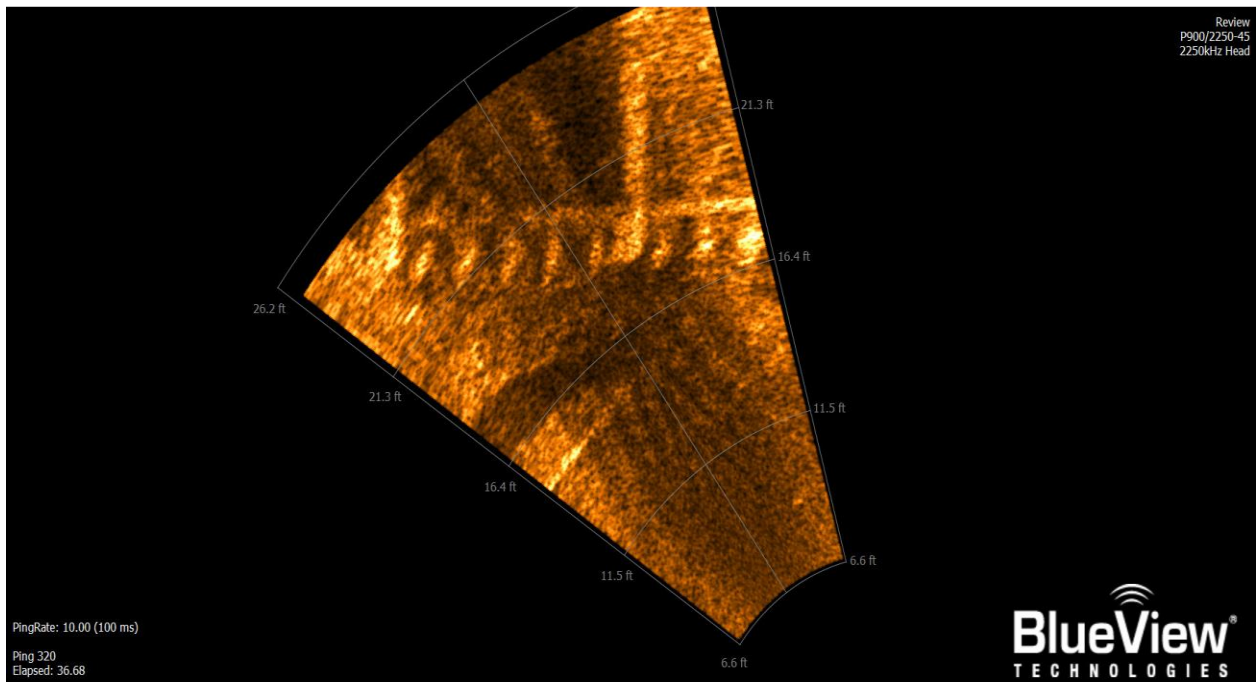
Intake Structure #4
Bar Screen and
conduit

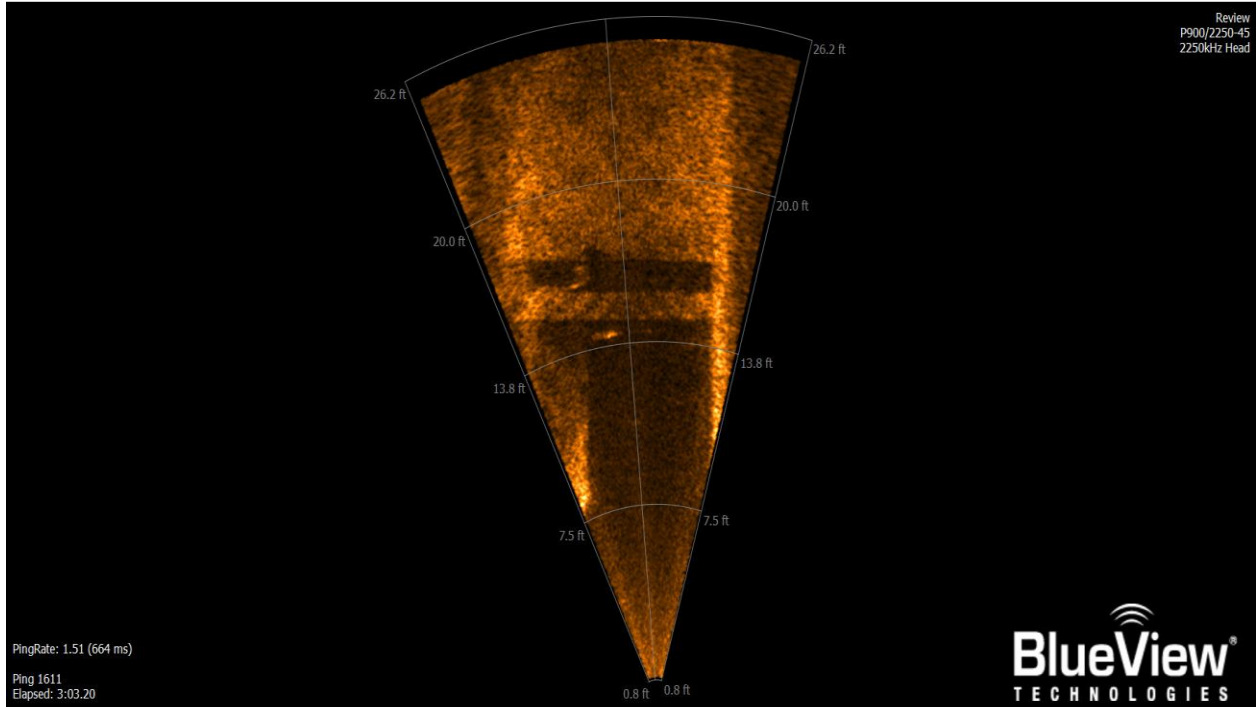
Conduit bay access opening inside Bay #1 intake pump compartment

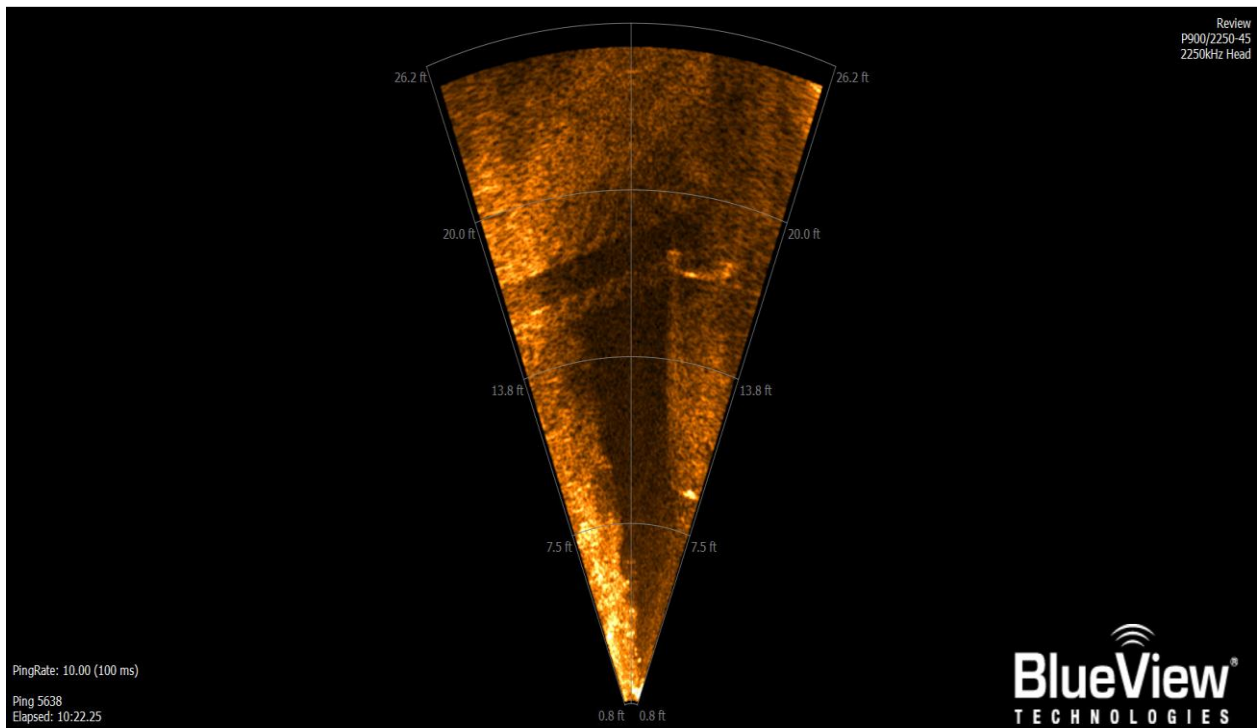
Diver bubbles and compartment access opening behind Pump Shaft #3 intake pump

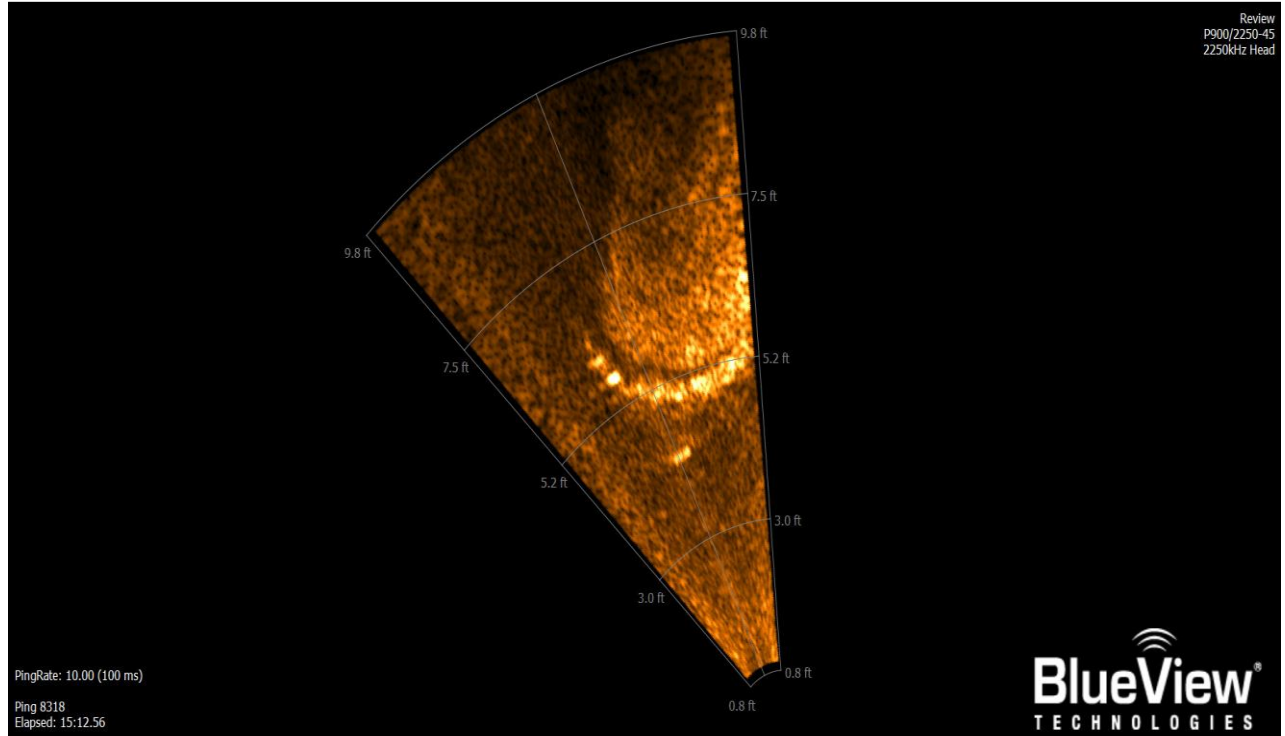
Flanges on Pump Shaft #4 intake pump
