June 27, 2025

RE: Review of Nineteenth (19th) Re-measure of Elevations at Monitoring Benchmarks and Monitoring Points Along the Water Line Segments W1A and W2A in the Woodlands, Texas

Review of Nineteenth (19th) Re-measure of the Elevations at Monitoring Points and Monitoring Benchmarks along Water Line Segments W1A and W2A

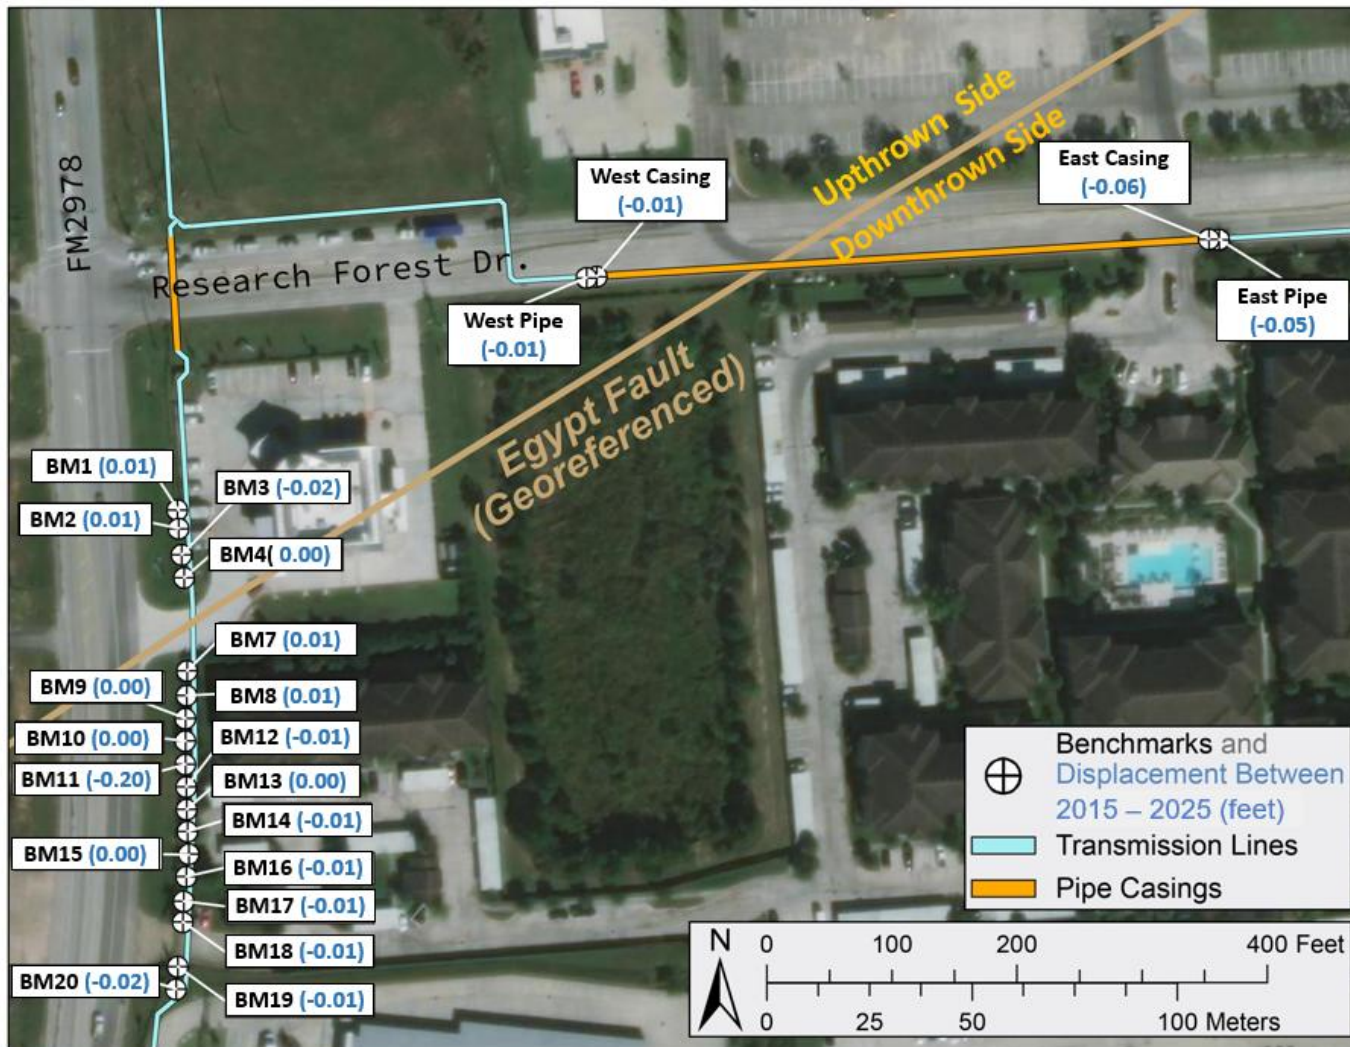
Figure 3 Satellite map showing the location of the Egypt Fault (Fugro, 2012), the W1A monitoring locations and calculated vertical displacement from March 2015 to March 2025 and the SJRA water line and pipe casing.

Egypt Fault Monitoring System - At the Egypt Fault Monitoring System (Figure 3), the changes in the elevations from March 2015 to March 2025 indicate that a greater decrease in pipe/casing elevation occurred on the downthrown side than on the upthrown side of the Egypt Fault. Over a 10-year period from 2015 to 2025, the pipe/casing elevation on the downthrown side of the Egypt Fault decreased 0.045 ft relative to the upthrown side of the Egypt Fault. The 0.045 ft decrease over an 10-year period translates into an average subsidence rate of approximately 0.0045 ft/yr.

W1A Segment - At the W1A segment where 18 monitoring benchmarks are located along FM 2978 (Figure 3), the changes in monitoring benchmark elevations from March 2015 to March 2025 indicate that a greater decrease in land elevation has occurred on the downthrown side than on the upthrown side of the Egypt Fault. Over the 10-year period from 2015 to 2025, the land surface on downthrown side of the Egypt Fault decreased 0.005 ft in elevation relative to the upthrown side of the Egypt Fault. The 0.005 ft decrease in land elevation over a 10-year period translates into an average subsidence rate of approximately 0.0005 ft/yr. (note: as explained in a note on page 7, benchmark 11 was not included in the analysis).

- The four monitoring benchmarks on the upthrown side of the Egypt Fault ranged from a decrease of 0.01 ft to an increase of 0.01 ft in elevation. The four monitoring benchmarks averaged no change in elevation.
- After omitting results from benchmark BM11, the thirteen monitoring benchmarks on the downthrown side of the Egypt Fault ranged from a decrease of 0.02 ft in elevation to an increase 0.01 ft change in elevation. The thirteen monitoring benchmarks averaged a change of a decrease of 0.005 ft change in elevation.
- From March 2015 to March 2025, the elevation data from the W1A Monitoring System indicates that the downthrown side of the fault decreased 0.005 ft in elevation relative to the upthrown side of the fault.

- The two monitoring points on the upthrown side of the Egypt Fault had a decrease of 0.01 ft in elevation.
- The two monitoring points on the downthrown side of the Egypt Fault had a decrease of 0.05 ft in elevation and a 0.06 ft decrease in elevation and averaged 0.055 ft decrease in elevation.
- From March 2015 to March 2025, the elevation data from the Egypt Fault Monitoring System indicates that the downthrown side of the fault decreased 0.045 ft in elevation relative to the upthrown side of the fault.

During the last 10 years, the monitoring data indicates that more downward movement occurred on the downthrown side on the Egypt Fault. Along Research Forest Drive, the downthrown side of the fault averaged a decrease of 0.045 ft in elevation more than the upthrown side of the fault. This amount of elevation change indicates that the downthrown side of the Egypt Fault is subsiding at rate approximately 0.005 ft/yr relative to the upthrown side of the Egypt Fault. Along FM 2978, the downthrown side of the fault averaged a decrease 0.005 ft in elevation more than the upthrown side of the fault. These amounts of elevation change are too small to be considered conclusive evidence that land subsidence is occurring along Egypt Fault where it intersects FM 2978.

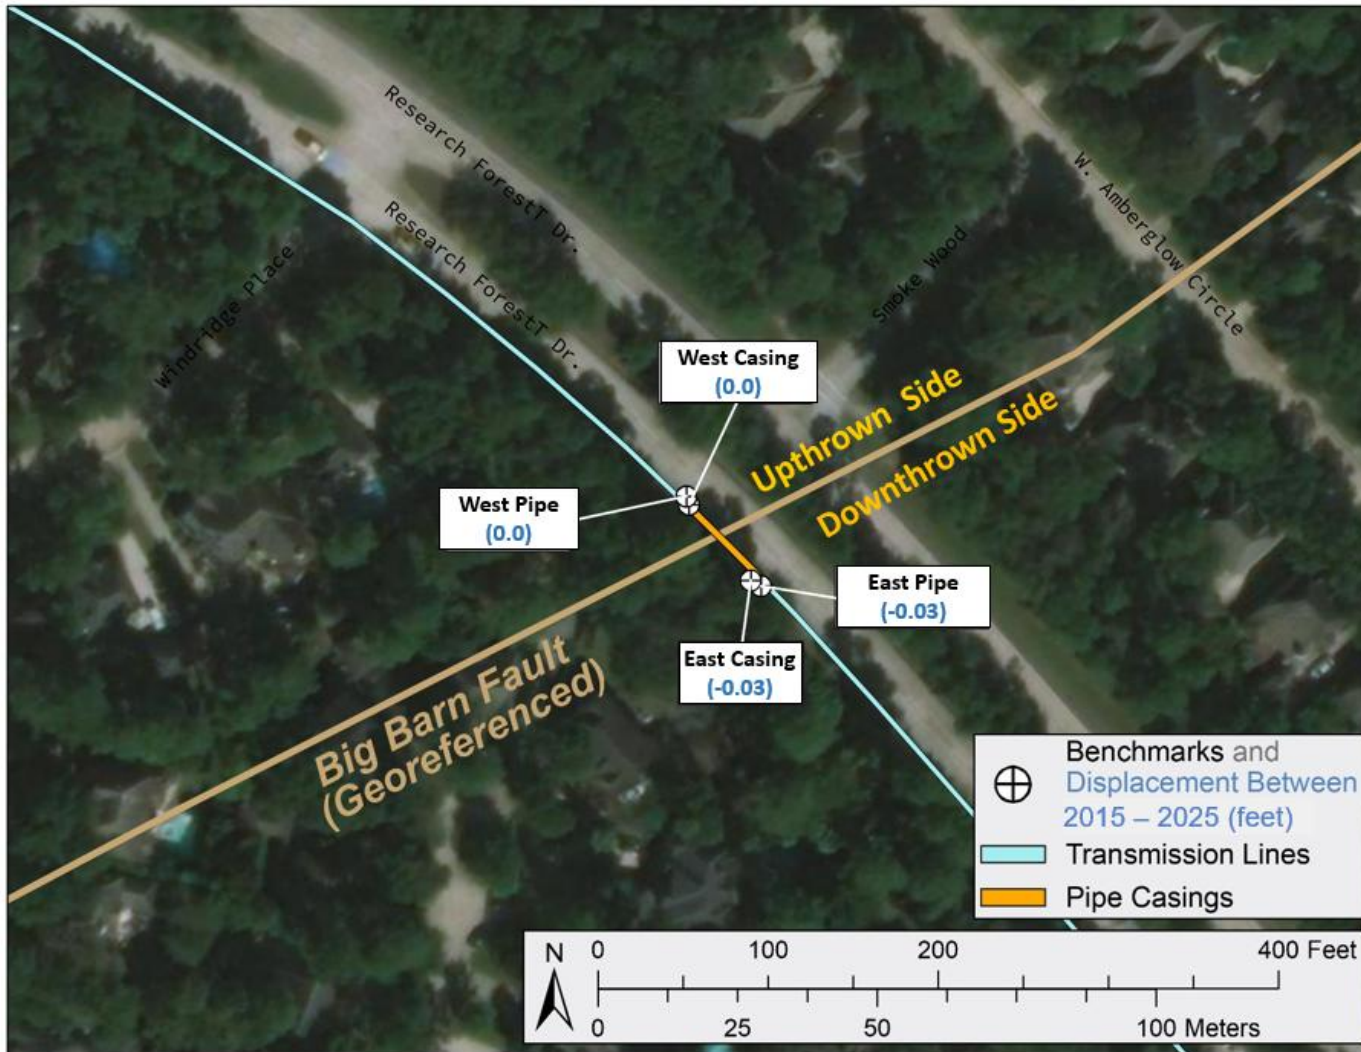
Figure 4 Satellite map showing the location of the Big Barn Fault (Fugro, 2012), the Big Barn Fault Monitoring System, calculated vertical displacement from March 2015 to March 2025, and the SJRA water line and pipe casing.

Big Barn Monitoring System - At the Big Barn Fault Monitoring System where four monitoring points on Research Forest Drive straddle the Big Barn Fault (Figure 4), the changes in the monitoring benchmark elevations indicate that a greater decrease in pipe/casing elevation has occurred on the downthrown side than on the upthrown side of the Big Barn Fault. Based on the change in elevations of the four monitoring benchmarks over a 10-year period from March 2015 to March 2025, the pipe/casing elevation on downthrown side of the Big Barn Fault decreased 0.030 ft relative to the upthrown side of the Big Barn Fault. The 0.030 ft decrease in pipe/casing over a 10-year period translates into average subsidence rate of approximately 0.003 ft/yr.

Last year: - Over the last year, the four monitoring points that comprise the Big Barn Fault Monitoring System along Research Forest Drive in Figure 4 had the following elevation changes:

- The two monitoring points on the upthrown side of the Big Barn Fault had no change in elevation and an increase of 0.01 ft in elevation. The two monitoring points averaged an increase of 0.005 ft in elevation.
- The two monitoring points on the downthrown side of the Big Barn Fault had no change in elevation and an increase of 0.01 ft in elevation. The two monitoring points averaged an increase of 0.005 ft in elevation.
- From March 2024 to March 2025, the elevation data from Big Barn Fault Monitoring System indicates that the upthrown side and the downthrown side of the fault have moved upward 0.005 ft in elevation.

Last 10 years: –From March 2015 to March 2025, the four monitoring points along Research Forest Drive near the Big Barn Fault in Figure 4 had the following elevation changes:

- The two monitoring points on the upthrown side of the Big Barn Fault had no change in elevation. The upthrown side of the fault averaged no change in elevation.
- The two monitoring points on the downthrown side of the Big Barn Fault had a decrease of 0.03 ft in elevation. The downthrown side of the fault averaged a decrease of 0.03 ft in elevation. asdf
- From March 2024 to March 2025, the elevation data from Big Barn Fault Monitoring System indicates that the downthrown side moved downward 0.03 ft relative to the upthrown side of the fault. A 0.03 ft decrease in elevation over 10 years translates into an average subsidence rate of approximately 0.003 ft/yr.

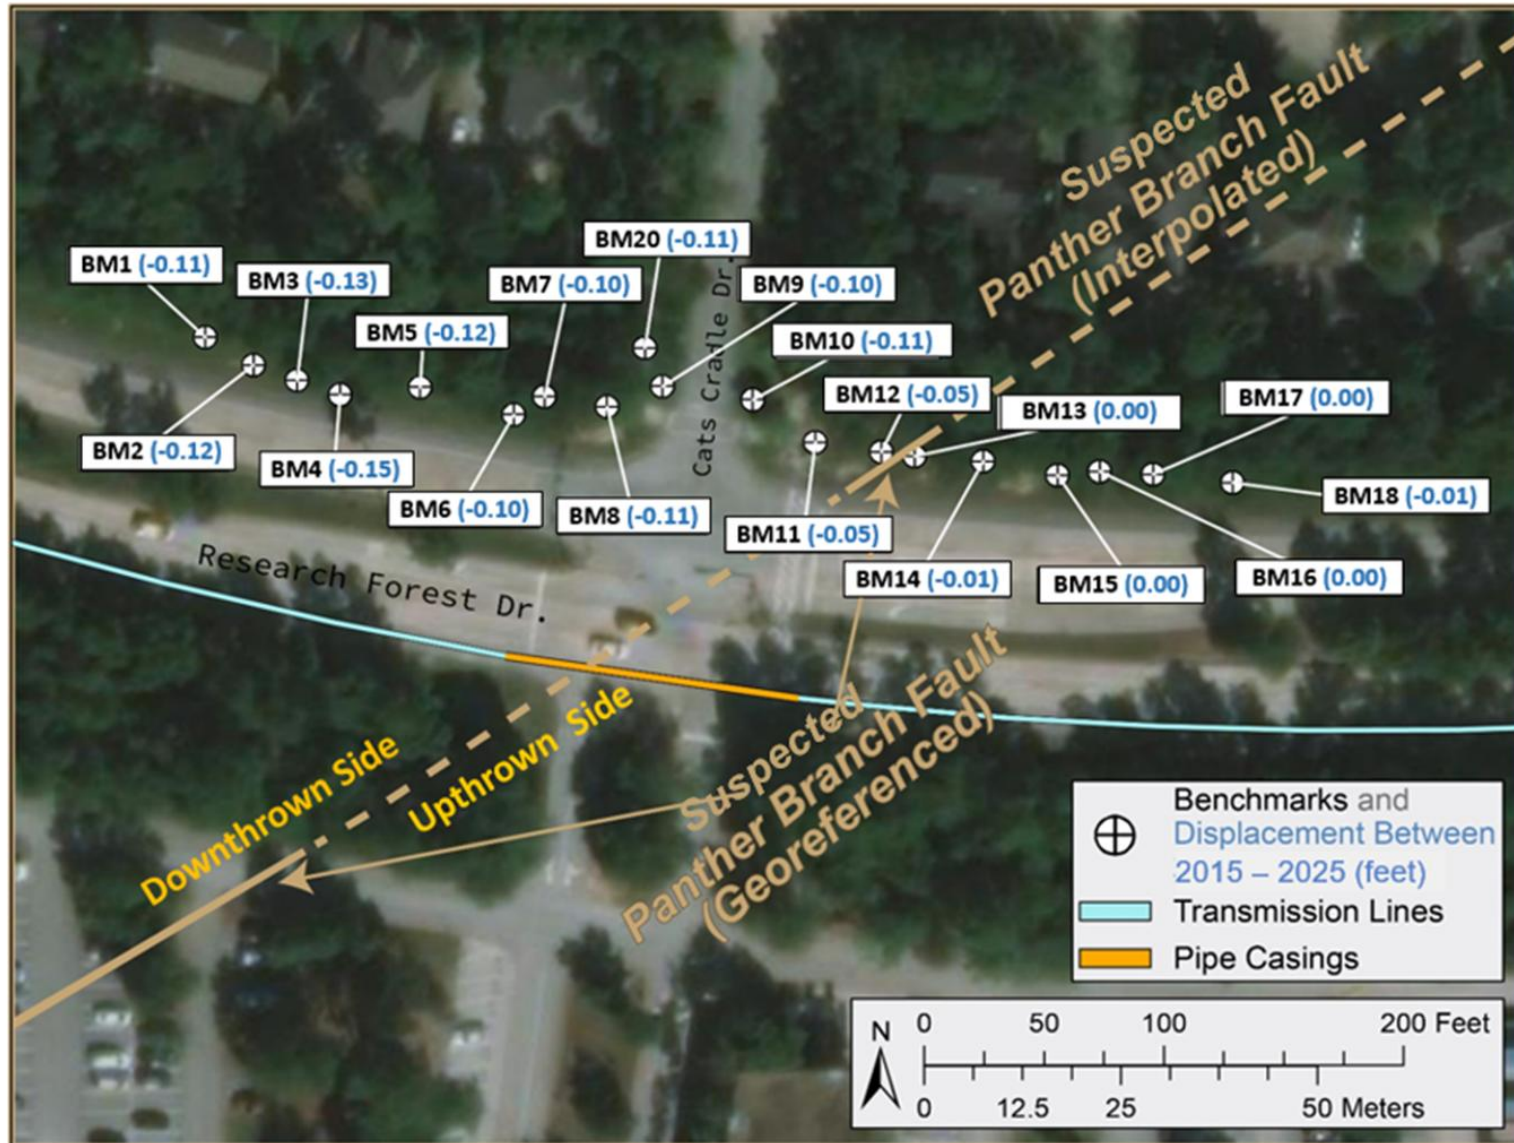
Figure 5 Satellite map showing the location of the suspected Panther Branch Fault mapped by INTERA, the Segment W2A Monitoring System, calculated vertical displacement from March 2015 to March 2025, and the SJRA water line and pipe casing.

W2A Segment - Along the W2A segment where 19 monitoring benchmarks on Research Forest Drive are located near the suspected Panther Branch Fault (Figure 5), the changes in the monitoring benchmark elevations suggest that greater land subsidence has occurred on the downthrown side than on the upthrown side of the suspected Panther Branch Fault. Based on the change in elevations of the 19 monitoring benchmarks over a 10-year period from March 2015 to March 2025, the land surface on downthrown side of the suspected Panther Branch Fault decreased 0.101 ft in elevation relative to the upthrown side of the suspected Panther Branch Fault. The 0.101 ft decrease in land elevation over a 10-year period translates into an average subsidence rate of approximately 0.010 feet per year (ft /yr).

Over the last year the 19 monitoring benchmarks that straddle the suspected Panther Branch Fault along Research Forest Drive at the Segment W2A Monitoring System in Figure 5 had the following elevation changes:

- The six monitoring benchmarks (MbM-13 through MbM-18) on the upthrown side of the suspected Panther Branch Fault had elevation changes that ranged from no change in elevation to an increase of 0.01 ft in elevation. The six monitoring benchmarks averaged an increase of 0.003 ft in elevation.
- The thirteen monitoring benchmarks (MbM-1 through MbM-12 and MbM-20) on the downthrown side of the suspected Panther Branch Fault had elevation changes that ranged from a decrease of 0.01 ft in elevation to no change in elevation. The thirteen monitoring benchmarks averaged a decrease of 0.006 ft in elevation.
- From March 2024 to March 2025, the downthrown side of the suspected Panther Branch Fault along Research Forest Drive moved downward less than 0.01 ft than the upthrown side of the suspected Panther Branch Fault.

From March 2015 to March 2025, the 19 monitoring benchmarks located along Research Forest Drive near the suspected Panther Branch Fault in Figure 5 had the following elevation changes:

- The six monitoring benchmarks (MbM-13 through MbM-18) on the upthrown side of the suspected Panther Branch Fault ranged between no change in elevation to a decrease of 0.01 ft change in elevation. The upthrown side of the fault averaged a decrease of 0.003 ft in elevation.
- The thirteen monitoring benchmarks (MbM-1 through MbM-12 and MbM-20) on the downthrown side of the suspected Panther Branch Fault had elevation changes that ranged from a decrease of 0.05 ft in elevation to a decrease of 0.15 ft in elevation. The downthrown side of the fault averaged a decrease of 0.1046 ft in elevation.
- From March 2015 to March 2025, the downthrown side of the fault moved downward 0.101 ft relative to the upthrown side of the fault. A 0.101 ft decrease in elevation over 10 years translates into an average subsidence rate of approximately 0.01 ft/yr.

Continued monitoring of ground elevation change is recommended because superimposed on the cyclic pattern of the lowering and rising of ground surface at the monitoring locations along Research Forest Drive, there is a gradual albeit small trend of greater lowering of the ground surface elevation on the downthrown side of the suspected Panther Branch Fault than on the upthrown side of the suspected fault. Based on a review of the LAN (2023) report, INTERA has determined that the difference in elevation change between the two sides of the fault poses no risk to the structural integrity of the GRP pipeline until at least 0.33 ft of differential subsidence has occurred across the suspected fault. Evaluation of any potential risks to the GRP pipeline structural integrity of the GRP pipeline after 0.33 ft of differential subsidence has occurred is beyond the scope of this report but is addressed by LAN (2023).

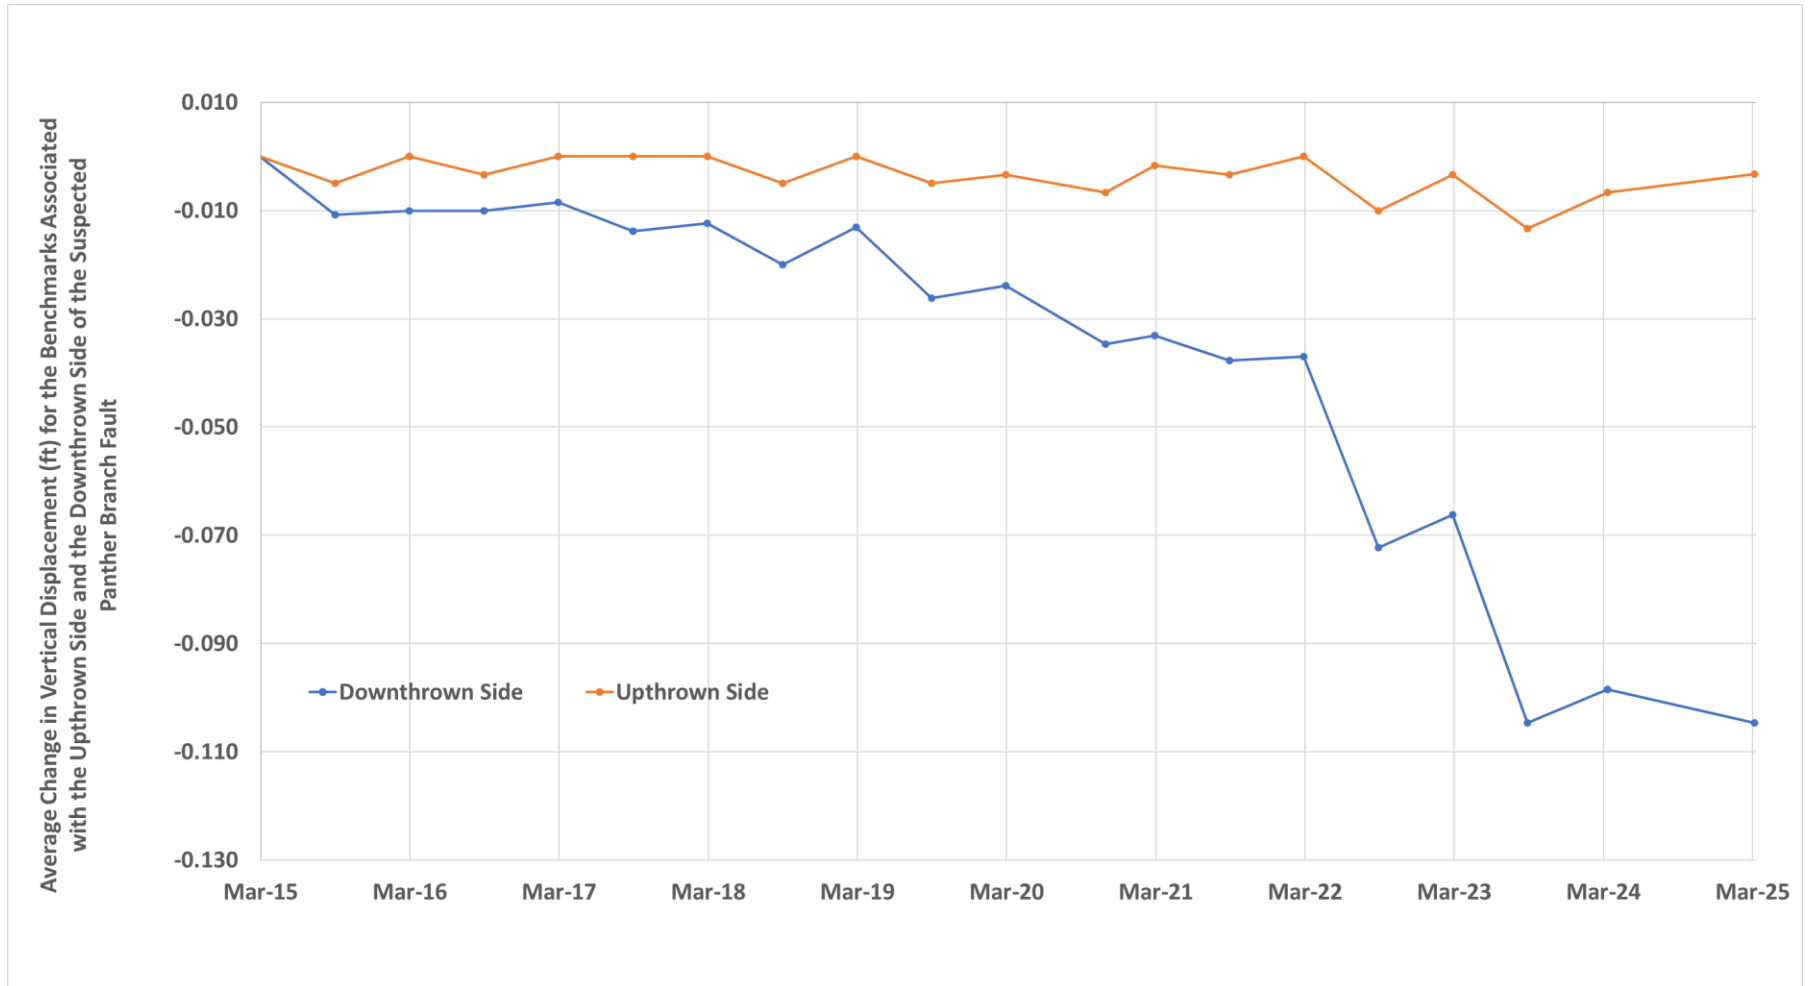
Figure 6 Comparison of average vertical displacement for the benchmarks located on the upthrown side and the downthrown side of the suspected Panther Branch Fault associated with the Segment W2A Monitoring System.

Figure 6 shows graphs for the average vertical displacement calculated for the benchmarks located on the upthrown side and the downthrown side of the suspected Panther Branch Fault as a function of time since March 2015. The graphs show that the downthrown side of the fault has consistently greater decrease in elevation than does the upthrown side of the fault. Whereas the upthrown side of the fault has not subsided more than 0.015 ft over a 1-year period (beginning in the month of March) within the 10-year monitoring period, the downthrown side of the fault has exhibited a general trend of declining elevation with greater displacement rates at later times. Over the 10-year monitoring period, the downthrown side of the suspected Panther Branch Fault a maximum decline of about 0.032 ft over a 1-year period (beginning in the month of March)

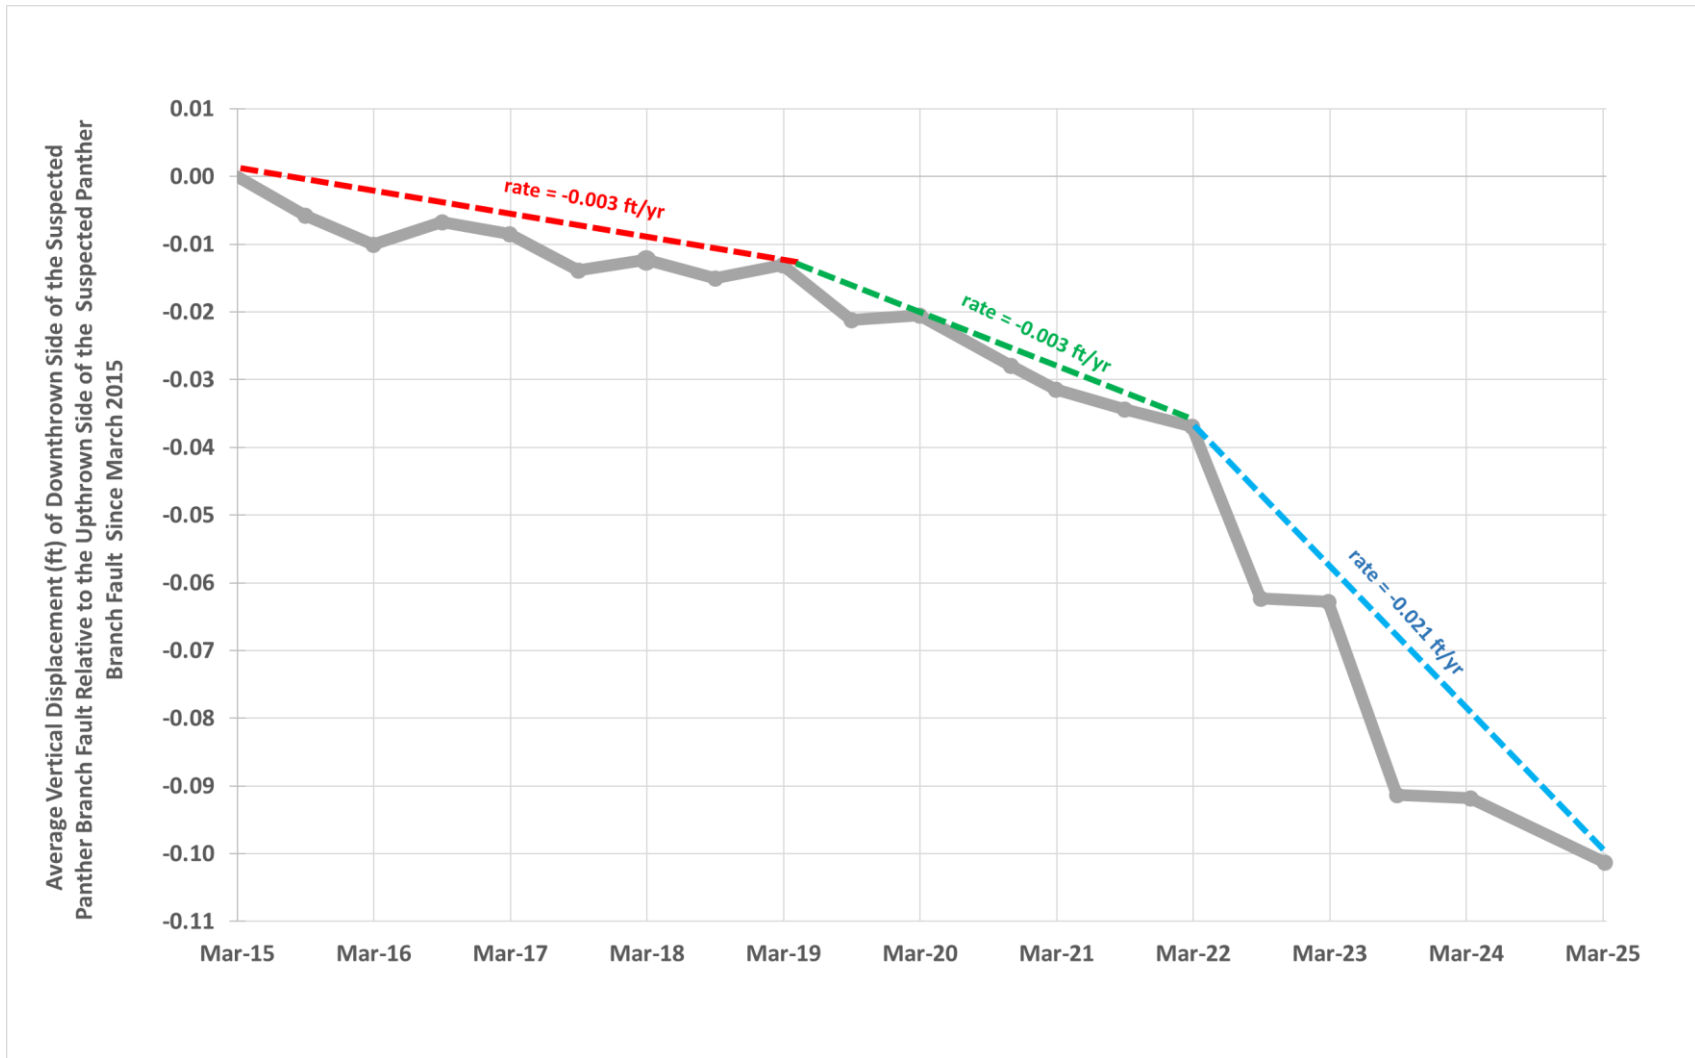
Figure 7 Relative vertical displacement and rates for relative vertical displacement for the downthrown side of the suspected Panther Branch Fault based on benchmarks associated with the Segment W2A Monitoring System

Figure 7 and Table 5 show the rates of vertical displacement for the downthrown side of suspected Panther Branch Fault relative to the upthrown side of the suspected Panther Branch Fault. The relative rate is calculated by subtracting the rate of displacement of the upthrown side from the rate of displacement of the downthrown side. The temporal changes in the displacement has been divided into three periods: 1) from March 2015 to March 2019, the rate of vertical displacement averaged 0.003 ft/yr downward; 2) from March 2019 to March 2022, the vertical displacement rate averaged 0.008 ft/yr downward; and 3) from March 2022 to March 2025, the vertical displacement rate averaged 0.021 ft/yr downward.

Figure 7 illustrates the increase in annual vertical displacement over time from March 2015. The greatest amount of displacement occurs over a two-year period from March 2024 to March 2024. Later in the report potential causes for this temporal trend are discussed.

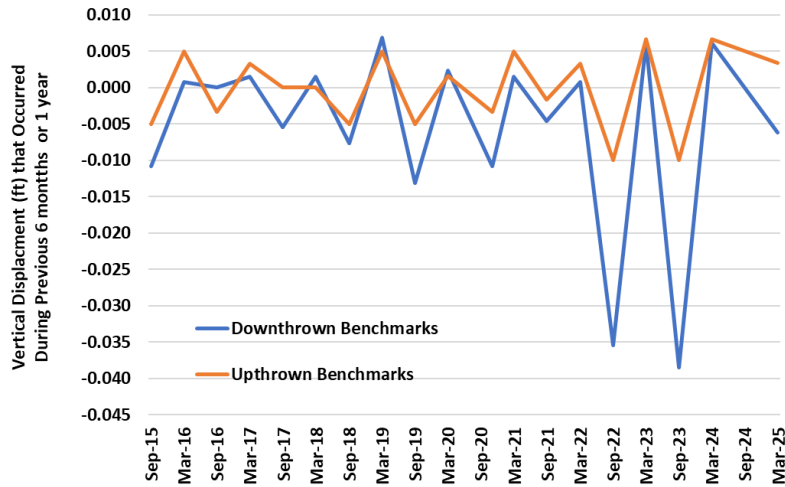
Figure 8 Vertical displacement that occurred during 6-months to 1-year intervals preceding the March and September measurements of benchmark elevations associated with Segment W2A Monitoring System along the suspected Panther Branch Fault.

The cyclic pattern in the vertical displacement is consistent with the presence of expansive soils (Barthélémy and others, 2023; Charpentier and others, 2022; Kai and others., 2020; Mostafiz and others, 2021; Wang, 2022). Expansive soils contain clays that can undergo volume change in response to fluctuations in soil moisture. During periods of high moisture content, these soils swell, expanding their volume. During periods of low-moisture content, expansive soils dry, which causes a reduction in their volume. The cyclic pattern of vertical displacement occurs as a result of seasonal changes in evapotranspiration (ET). In the Gulf Coast of Texas ET is lowest from November through February (~20% of annual total over five months) and highest in other months with maximum monthly totals occurring between June and August for different locations (Scanlon and others, 2012).

- before 2020 wet soil conditions occurred for both summer and winter months which is consistent with the smaller amounts of vertical displacements from 2015 to 2019 in Figure 8;
- From 2021 to 2023, the soils became gradually drier which is consistent with increasingly greater vertical displacements in Figure 8;
- during summer months from 2021 to 2023 where moderate drought conditions existed, the largest amounts of subsidence occurred.

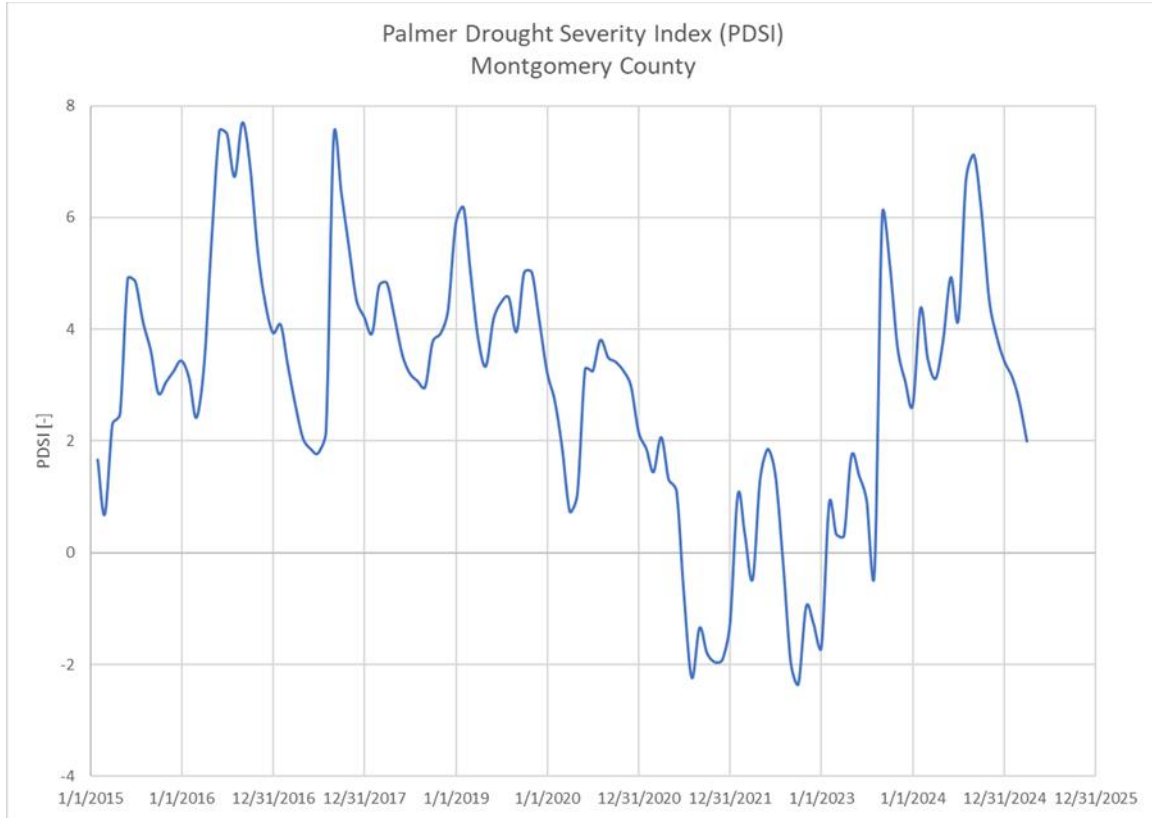
Figure 10 Monthly values for the Palmer Drought Severity Index (PDSI) form estimating relative dryness of soils for Montgomery County (from <https://wrcc.dri.edu/wwdt/time/>.)

The PDSI is used to estimate the relative dryness of the soil and is calculated from ET, rainfall, the soil water holding capacity from soil map developed by the National Cooperative Soil Survey. PSDI values range from +10 to -10 with lower number represent drier conditions. Table 7 provides additional details on the soil’s classifications associated with the PSDI numbers. Among the saline features in Figure 10 are:

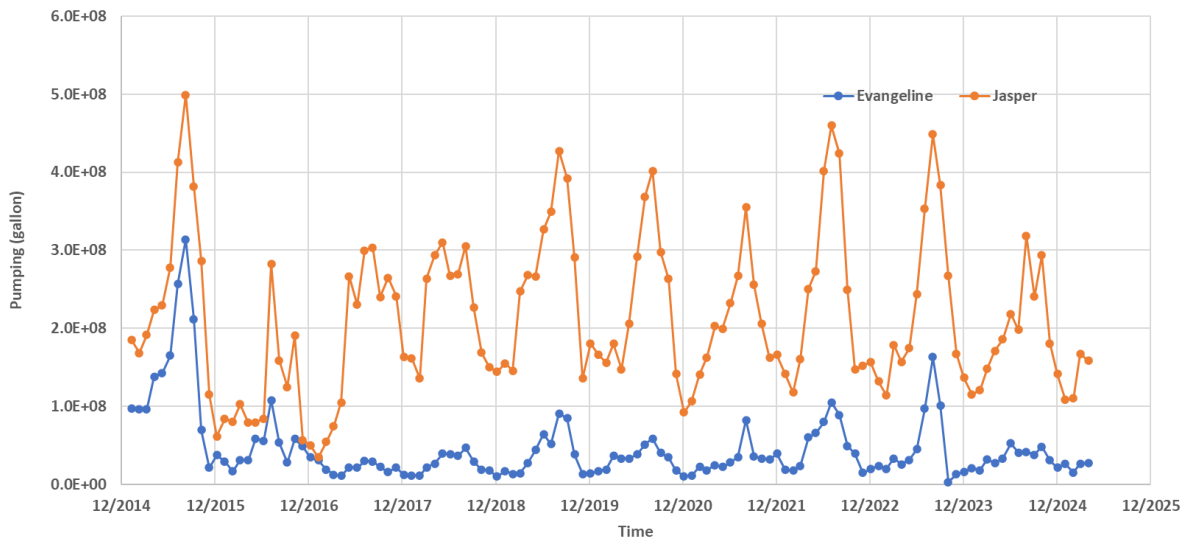
Figure 11 Monthly production from the Woodlands Wells from the Evangeline and Jasper aquifers.

Another factor that may be contributing to the cyclic pattern between lowering and rising of the ground is the cyclic pattern in groundwater production. As shown in Figure 11, groundwater production from the SJRA wellfield is much greater during the summer months than during the winter months. During the periods of increased pumping, the hydrostatic pressure in the saturated aquifer is reduced, which in turn may cause consolidation of the aquifer matrix. If the reduction in hydrostatic pressure occurs over a sufficiently short time interval and is below a threshold called the critical drawdown, then the consolidation that occurs as a result of the reduced hydrostatic presume is elastic, meaning that the subsurface will expand if and when the hydrostatic pressure return with a rise in the water level.
