RE: Review of Twentieth (20th) Re-measure of Elevations at Monitoring Benchmarks and Monitoring Points Along the Water Line Segments W1A and W2A in the Woodlands, Texas

Review of Twentieth (20) Re-measure of the Elevations at Monitoring Points and Monitoring Benchmarks along Water Line Segments W1A and W2A

Overview of Twentieth (20th) Re-measure of the Elevations at Monitoring Points and Monitoring Benchmarks along Water Line Segments W1A and W2A

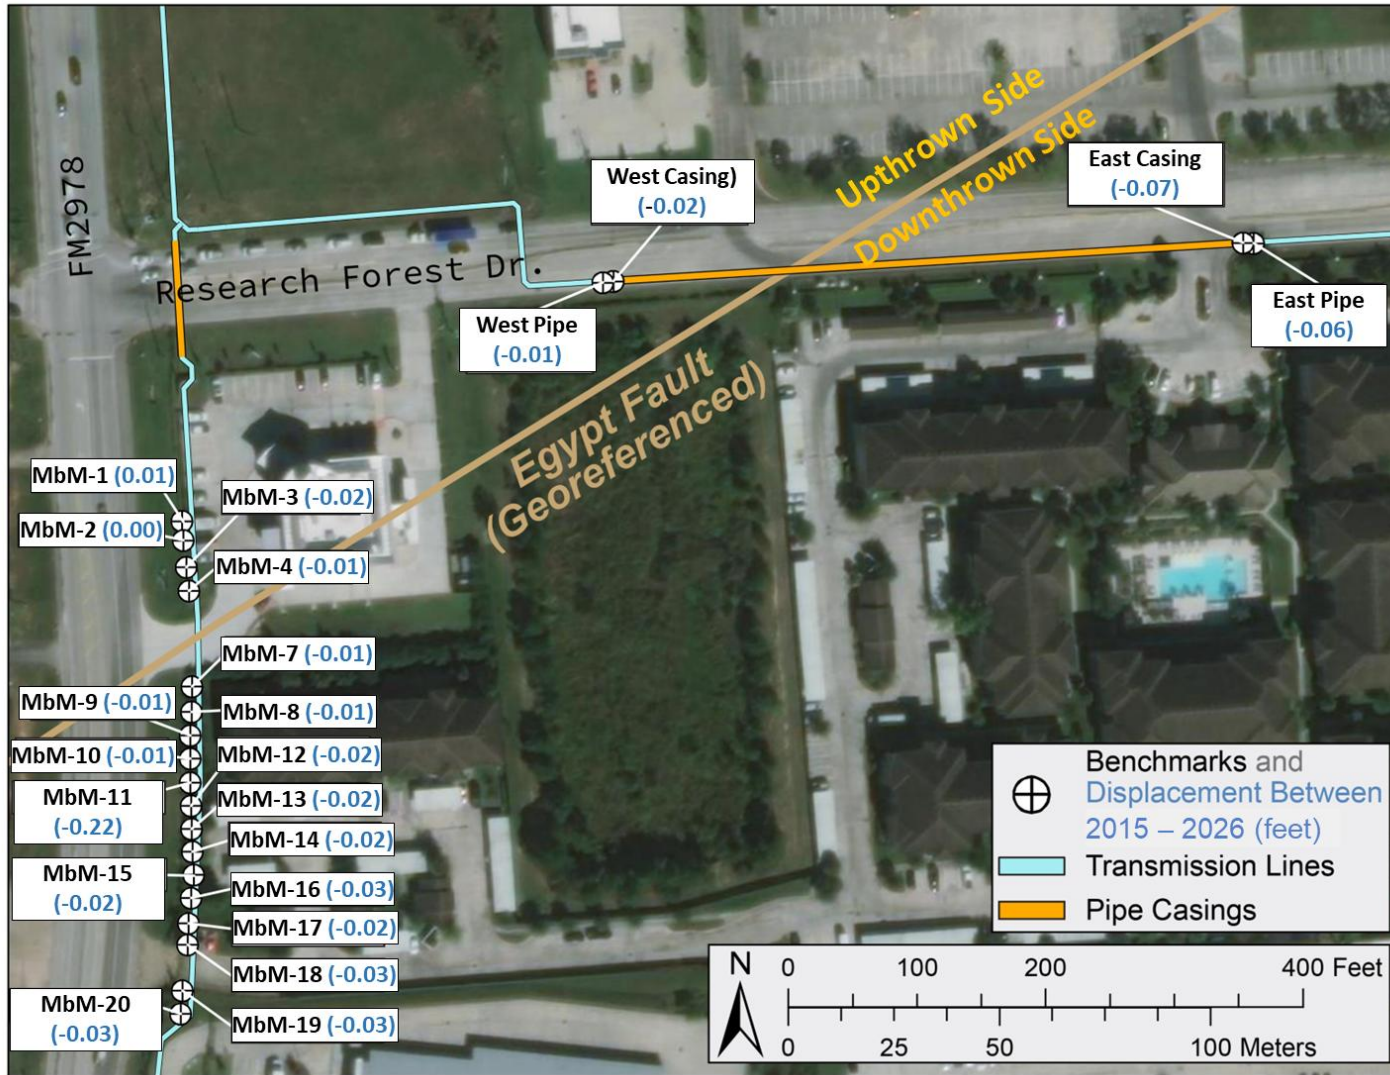
Figure 3 Satellite map showing the location of the Egypt Fault (Fugro, 2012), the W1A monitoring locations and calculated vertical displacement from March 2015 to March 2026 and the SJRA water line and pipe casing.

Egypt Fault Monitoring System – At the Egypt Fault Monitoring System (Figure 3), the changes in the elevations from March 2015 to March 2026 indicate that a greater decrease in pipe/casing elevation occurred on the downthrown side than on the upthrown side of the Egypt Fault. Over a 11-year period from 2015 to 2026, the pipe/casing elevation on the downthrown side of the Egypt Fault decreased 0.05 ft relative to the upthrown side of the Egypt Fault. The 0.05 ft decrease over an 11-year period translates into an average subsidence rate of approximately 0.0045 ft/yr.

W1A Segment – At the W1A segment where 18 monitoring benchmarks are located along FM 2978 (Figure 3), the changes in monitoring benchmark elevations from March 2015 to March 2026 indicate that a greater decrease in land elevation has occurred on the downthrown side than on the upthrown side of the Egypt Fault. Over the 11-year period from 2015 to 2026, the land surface on downthrown side of the Egypt Fault decreased 0.015 ft in elevation relative to the upthrown side of the Egypt Fault. The 0.015 ft decrease in land elevation over an 11-year period translates into an average subsidence rate of approximately 0.0014 ft/yr (note: as explained below benchmark 11 was not included in the analysis).

From March 2025 to March 2026, our analysis of the elevation data from the W1A Segment indicates that the downthrown side of the fault has moved downward relative to the upthrown side of the fault.

During the last 11 years, the monitoring data indicates that more downward movement occurred on the downthrown side on the Egypt Fault. Along Research Forest Drive, the downthrown side of the fault averaged a decrease of 0.05 ft in elevation more than the upthrown side of the fault. This amount of elevation change indicates that the downthrown side of the Egypt Fault is subsiding at rate approximately 0.0045 ft/yr relative to the upthrown side of the Egypt Fault. Along FM 2978, the downthrown side of the fault averaged a decrease of 0.015 ft in elevation more than the upthrown side of the fault. These amounts of elevation change are too small to be consider conclusive evidence that land subsidence is occurring along Egypt Fault where it intersects FM 2978.

After 11 years of monitoring the change in the monitoring point elevations at the Egypt Fault Monitoring System, the downthrown side of the fault had subsided 0.05 ft relative to the upthrown side of the fault. Thus, the average rate of subsidence of the downthrown side of the fault relative to the upthrown side of the fault is approximately 0.00455 ft/year. Based on the information that INTERA has reviewed, INTERA concludes the water line is not at risk of damage from land subsidence where it crosses the Egypt Fault along Research Forest Drive for the next 50 years if land subsidence continues at its current rate and if the SJRA safeguards work as designed.

Along FM 2978, the 16-inch water line extends to SJRA Woodlands Division Water Plant No. 4. Instead of using pipe casing to protect the water line, a SJRA contractor installed a series of ball connections in the vicinity of the Egypt Fault to accommodate movement of up to 0.25 inches of vertical movement per year over a 50-year period, or a total of 12.5 inches. Along a length of approximately 400 ft, six ball couplings were installed. During 11 years of monitoring, the average changes in the monitoring benchmark elevations are a decrease of 0.005 ft and 0.02 ft in elevation on the upthrown and downthrown side of the fault, respectively. Thus, the subsidence of the downthrown side of the fault relative to the upthrown side of the fault is approximately 0.015 over 11 years, which translates to 0.0014 ft/yr. Based on the information that INTERA has reviewed, INTERA concludes that the water line is not at risk of damage from land subsidence where it crosses the Egypt Fault along FM 2978 for the next 50 years if land subsidence continues at its current rate and if the SJRA safeguards work as designed.

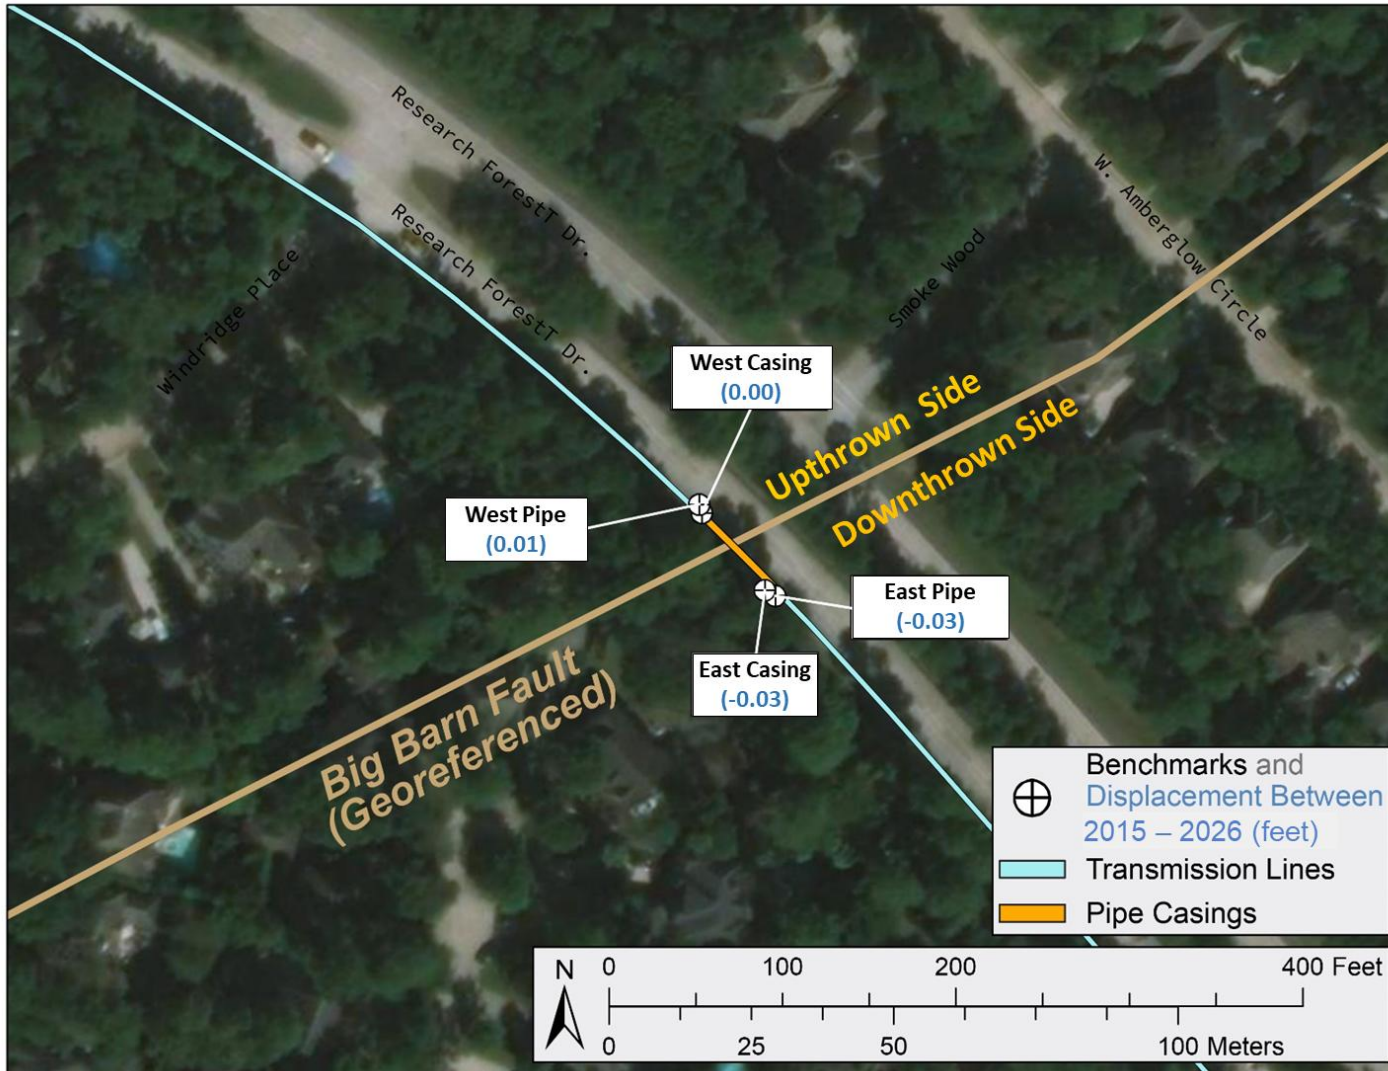
Figure 4 Satellite map showing the location of the Big Barn Fault (Fugro, 2012), the Big Barn Fault Monitoring System, calculated vertical displacement from March 2015 to March 2026, and the SJRA water line and pipe casing.

Big Barn Monitoring System – At the Big Barn Fault Monitoring System where four monitoring points on Research Forest Drive straddle the Big Barn Fault (Figure 4), the changes in the monitoring benchmark elevations indicate that a greater decrease in pipe/casing elevation has occurred on the downthrown side than on the upthrown side of the Big Barn Fault. Based on the change in elevations of the four monitoring benchmarks over an 11-year period from March 2015 to March 2026, the pipe/casing elevation on downthrown side of the Big Barn Fault decreased 0.035 ft relative to the upthrown side of the Big Barn Fault. The 0.035 ft decrease in pipe/casing over an 11-year period translates into average subsidence rate of approximately 0.0032 ft/yr.

Last year: – Over the last year, the four monitoring points that comprise the Big Barn Fault Monitoring System along Research Forest Drive in Figure 4 had the following elevation changes:

- The two monitoring points on the upthrown side of the Big Barn Fault had no change in elevation and an increase of 0.01 ft in elevation with an average change of 0.005 ft increase in elevation.

Last 11 years: – From March 2015 to March 2026, the four monitoring points along Research Forest Drive near the Big Barn Fault in Figure 4 had the following elevation changes:

- The two monitoring points on the upthrown side of the Big Barn Fault ranged from no change in elevation to an increase of 0.01 ft in elevation and averaged an increase of 0.005 ft in elevation.
- The two monitoring points on the downthrown side of the Big Barn Fault ranged had a decrease of 0.03 ft in elevation.

The changes in the elevation of monitoring points that straddle the Big Barn Fault indicate that the downthrown side of the fault has subsided approximately 0.035 ft more than the upthrown side of the fault. A 0.035 ft decrease in relative elevation over 11 years translates into an average subsidence rate of approximately 0.0032 ft/yr

INTERA has reviewed the drawings for the safeguards that SJRA's contractor constructed for the transmission pipe at the Big Barn Fault Monitoring System. The safeguards are similar to the safeguards SJRA's contractor constructed using pipe casing for the Egypt Fault. The average change in the monitoring benchmark elevations at the Big Barn Fault over 11 years for the upthrown side and for the downthrown side of the Big Barn Fault are an increase of 0.005 ft and a decrease of 0.030 ft in elevation, respectively. Thus, the decrease of the downthrown side of the fault relative to the upthrown side is 0.035 ft over 11 years, or approximately 0.0032 ft/yr. The safeguards that were constructed are designed to handle 12.5 inches of vertical movement over 50 years or approximately 0.021 ft/year. Based on the information that INTERA has reviewed, INTERA concludes that the water line is not at risk of damage from land subsidence where it crosses the Big Barn Fault along Research Forest Drive for the next 50 years if land subsidence continues at its current rate and if the SJRA safeguards work as designed.

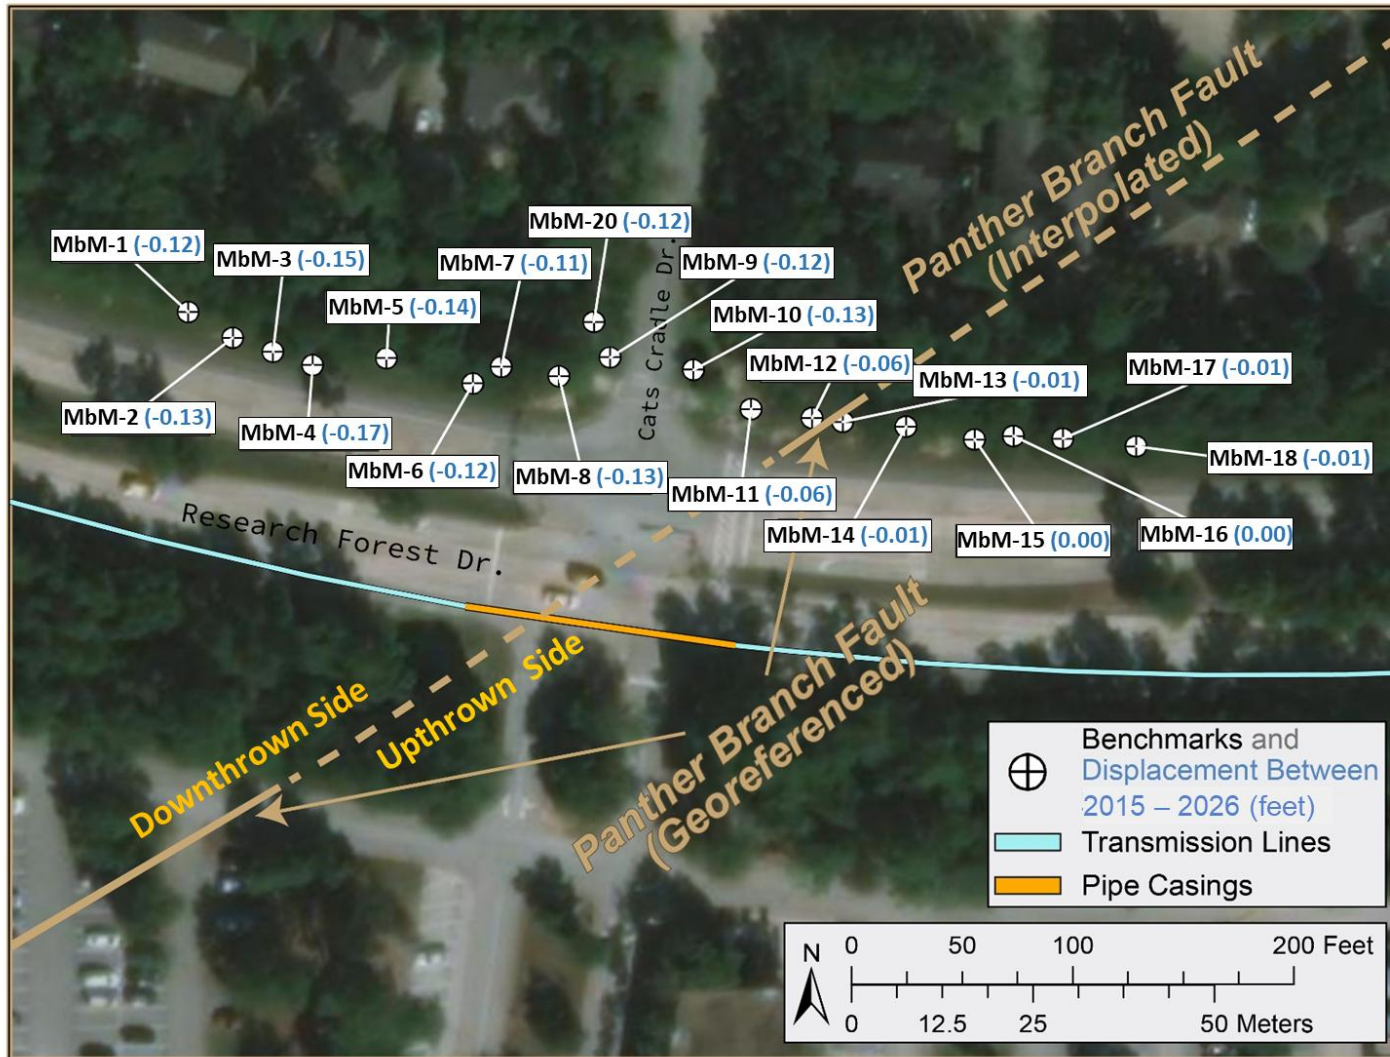
Figure 5 Satellite map showing the location of the suspected Panther Branch Fault mapped by INTERA, the Segment W2A Monitoring System, calculated vertical displacement from March 2015 to March 2026, and the SJRA water line and pipe casing.

W2A Segment – Along the W2A segment where 19 monitoring benchmarks on Research Forest Drive are located near the suspected Panther Branch Fault (Figure 5), the changes in the monitoring benchmark elevations suggest that greater land subsidence has occurred on the downthrown side than on the upthrown side of the suspected Panther Branch Fault. Based on the change in elevations of the 19 monitoring benchmarks over an 11-year period from March 2015 to March 2026, the land surface on downthrown side of the suspected Panther Branch Fault decreased 0.113 ft in elevation relative to the upthrown side of the suspected Panther Branch Fault. The 0.113 ft decrease in land elevation over an 11-year period translates into an average subsidence rate of approximately 0.0103 feet per year (ft /yr).

- The six monitoring benchmarks (MbM-13 through MbM-18) on the upthrown side of the suspected Panther Branch Fault had elevation changes that ranged from no change in elevation to a decrease of 0.01 ft in elevation.

- The thirteen monitoring benchmarks (MbM-1 through MbM-12 and MbM-20) on the downthrown side of the suspected Panther Branch Fault had elevation changes that ranged from 0.01 ft to 0.02 ft decrease in elevation.

From March 2025 to March 2026, the downthrown side of the suspected Panther Branch Fault along Research Forest Drive averaged 0.012 ft greater subsidence than the upthrown side of the suspected Panther Branch Fault.

From March 2015 to March 2026, the 19 monitoring benchmarks located along Research Forest Drive near the suspected Panther Branch Fault in Figure 5 had the following elevation changes:

- The six monitoring benchmarks (MbM-13 through MbM-18) on the upthrown side of the suspected Panther Branch Fault ranged between no change in elevation to a decrease of 0.01 ft change in elevation and averaged a decrease of 0.007 ft in elevation.
- The thirteen monitoring benchmarks (MbM-1 through MbM-12 and MbM-20) on the downthrown side of the suspected Panther Branch Fault had elevation changes that ranged from a decrease of 0.06 ft to a decrease of 0.17 ft and averaged a decrease of 0.12 ft.

The changes in the elevation at the monitoring benchmarks near the suspected Panther Branch Fault indicate that the downthrown side of the fault has subsided approximately 0.11 ft more than the upthrown side of the fault. The 0.11 ft decrease in elevation over 11 years translates into an average subsidence rate of approximately 0.01 ft/yr since March 2015.

Because the Fugro report (2012) did not show that the suspected Panther Branch Fault crossing the water line, SJRA's consultant did not design nor did SJRA's contractor construct safeguards to protect the water line from differential subsidence associated with the suspected Panther Branch Fault. The average change in the monitoring benchmark elevations at the suspected Panther Branch Fault over 11 years for the upthrown side and for the downthrown side of the suspected Panther Fault are a decrease of 0.007 ft and a decrease of 0.12 ft in elevation, respectively. Thus, the decrease of the downthrown side of the fault relative to the upthrown side is about 0.113 ft over 11 years, or approximately 0.0103 ft/yr. Figure 7 shows that since March 2022, the elevation decreased by an average rate of 0.019 ft/yr. Per discussion with SJRA, SJRA plans to continue to monitor subsidence using the benchmarks associated with the Segment W2A Monitoring System and to investigate what safeguards may be needed to protect the transmission line.

Based on the changes in monitoring benchmark elevations and benchmark points during the last 11 years, the SJRA GRP water line is not at risk of damage from land subsidence where it crosses the Egypt Fault and the Big Barn Fault for the next 50 years if land subsidence continues at its current rate and if the consultant's safeguards work as designed. For the suspected Panther Branch Fault, the amount of subsidence that has occurred since March 2015 does not pose a threat to the safety of water line based on INTERA's discussion with SJRA consultants who designed the water line. However, INTERA recommends SJRA continue with studies of the suspected Panther Branch Fault study to determine if and

where the suspected Panther Branch Fault crosses the SJRA GRP water line and whether mitigation measures will be needed in future.

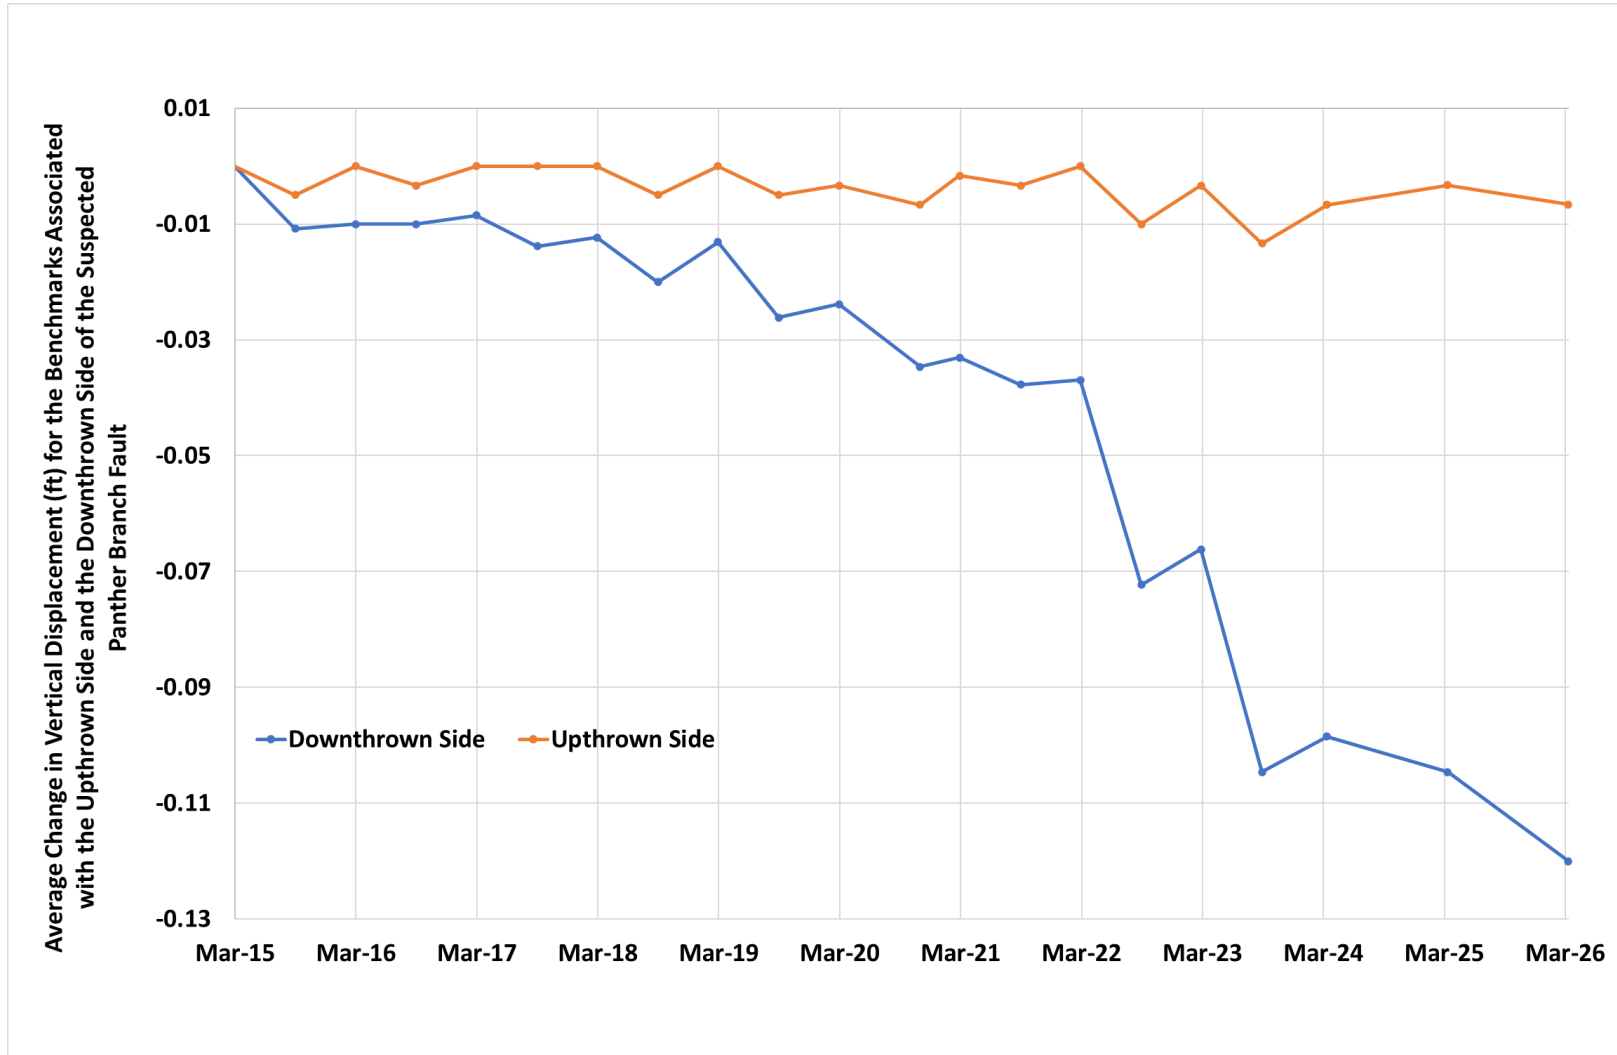
Figure 6 Comparison of average vertical displacement for the benchmarks located on the upthrown side and the downthrown side of the suspected Panther Branch Fault associated with the Segment W2A Monitoring System.

Figure 6 shows graphs for the average vertical displacement calculated for the benchmarks located on the upthrown side and the downthrown side of the suspected Panther Branch Fault as a function of time since March 2015. The graph shows that the downthrown side of the fault has consistently greater decrease in

elevation than the upthrown side. Whereas the upthrown side of the fault has not subsided more than 0.015 ft over a 1-year period within the 11-year monitoring period, the downthrown side of the fault has exhibited a general trend of declining elevation with greater displacement rates in the latter years. Over the 11-year monitoring period, the average net decline in elevation on the downthrown side of the Panther Branch Fault relative to the upthrown side was 0.0103 ft per year.

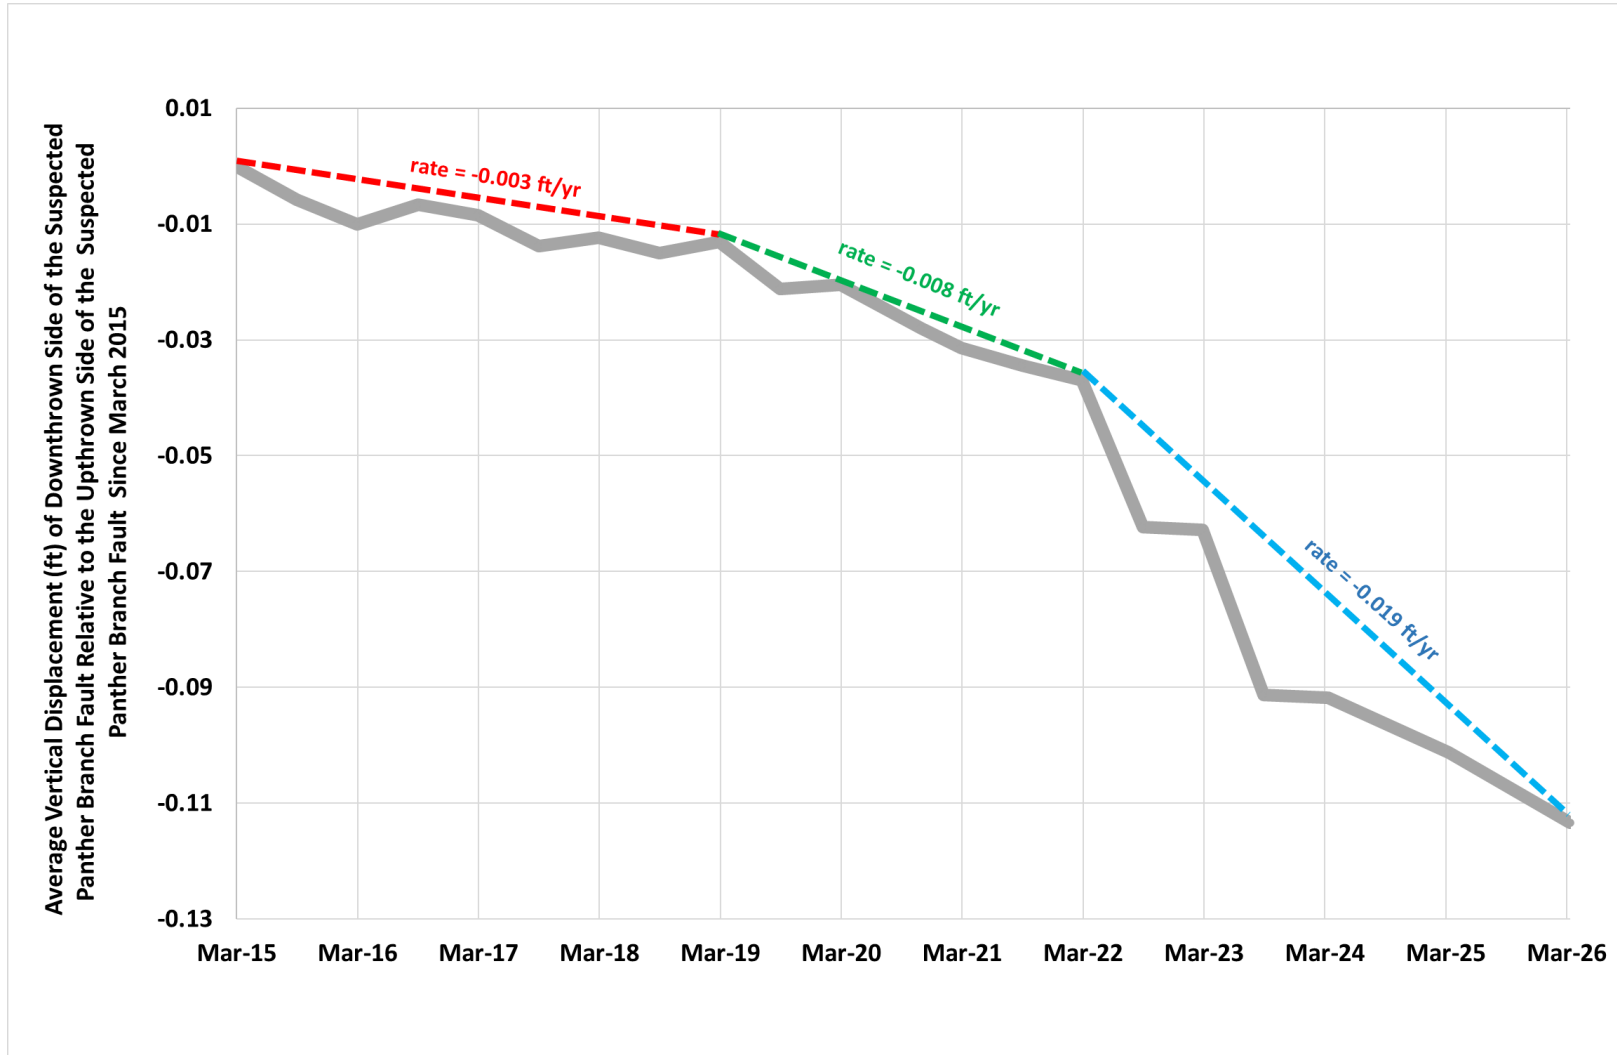
Figure 7 Relative vertical displacement and rates for relative vertical displacement for the downthrown side of the suspected Panther Branch Fault based on benchmarks associated with the Segment W2A Monitoring System

Figure 7 and **Table 5** show the rates of vertical displacement for the downthrown side of suspected Panther Branch Fault relative to the upthrown side of the suspected Panther Branch Fault. The relative rate is calculated by subtracting the rate of displacement of the upthrown side from the rate of displacement of the downthrown side. The temporal changes in the displacement have been divided into three periods: 1) from March 2015 to March 2019; 2) from March 2019 to March 2022; and 3) from March 2022 to March 2026.

- From Fall 2023 to December 2024, the PDSI values greater than 3 indicate very wet to extremely wet soil conditions. During a portion of that time interval, Figure 7 shows that the rate of subsidence was similar to the low rate that occur prior to January 2020 when wet soil conditions also prevailed. The occurrence of low subsidence rate and rebounds during periods with high PDSI values is presented later in the report support the conclusions that the shrinkage of clayed soil is the most likely cause for the observed subsidence at the W2A Segment.

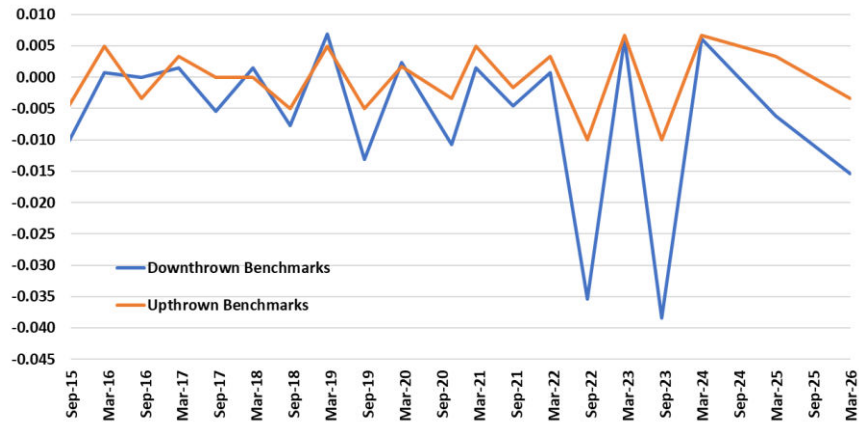
Figure 8 Vertical displacement that occurred during 6-months to 1-year intervals preceding the March and September measurements of benchmark elevations associated with Segment W2A Monitoring System along the suspected Panther Branch Fault.

- Before January 2020, the PDSI was primarily greater than 3 indicating very wet to extremely wet soil conditions for both summer and winter months which is consistent with the smaller amounts of vertical displacements from 2015 to 2019 in Figure 8;

- From January 2021 to June 2023, the PDSI was less than 2 and average about 0 indicating drier moisture conditions than the conditions for the previous 6 years, which is consistent with increasing in the rate of vertical displacements in Figure 8;

- During summer months from 2021 to 2023 where moderate drought conditions existed, Figure 8 shows that the largest amounts of subsidence occurred. Based on the correlations observed between PDSI and changes in land elevation (which are discussed later in the report) the shrinkage of clayey soil is the most likely cause for the observed subsidence.

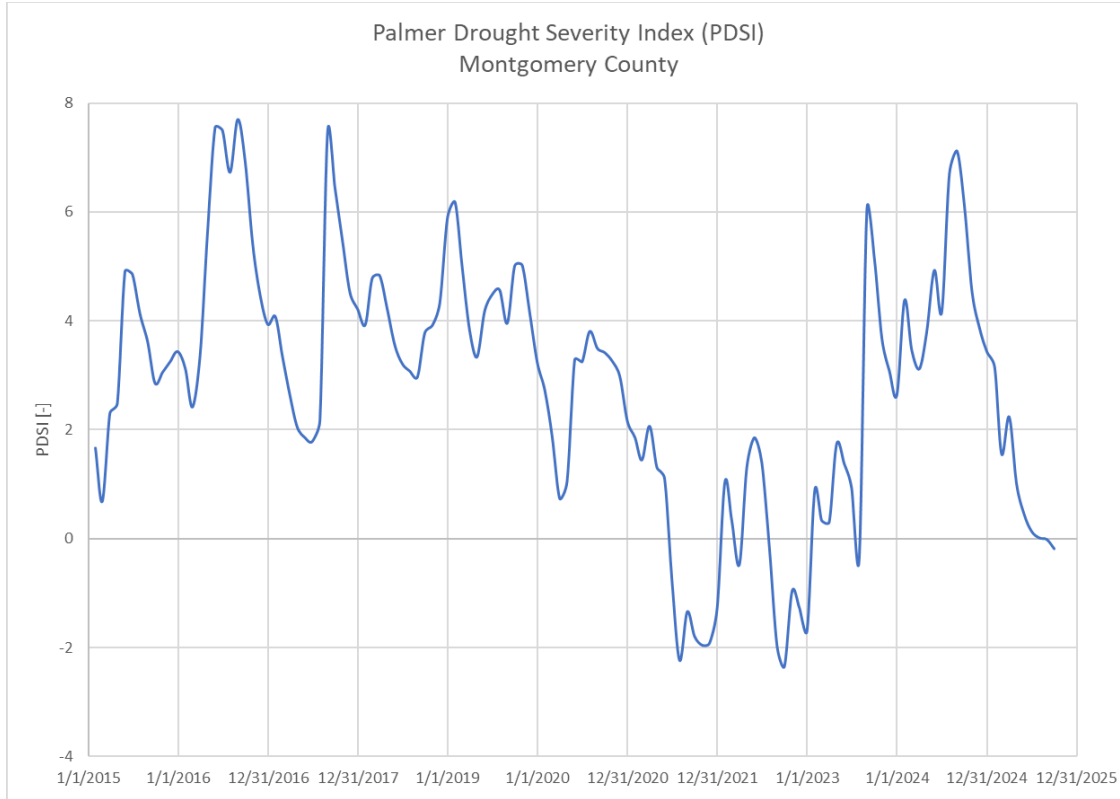
Figure 10 Monthly values for the Palmer Drought Severity Index (PDSI) form estimating relative dryness of soils for Montgomery County (from [https://wrcc.dri.edu/wwdt/time/.](https://wrcc.dri.edu/wwdt/time/))

The PDSI is used to estimate the relative dryness of the soil and is calculated from ET, rainfall, the soil water holding capacity from soil map developed by the National Cooperative Soil Survey. PSDI values range from +10 to -10 with lower number represent drier conditions. Table 7 provides additional details on the soil's classifications associated with the PSDI numbers. Among the saline features in Figure 10 are:

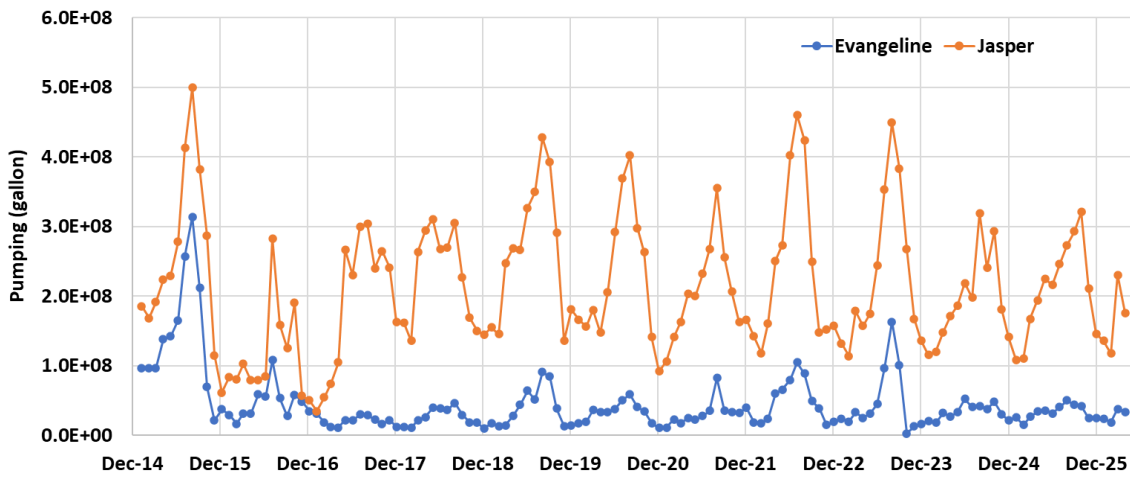
Figure 11 Monthly production from the Woodlands Wells from the Evangeline and Jasper aquifers.

Besides causing the expansive soils to subside, drought conditions can indirectly affect land subsidence by impacting the amount of water used by homeowners. As a general rule, homeowners will water their lawn more during drought conditions than during wet conditions unless regulated not to do so. Consequently, water use tends to peak during the summer months as is reflected in monthly pumping amounts shown in Figure 11. Figure 11 shows SJRA pumping from the Evangeline and the Jasper aquifers.

Among the potentially important features of Figure 11 is the increases in the production from the Evangeline aquifers in 2022 and 2023. If this increase in production caused a reduction in the water pressure, then the higher pumping rates would have contributed to the increase in the subsidence rates during the summer months in 2022 and 2023.
