Lake Houston Pump Station

JOB REPORT

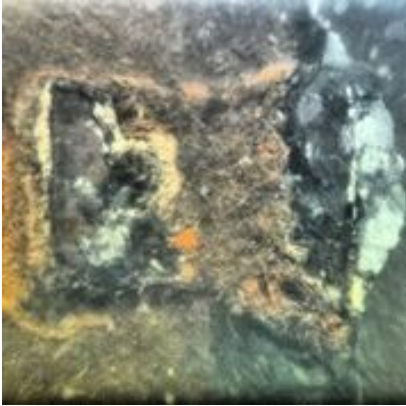
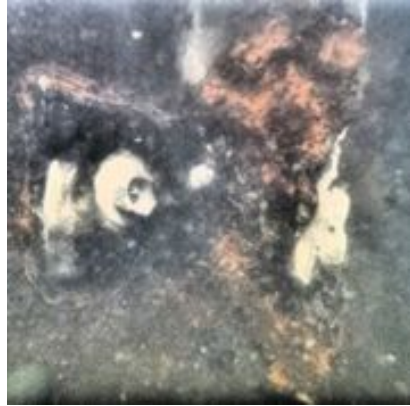
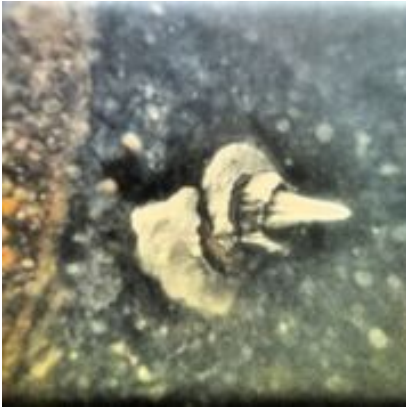
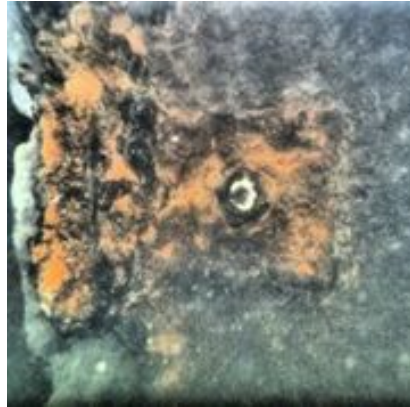
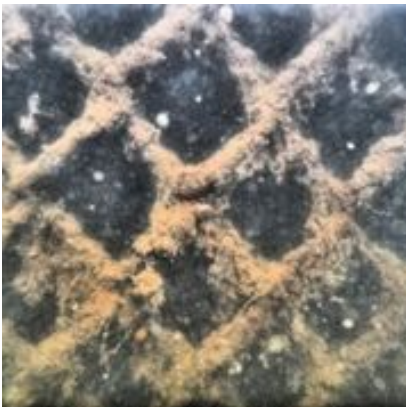
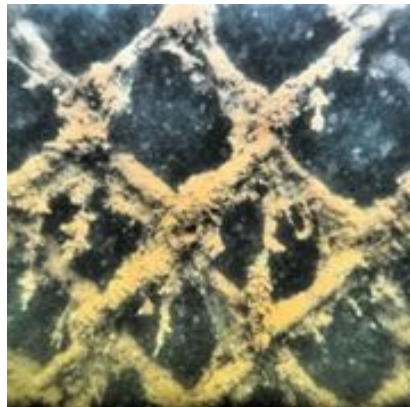
Lake Houston Pump Station
