GRP Review Committee Meeting July 24, 2023

San Jacinto River Authority Groundwater Reduction Plan Program

Analysis of Panther Branch Fault Protection on 42" GRP Water Transmission line (Segment W2A)

7/24/23

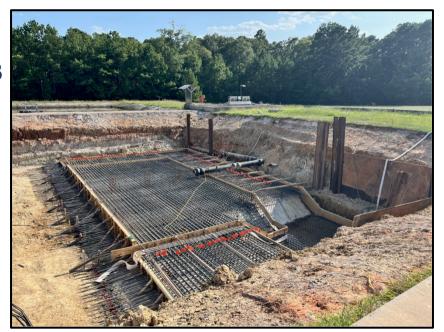
Process Water Recovery Basins Lining Improvements

- ➤ Mobilization & Submittals
- ➤ Demolition of Northern Basin
- ➤ Piping Inspection and Wrapping
- ➤ Rebar Placement and Formwork

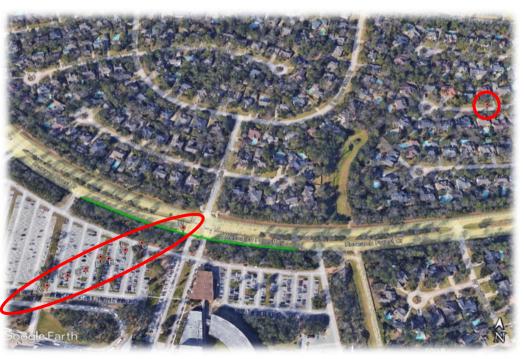
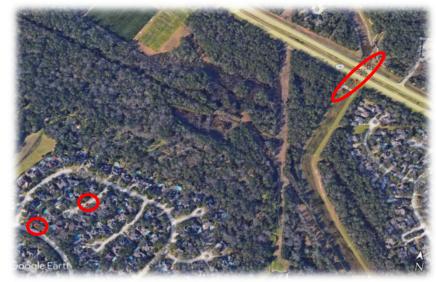
Surface Features

Visual evidence of pavement damage near focus area

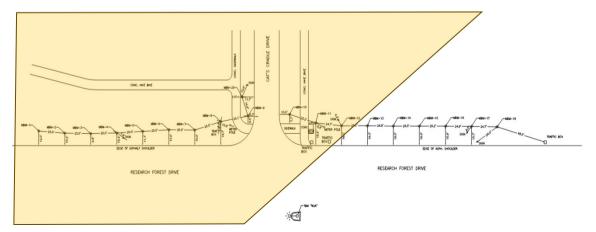
Surface Monitoring Summary

- Measured negative surface movement (settlement), west of interpolated fault line
- Maximum settlement = 1.08" at one point, BM4
 - Average rate of 0.13"/yr
- Average movement of points on the west side = 0.10"/yr

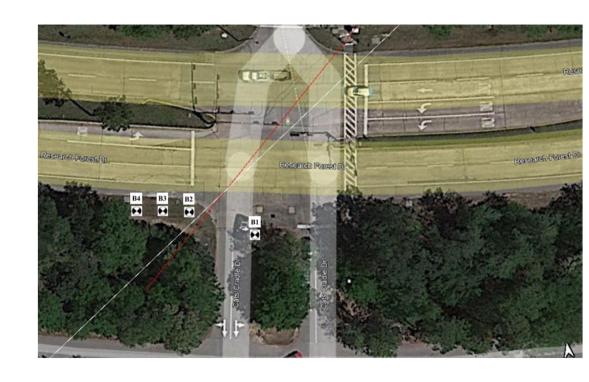
Boring Locations at Cat's Cradle

- 4 x 300-ft deep borings
 - 1 on "stationary" side
 - 3 on "sinking" side
- Pre-locate existing utilities
- Traffic Control
- Work around School Schedule
- Soil disposal

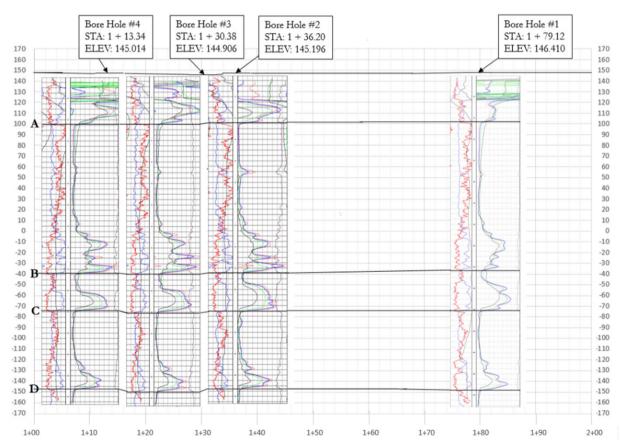
Bore Logs at Cat's Cradle

- No shift in soil between bore holes
- No indication of subsurface fault

No evidence of subsurface faulting identified in vicinity of 42-inch WL

Low risk to 42-inch water line
