# Lake Conroe Watershed Protection Plan Program – Progress Report

By: Daniel Hilderbrant and Shane Simpson

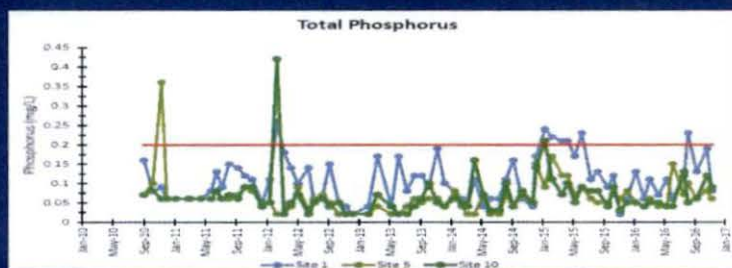
**Total Phosphorus Concentrations in Lake Conroe**

some additional constituents like silica, iron, manganese, etc. In general, both of these program's sampling results show water quality averages within the TCEQ standards and recommended levels for each tested constituent. Occasional variations in water quality do occur, which show some parameters to fall outside the desired level, but these spikes are temporary and typically follow periods of heavy rainfall. An example of the water quality data from the report is shown above.

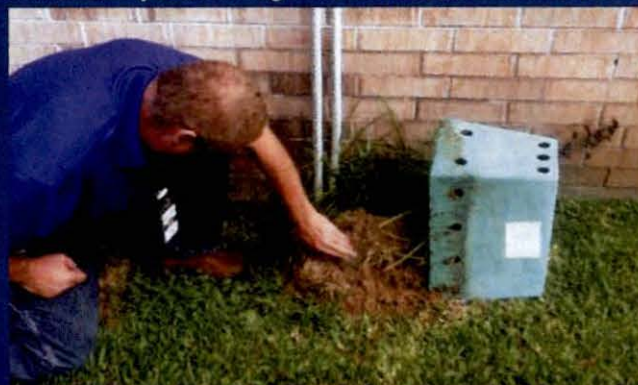
**Randy Acreman inspects an Aerator on an OSSF System**
