# Lake Conroe Dam Relief Well Rehabilitation Pilot Study Project Summary

*Client: San Jacinto River Authority  
SJRA Project No: LCPR0027.1001.2C006*

June 11, 2018

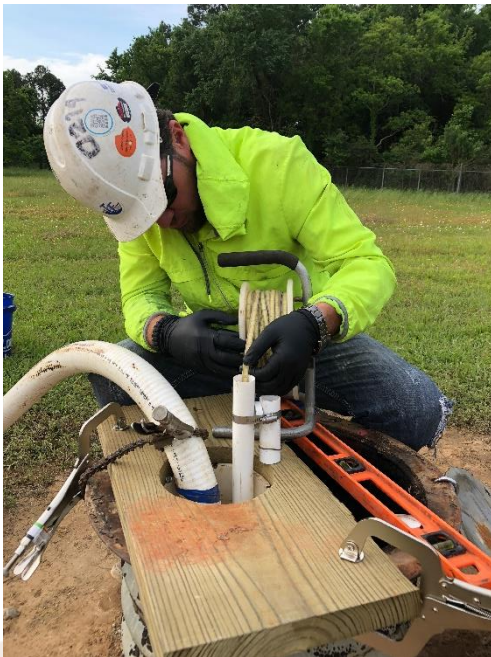
We began the process by first performing the video inspection; however, the resulting video showed that

the well was filled with growth\deposits which made it difficult to determine the condition of the well riser and screen. It was then determined to perform the initial video inspection of the wells following the initial artesian flow tests and pump tests, to allow for the removal as much debris from the wells as possible, prior to the video inspection.

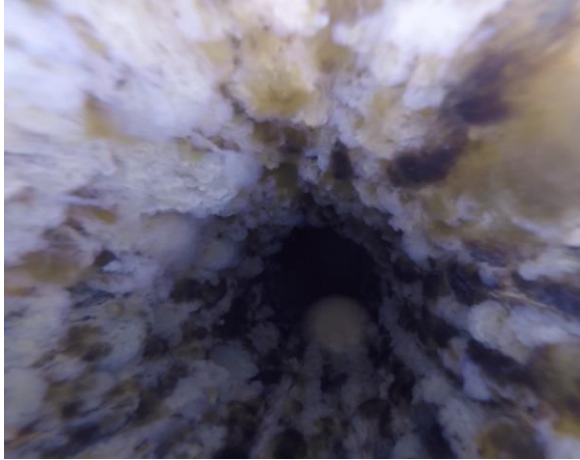
*Relief Well 5: Pre-Maintenance*

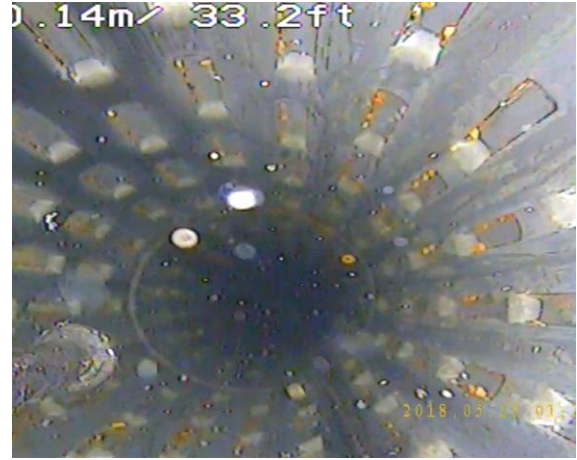
*Relief Well 5: Post-Maintenance*

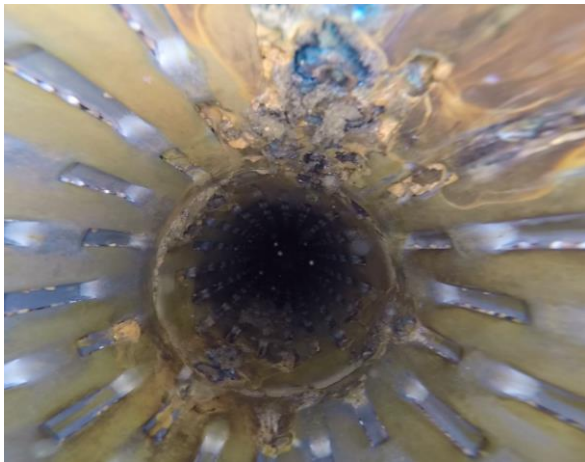
*Relief Well 10: Pre-Maintenance (After Pump Test)*

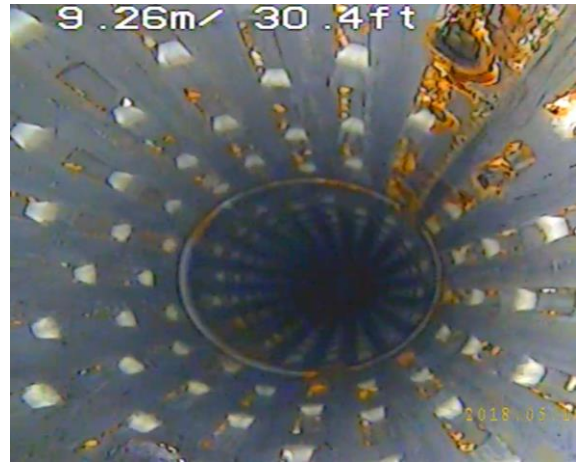
*Relief Well 10: Post-Maintenance*

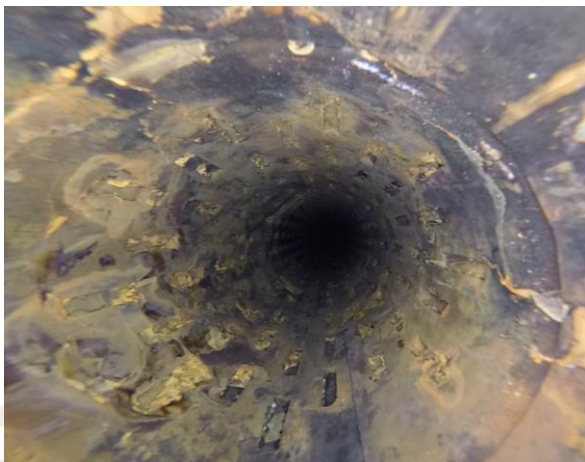
*Relief Well 18: Pre-Maintenance (After Pump Test)*

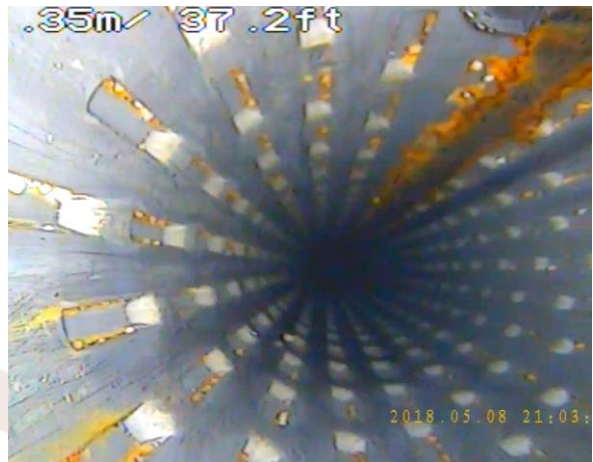
*Relief Well 18: Post-Maintenance*
