LAKE CONROE DAM RELIEF WELLS REHABILITATION

CSP NO. 19-0012

SUPPLEMENTAL INFORMATION PACKET

TerraFirma Earth Technologies, Ltd. (TF) was contracted by the San Jacinto River Authority (SJRA) to perform maintenance on three selected relief wells (RW-5, RW-10, and RW-18) along the toe of the Lake Conroe Dam in an effort to collect data to determine the best means and methods for developing a rehabilitation and maintenance program for the other seventeen relief wells.

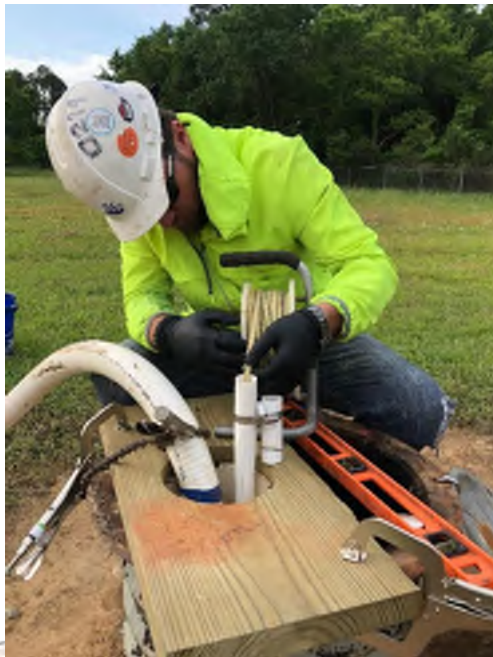
We began the process by first performing the video inspection; however, the resulting video showed that

the well was filled with growth\deposits which made it difficult to determine the condition of the well riser and screen. It was then determined to perform the initial video inspection of the wells following the initial artesian flow tests and pump tests, to allow for the removal as much debris from the wells as possible, prior to the video inspection.

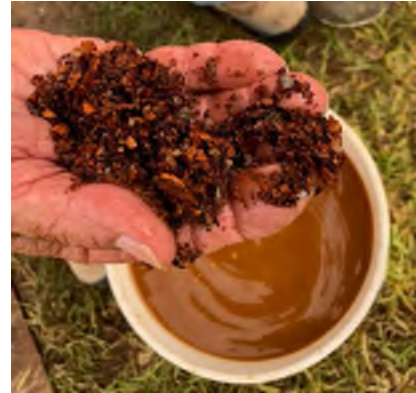
Prior to mechanical cleaning, each well was sounded, and the well depth recorded. Mechanical cleaning consisted of brushing of the well casing and screen utilizing a double brush assembly manufactured by Cotey Chemical Corporation. Each well was brushed for 1 minute per foot of screen/riser in 5-foot segments. Brushing of the well was followed up by running a surge block up and down along the well screen surface. A Bobcat S300, fitted with a mast fitted with a variable speed hydraulic hoist, was utilized to run both the brush and the surge block up and down within the well assembly, at the desired speeds. Upon completion of the mechanical brushing/surging, each well was airlifted into a holding tank until reasonably free and clear of debris. The waste water was allowed to settle before the clear water was decanted and discharged into a ditch on-site, as directed by SJRA. Each well was then sounded and the well depth recorded.

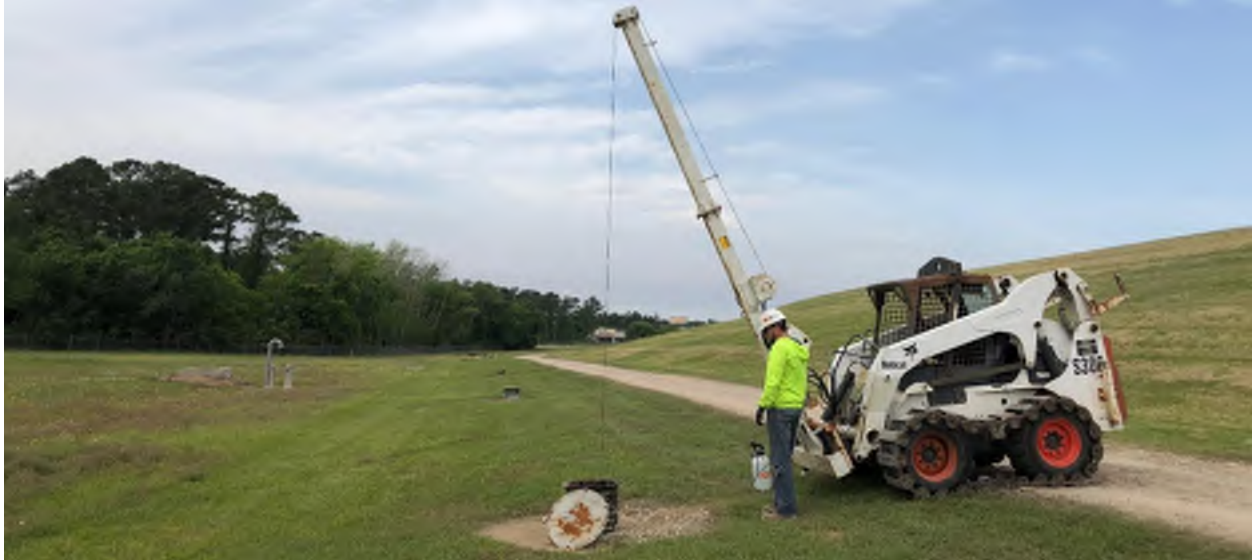
After the initial injection of the acid solution a double surge block was slowly raised and lowered in the well to blend the solution throughout the well column. After blending, the speed of the surging action was increased to approximately 3fps. Each well was surged for approximately 2 minutes per foot of screen and 1 minute per foot of casing. Upon completion of the surging action, the pH was again taken and product was re-introduced in the same manner as described above to ensure the well pH was maintained below 3.0.

Over the course of four days, the wells were intermittently agitated in manner described above, during normal working hours. In the original scope, it was planned to perform this work over three days, but also at night. In conjunction with SJRA and Freese and Nichols, it was determined to add a fourth day of agitation, and eliminate the nighttime agitation, due to safety concerns.

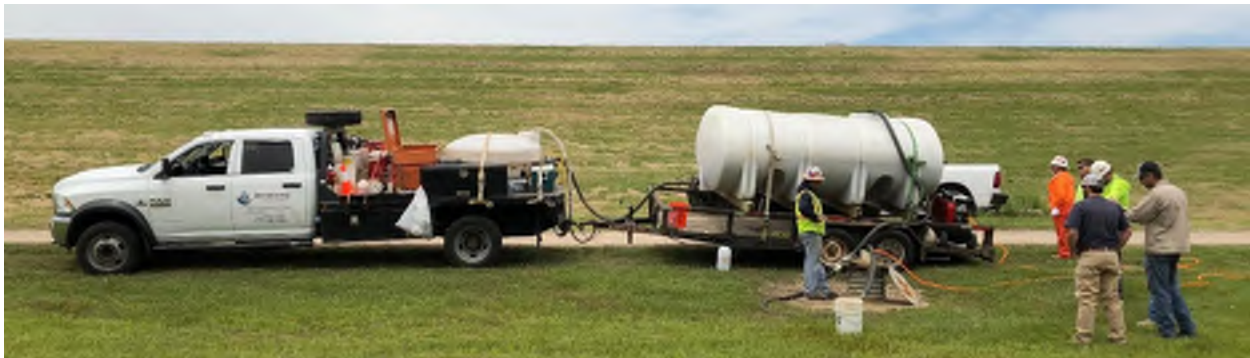
A solution of sodium hypochlorite and Nuwell 410 Chlorine Enhancer was prepared to disinfect all each of the three wells to neutralize any remaining contaminants within the wells. The solution was prepared by first filling the holding tank with approximately 620 gallons of water. Next, 2.5 quarts of Nuwell 410 were added to the tank. Finally, one gallon of Sodium Hypochlorite 12.5% was added to the solution. A trash pump was utilized to recirculate the solution during the mixing process to ensure a homogenous blend throughout the solution. Prior to mixing the solution, it was noted that our quantities were generated using the documentation from the manufacturer and differed from those called for in the specifications. We were advised that our quantities were acceptable. Specifically, the amount of Sodium Hypochlorite was adjusted per the manufactures application guide to compensate for a 12.5% solution, vs the 5% solution in the specifications, and it was calculated to use 2.5 quarts of Nuwell 410 per the application guide versus the 4 gallons called for in the specification.

Starting at RW-18, the solution was jetted into the well starting at the bottom. The jetting tool was slowly raised as the solution was added. The water level in the riser extension always remained below the top of the extension indicating that the solution was penetrating into the formation surrounding the relief wells. An attempt was made to measure the chlorine concentration at the top of the well using standard pool test strips, however, they did not react to the water. TF consulted Johnson Well Products, and they determined that it was likely that our concentration was too high outside of the range for these strips. As the solution had been mixed to the manufacturers specification, we continued with the disinfection process. Once the solution had been jetted in, a surge block was placed into the well and the solution was blended for 5 minutes to ensure equal distribution of the disinfectant throughout the well. Following this, this procedure was repeated for wells RW-10, and finally RW-5.
