Summary Memorandum

Wastewater Treatment Facility No. 1 Fence Line and Off-Site Odor Assessment

June 2020

San Jacinto River Authority

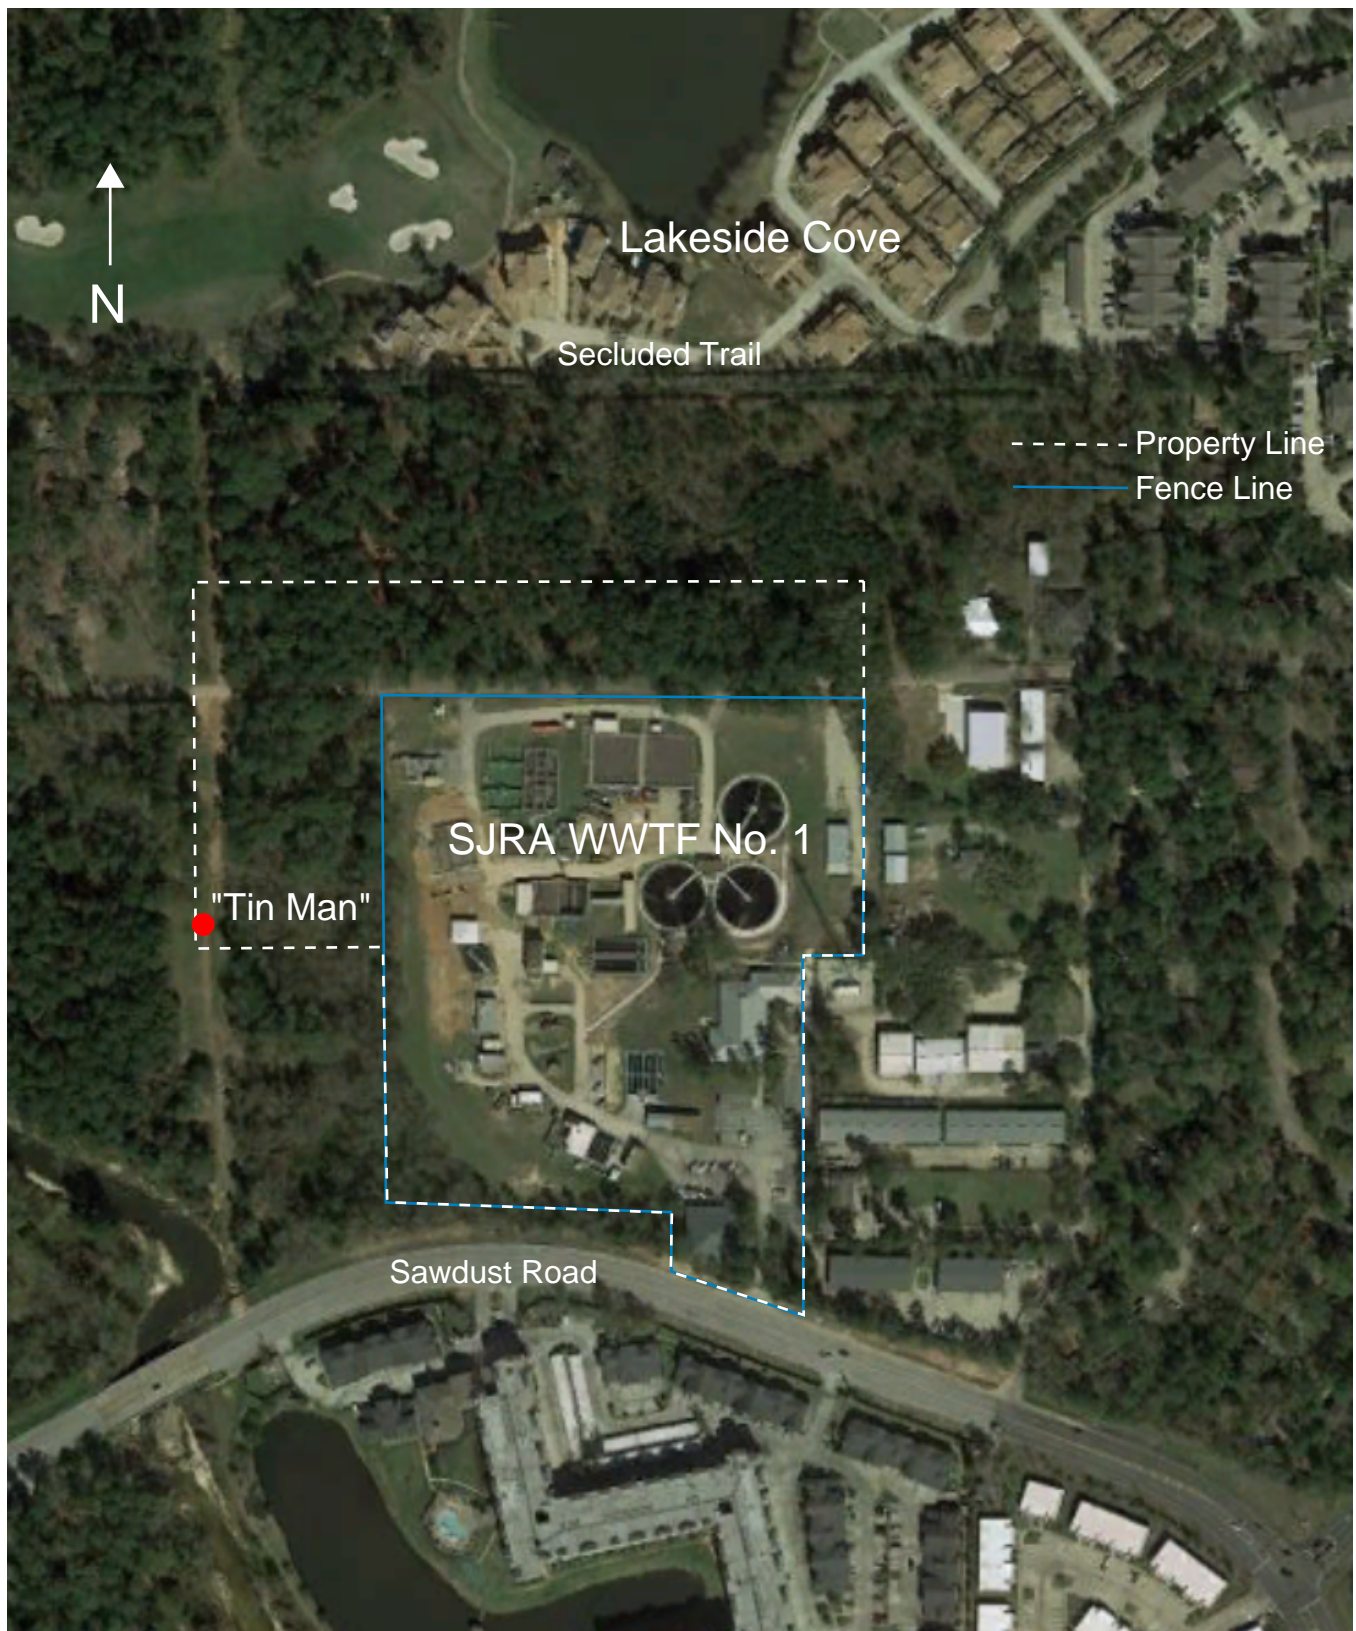
EXHIBIT 1: SJRA WWTF NO. 1 AREA MAP

Image Sourced from Google Earth®

SJRA has concerns with potential odors emanating from WWTF No. 1 located on Sawdust Road as seen in **Exhibit 1** and how those odors may be impacting nearby sensitive receptors. Perkins Engineering Consultants, Inc. (PECI) was retained to develop a fence line monitoring plan to suggest locations for monitoring of ambient H₂S levels within and adjacent to the SJRA WWTF No. 1. PECI was also tasked with reviewing the H₂S data and assessing whether the conditions present a “nuisance” to the public. There are other odorous compounds from wastewater besides H₂S that could contribute to off-site odors. H₂S was the chosen compound to measure because it is the most common odorant from wastewater treatment facilities and there are instruments available to continuously monitor very low-level concentrations in ambient air.

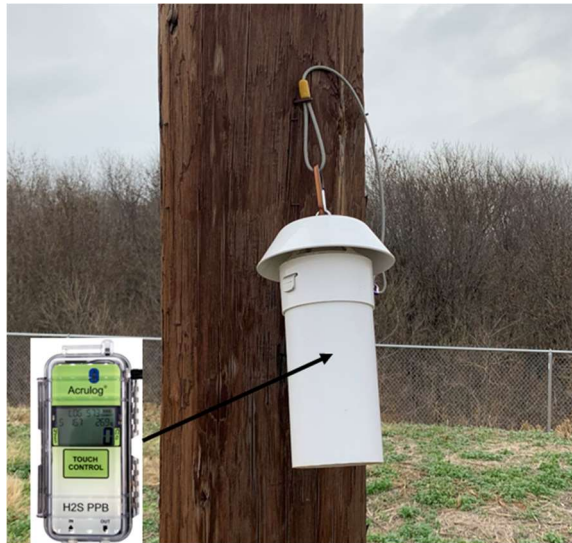
Figure 1 Acrulog® PPB Monitors

For this study, odor monitoring was conducted at various locations along the WWTF fence line, at nearby properties adjacent to the WWTF, and at an offsite location where the wastewater collection system may be contributing to the perceived odors. Acrulogs® were used to monitor ambient H₂S levels along the SJRA WWTF No. 1 fence/property line. They were mounted inside of a weather protection guard shown in Figure 1. The concentration range for those meters was 0 to 2000 ppb. They were set to take readings every ten minutes so that a 30-minute average concentration could be calculated if persistent readings were encountered. Each monitor was calibrated by the distributor prior to being deployed.

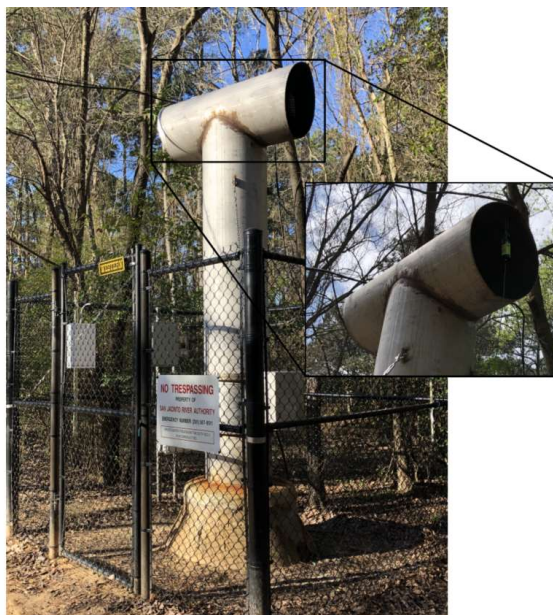
Figure 3: "Tin Man" H₂S Monitor Location

In order to determine if the nearby wastewater collection system exhaust system was also contributing to potential nuisance odors for the neighboring communities, separate sampling was performed on the discharge vent of the structure. An AcruLog® monitor with a range from 0-

200 ppm (0-200,000 ppb) was placed at the discharge of the “Tin Man” as shown in Figure 3 below.

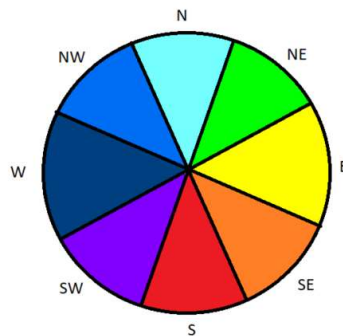
For graphs that indicate wind direction, use the following to determine direction:
