June 27, 2025

RE: Review of Nineteenth (19th) Re-measure of Elevations at Monitoring Benchmarks and Monitoring Points Along the Water Line Segments W1A and W2A in the Woodlands, Texas

Review of Nineteenth (19th) Re-measure of the Elevations at Monitoring Points and Monitoring Benchmarks along Water Line Segments W1A and W2A

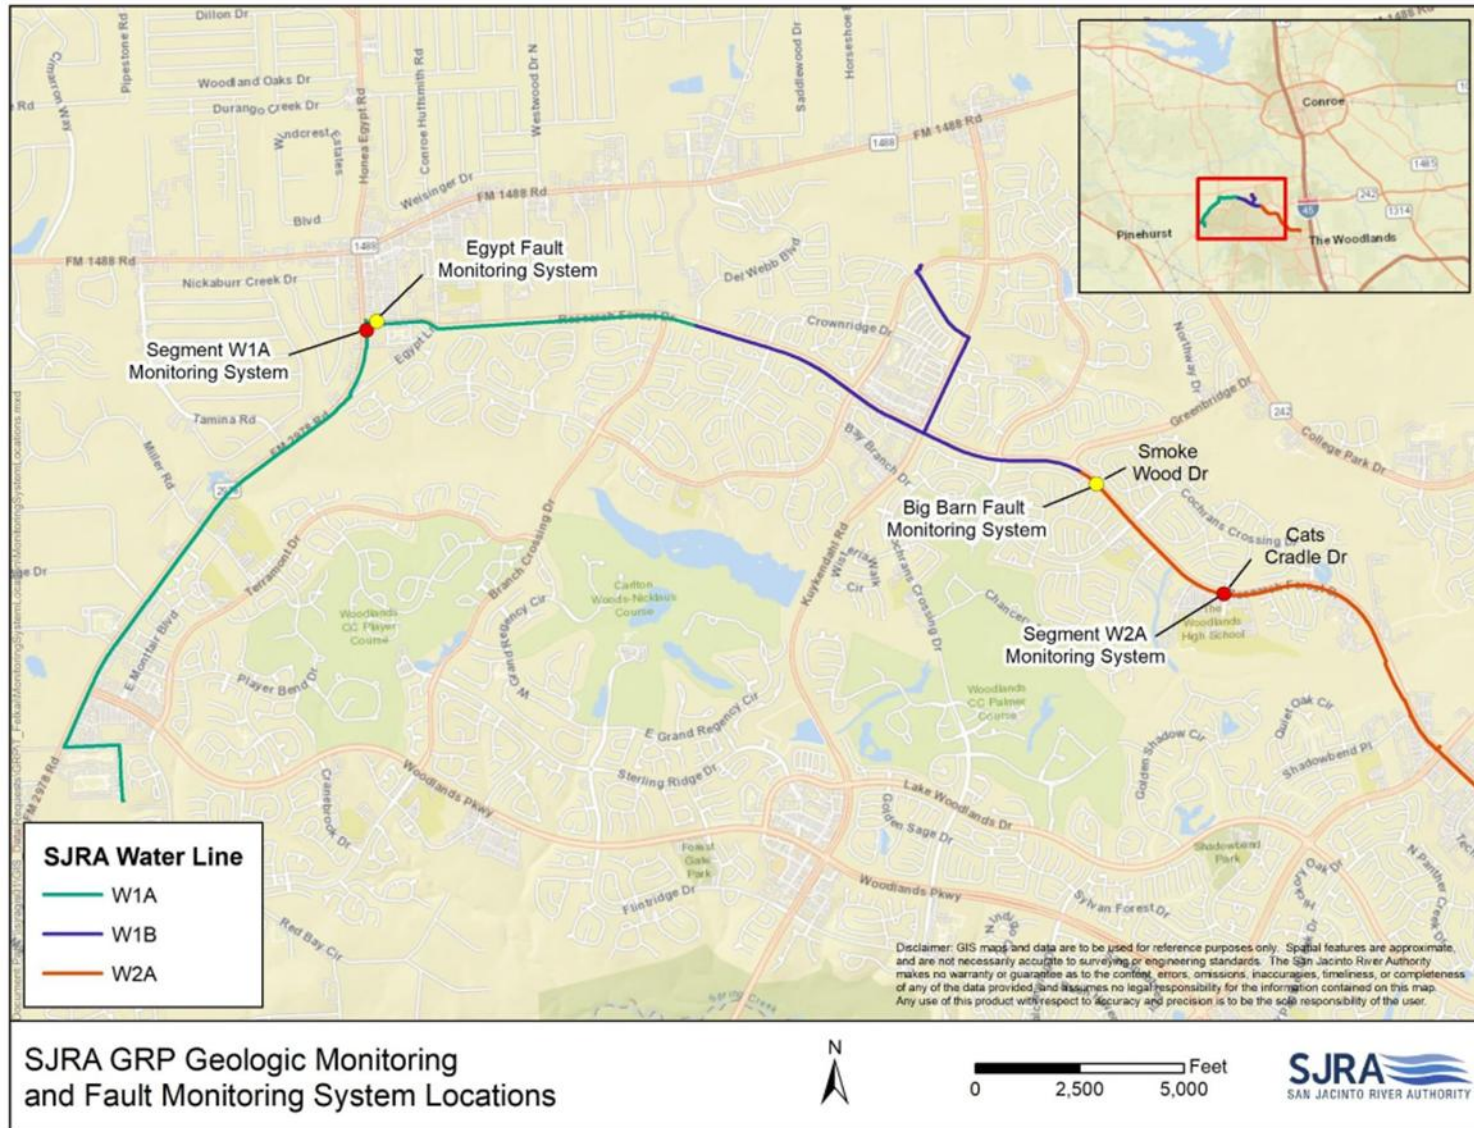
Figure 1 SJRA Groundwater Reduction Plan (GRP) Fault Monitoring System Locations (<https://www.sjra.net/grp/fault-monitoring/>)

Figure 1 shows the locations of the water line segments W1A and W2A and the four monitoring systems. Each of the monitoring systems consists of monitoring points or monitoring benchmarks. Monitoring benchmarks terminate in the ground and are used to measure elevation changes in the soil. Monitoring points terminate on top of a pipe or a pipe casing and are used to measure the elevation changes of the water line. The Egypt Fault Monitoring System and the Big Barn Fault Monitoring System consists only of monitoring points. The Segment W1A Monitoring System and Segment W2A Monitoring System consist of only monitoring benchmarks.

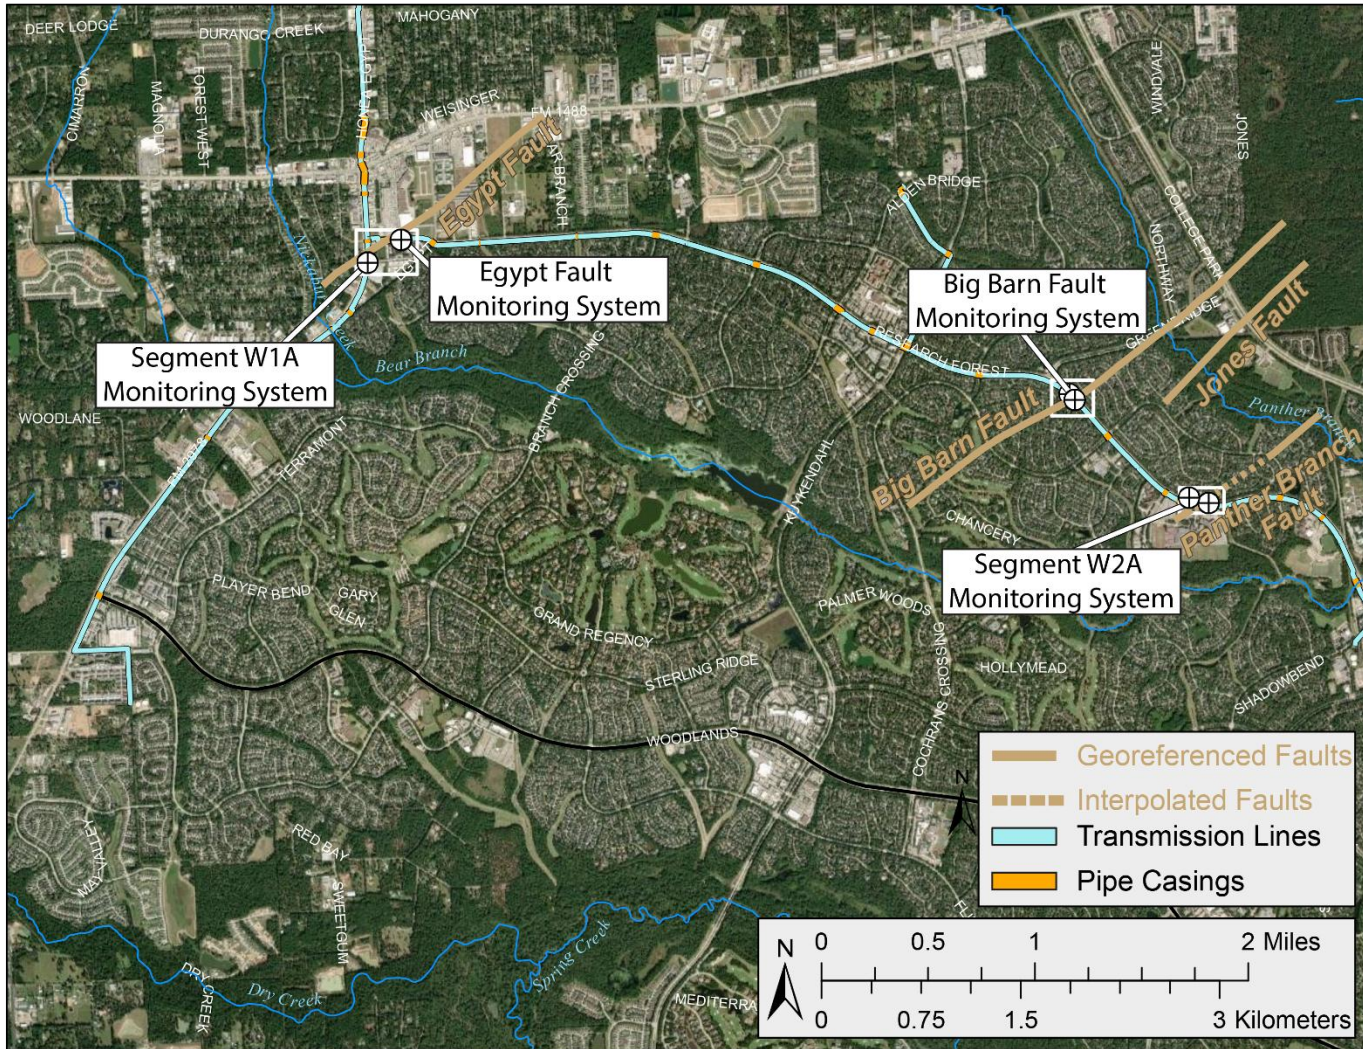
Figure 2 Satellite map showing the location of the SJRA water line, the fault locations mapped by Fugro (2012), and SJRA monitoring systems.

Figure 2 is a satellite map that shows the San Jacinto River Authority (SJRA) Groundwater Reduction Plan (GRP) water line and the faults that have been identified in the vicinity of water line segments W1A and W2A by Fugro (2012). The lateral extent of the Egypt, Big Barn, Jones, and suspected Panther Branch faults reported by Fugro (2012) are represented by the georeferenced fault lines. In their study, Fugro (2012) did not extend the suspected Panther Branch Fault across the SJRA GRP water line route. INTERA mapped the interpolated portion of the suspected Panther Branch Fault in Figure 2 in 2021 based on an evaluation of the monitoring benchmark elevation for Segment W2A and aerial photographs of scarp locations in the parking lot of The Woodlands High School.

At the Egypt Fault Monitoring System (see Figures 2 and 3) and the Big Barn Fault Monitoring System (see Figures 2 and 4), SJRA hired consultants to design and contractors to build safeguards to protect the water line from potential damage caused by fault movement. At these two locations, SJRA also hired a consultant to install monitoring points to monitor changes in the elevation of the transmission pipe and casing near the faults. At the water line segment W1A Monitoring System (Figures 2 and 3), SJRA hired a consultant to design and a contractor to build safeguards to protect the water line from potential damage caused by fault movement. Additionally, at the water line segment W1A Monitoring System, SJRA hired consultants to install monitoring benchmarks to monitor changes in land elevations over time.

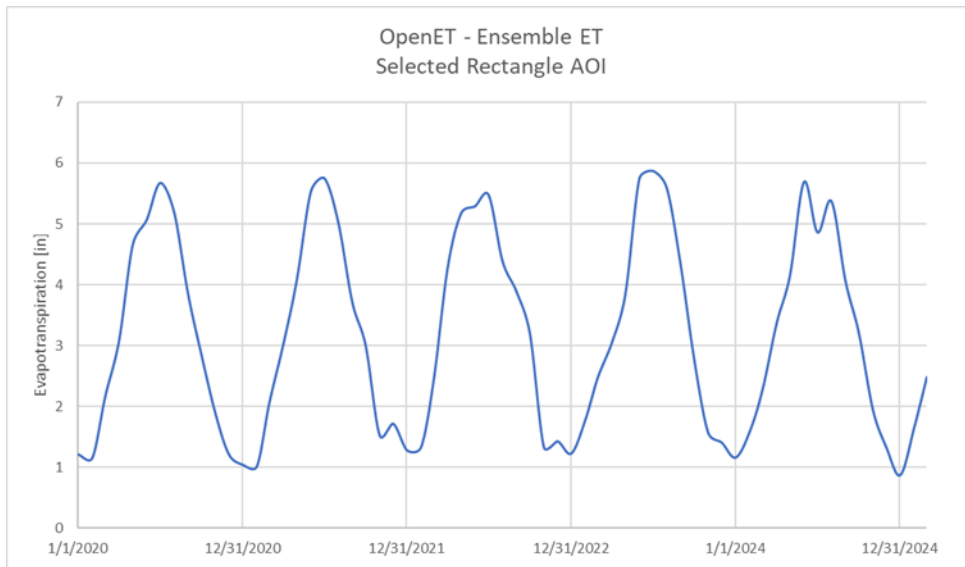
A primary factor that contributes to seasonal patterns of drying and wetting of soils is evapotranspiration (ET). Figure 9 shows monthly values for evapotranspiration at the Segment W2A Monitoring System obtained from the OpenET data portal (<https://etdata.org>). The OpenET values presented here are an ensemble average of six different algorithms based on thermal satellite data and auxiliary data (Melton and others, 2022). The monthly values show a distinctive cyclic pattern with approximately 270% greater ET from March to September than from September to March. Besides ET, the monthly Palmer Drought Severity Index (PDSI) values in Figure 10 are consistent with the cyclic pattern in the vertical displacement and the greatest subsidence rates during the summer of 2022 and 2023. PDSI data for Montgomery County was obtained from the Western Regional Climate Center (2024).

Figure 9 Monthly evapotranspiration (ET) amounts obtained for Segment W2A Monitoring System along the suspected Panther Branch Fault by OpenET (<https://etdata.org/faq>) Average cumulative ET amount from March to September and from September to March is about 25 inches and about 10 inches, respectively.
