RE: Review of Twentieth (20th) Re-measure of Elevations at Monitoring Benchmarks and Monitoring Points Along the Water Line Segments W1A and W2A in the Woodlands, Texas

Review of Twentieth (20) Re-measure of the Elevations at Monitoring Points and Monitoring Benchmarks along Water Line Segments W1A and W2A

Overview of Twentieth (20th) Re-measure of the Elevations at Monitoring Points and Monitoring Benchmarks along Water Line Segments W1A and W2A

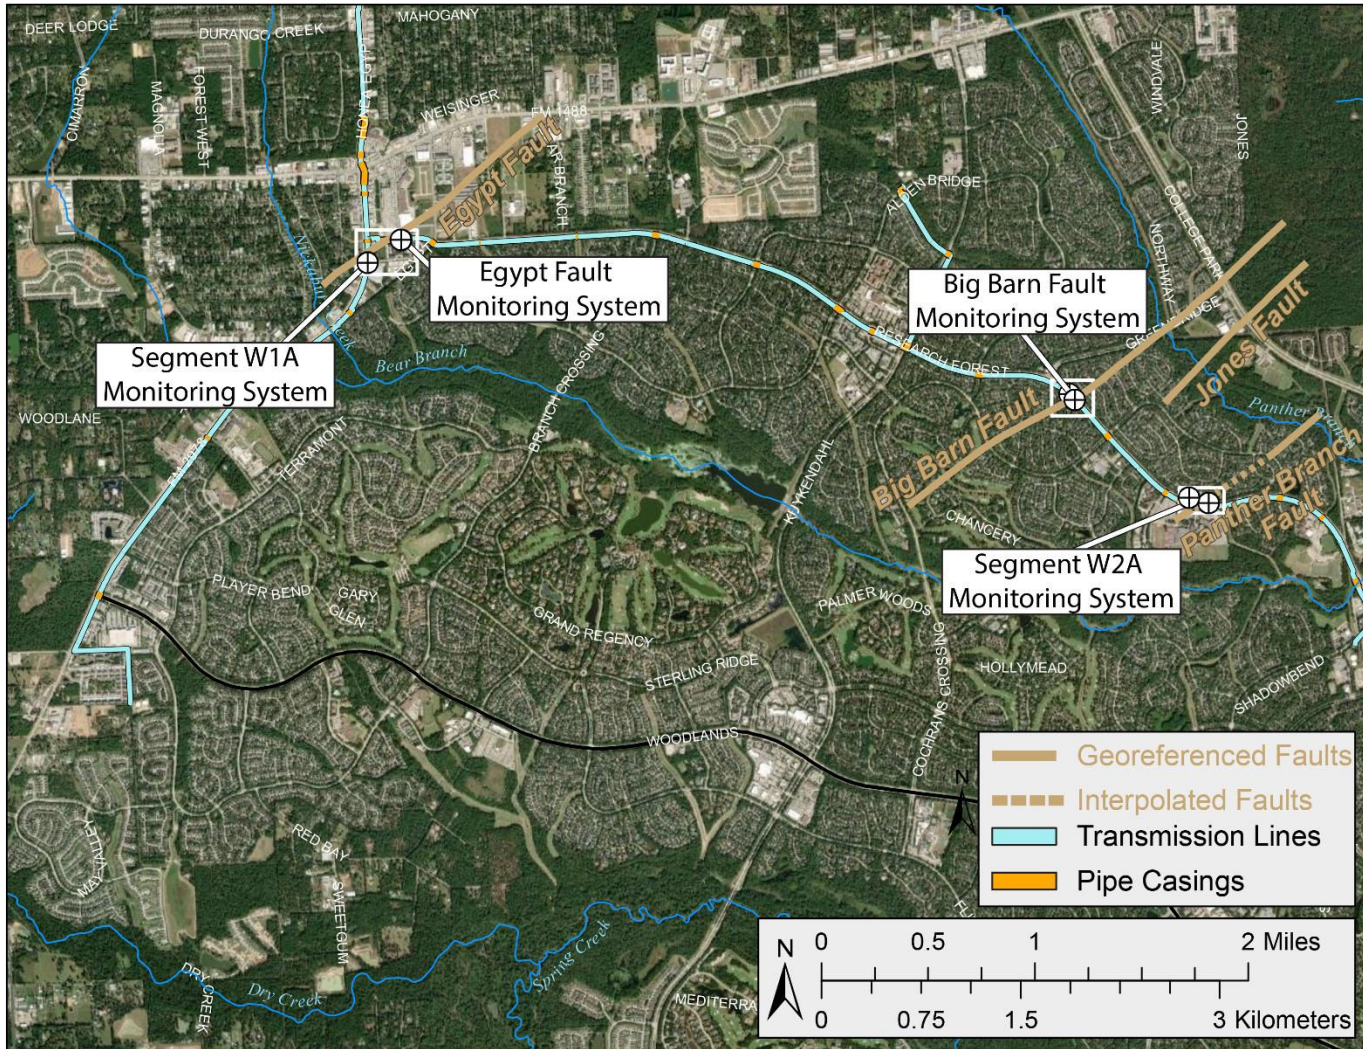
Figure 2 Satellite map showing the location of the SJRA water line, the fault locations mapped by Fugro (2012), and SJRA monitoring systems.

Figure 2 is a satellite map that shows the San Jacinto River Authority (SJRA) Groundwater Reduction Plan (GRP) water line and the faults that have been identified in the vicinity of water line segments W1A and W2A by Fugro (2012). The lateral extent of the Egypt, Big Barn, Jones, and suspected Panther Branch faults reported by Fugro (2012) are represented by the georeferenced fault lines. In their study, Fugro (2012) did not extend the Panther Branch Fault across the SJRA GRP water line route. INTERA mapped the interpolated portion of the suspected Panther Branch Fault in Figure 2 in 2021 based on an evaluation of the monitoring benchmark elevation for Segment W2A and aerial photographs of scarp locations in the parking lot of The Woodlands High School.

At the Egypt Fault Monitoring System (see **Figures 2 and 3**) and the Big Barn Fault Monitoring System (see **Figures 2 and 4**), SJRA hired consultants to design and contractors to build safeguards to protect the water line from potential damage caused by fault movement. At these two locations, SJRA also hired a consultant to install monitoring points to monitor changes in the elevation of the transmission pipe and casing near the faults. At the water line segment W1A Monitoring System (Figures 2 and 3), SJRA hired a consultant to design and a contractor to build safeguards to protect the water line from potential damage caused by fault movement. Additionally, at the water line segment W1A Monitoring System, SJRA hired consultants to install monitoring benchmarks to monitor changes in land elevations over time.

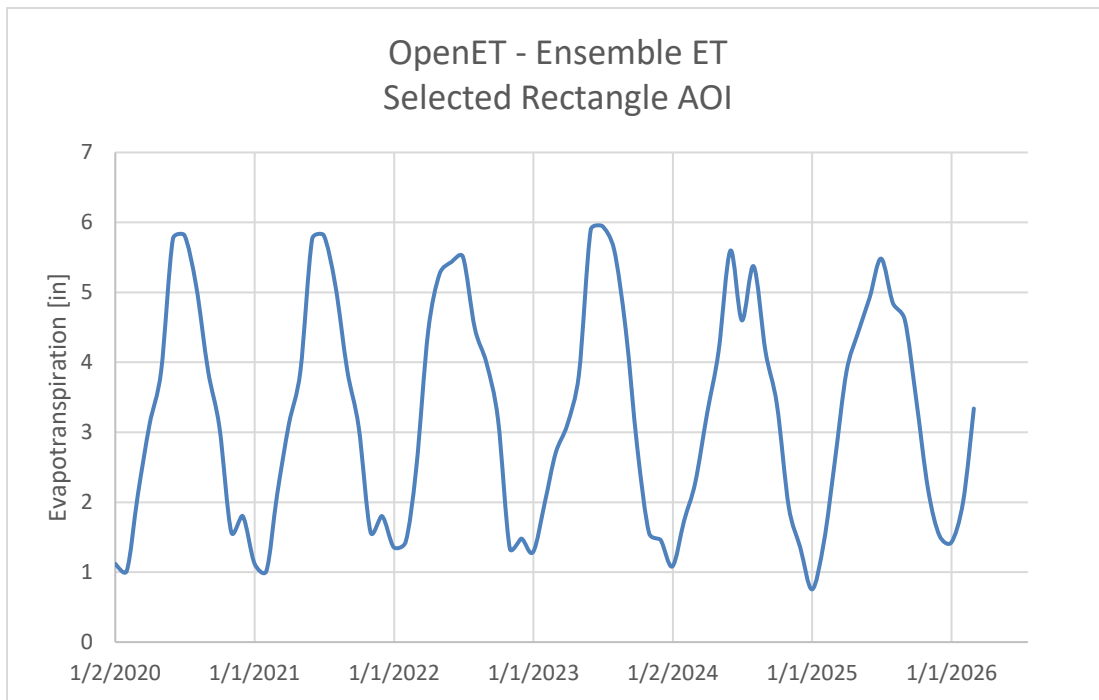
A primary factor that contributes to seasonal patterns of drying and wetting of soils is evapotranspiration (ET). Figure 9 shows monthly values for evapotranspiration at the Segment W2A Monitoring System obtained from the OpenET data portal (<https://etdata.org>). The OpenET values presented here are an ensemble average of six different algorithms based on thermal satellite data and auxiliary data (Melton and others, 2022). The monthly values show a distinctive cyclic pattern with approximately 270% greater ET from March to September than from September to March. Besides ET, the monthly Palmer Drought Severity Index (PDSI) values in Figure 10 are consistent with the cyclic pattern in the vertical displacement and the greatest subsidence rates during the summer of 2022 and 2023. PDSI data for Montgomery County was obtained from the Western Regional Climate Center (2024).

Figure 9 Monthly evapotranspiration (ET) amounts obtained for Segment W2A Monitoring System along the suspected Panther Branch Fault by OpenET (<https://etdata.org/faq>). Average cumulative ET amount from March to September and from September to March is about 25 inches and about 10 inches, respectively.
