**ADDENDUM NO. 1
RFCSP # 18-0036**

Re: **RFCSP No. 18-0036 Siphon 7 Improvements – Phase 1**

VICINITY MAP
 SJRA HIGHLANDS CAPACITY IMPROVEMENTS PROGRAM
 PROPOSED SIPHON NO. 7 IMPROVEMENTS
 HARRIS COUNTY, TEXAS

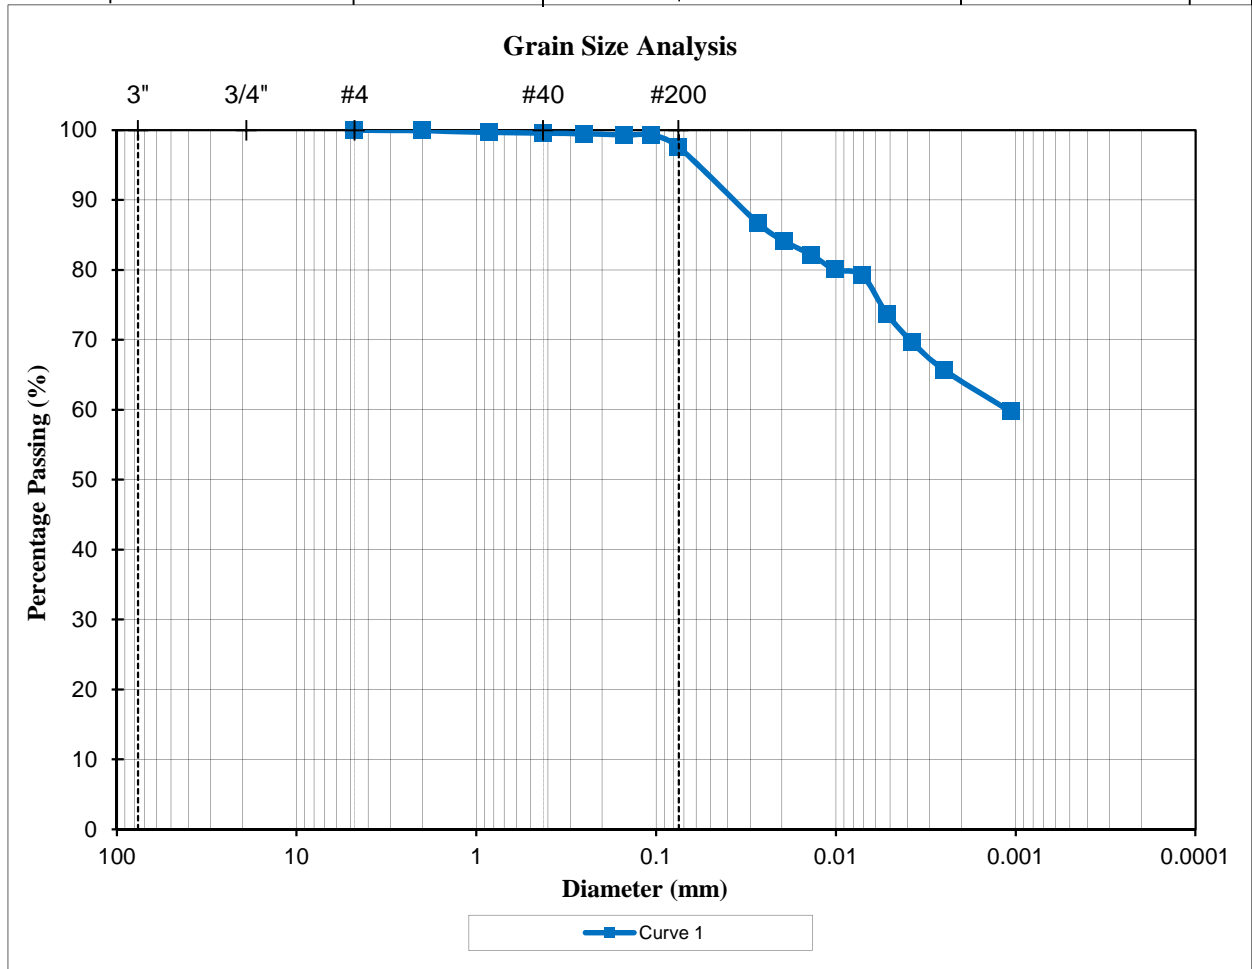
<u>Curve</u>	<u>Boring</u>	<u>Depth (ft)</u>	<u>Soil Description</u>	<u>Cu</u>	<u>Cc</u>	<u>D₅₀ (mm)</u>
1	B-2	4-6	Fill: Fat Clay (CH)	N/A	N/A	N/A

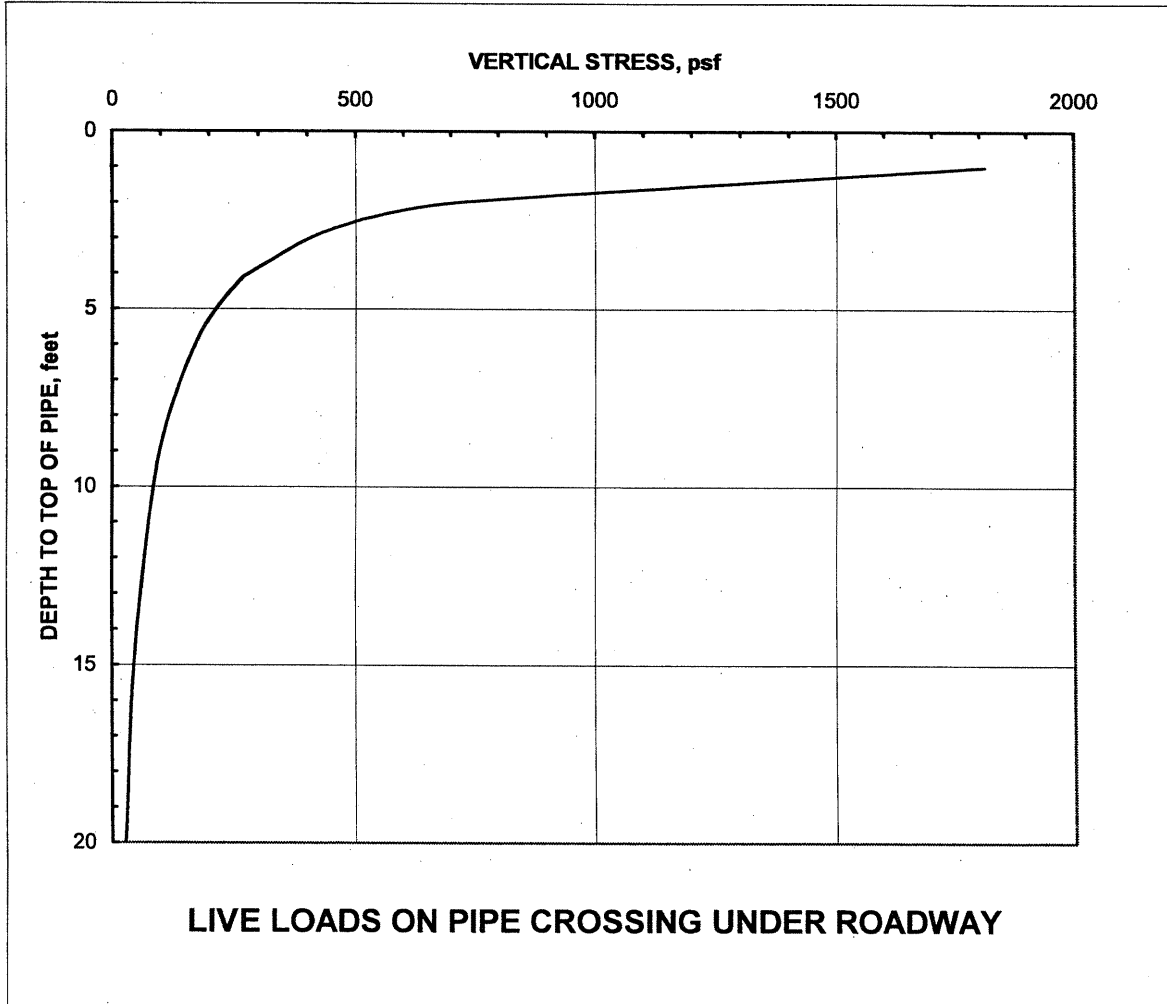
- Note: 1. The vertical stress was estimated using AASHTO HS20 truck axle loadings on paved surfaces (Reference: ASCE 15-98, "Standard Practice for Direct Design of Buried Precast Concrete Pipe Using Standard Installations").
2. Single truck passing.

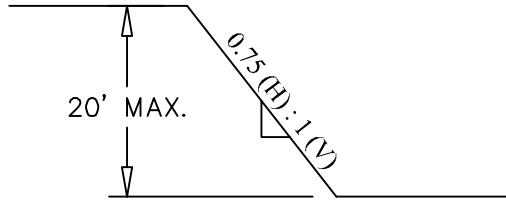
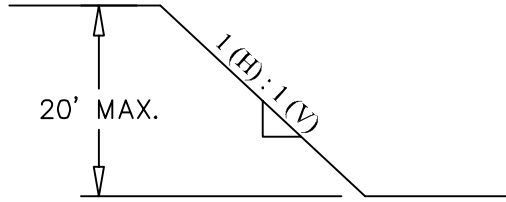
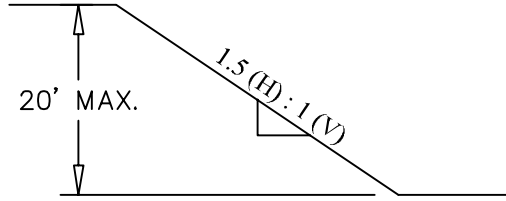
MAXIMUM ALLOWABLE SLOPES

TYPE A SOILS

TYPE B SOILS	N/A

TYPE C SOILS	N/A

(2) Maximum depth for above slopes is 20 feet. For slopes deeper than 20 feet, trench protection should be designed by the Contractor's professional engineer.

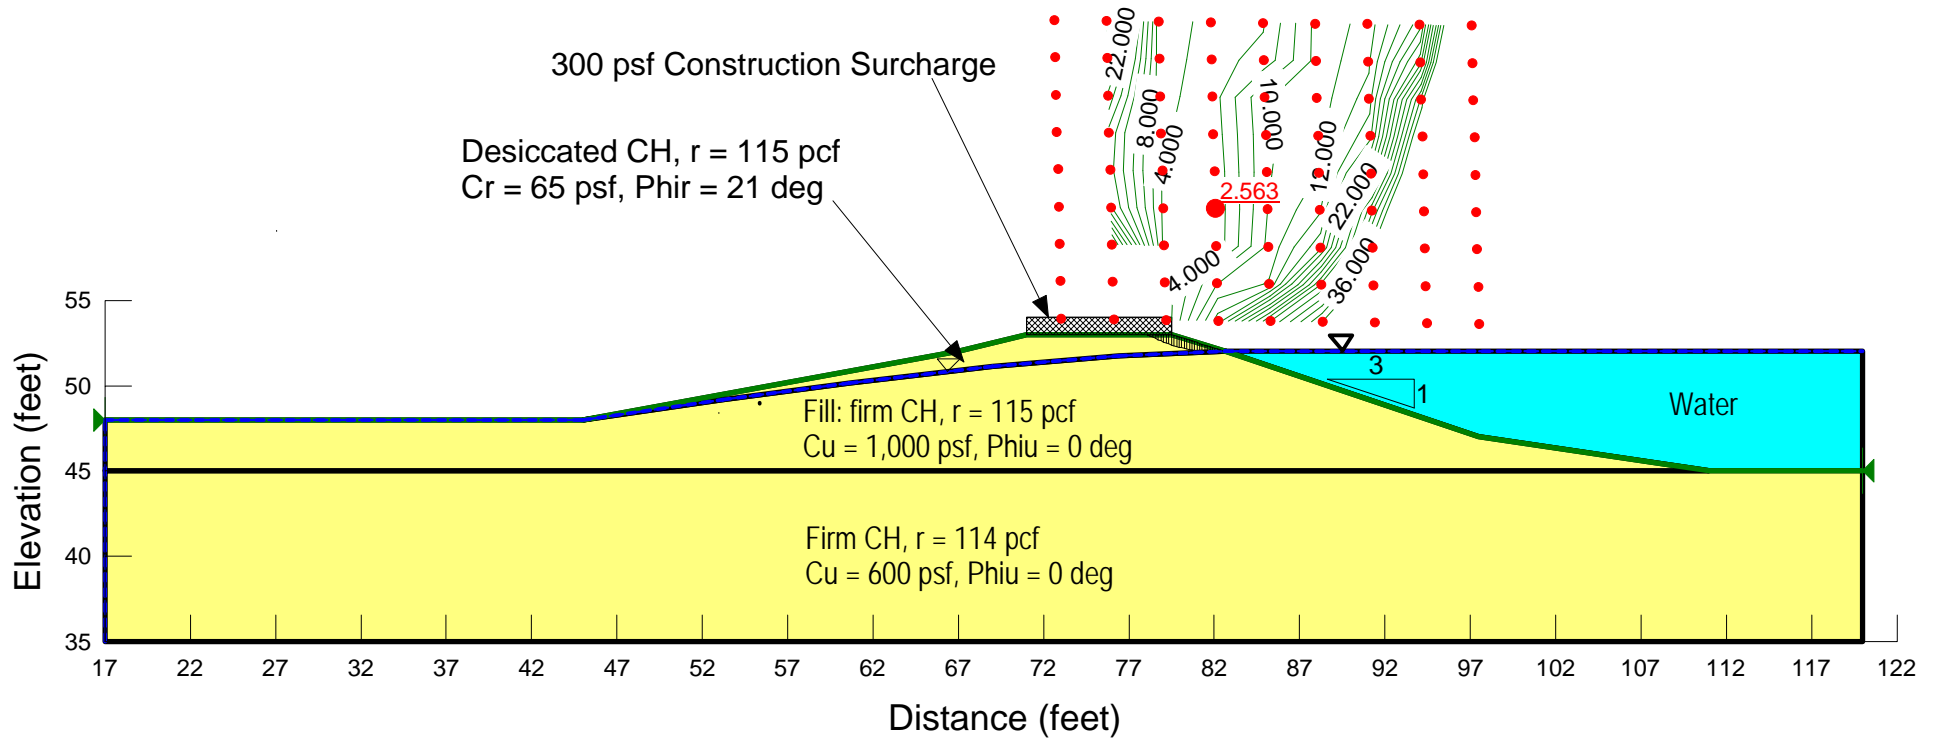
G134-15 SJRA MAIN CANAL SIPHON NO. 7
 CROSS SECTION A-A - SLOPE STABILITY ANALYSIS
 EXISTING WATERSIDE SLOPE, UPPER SLOPE H:V = 3:1, LOCAL SLIDE FOR NORTH EMBANKMENT
 BASED ON BORING B-2, SHORT TERM CONDITION

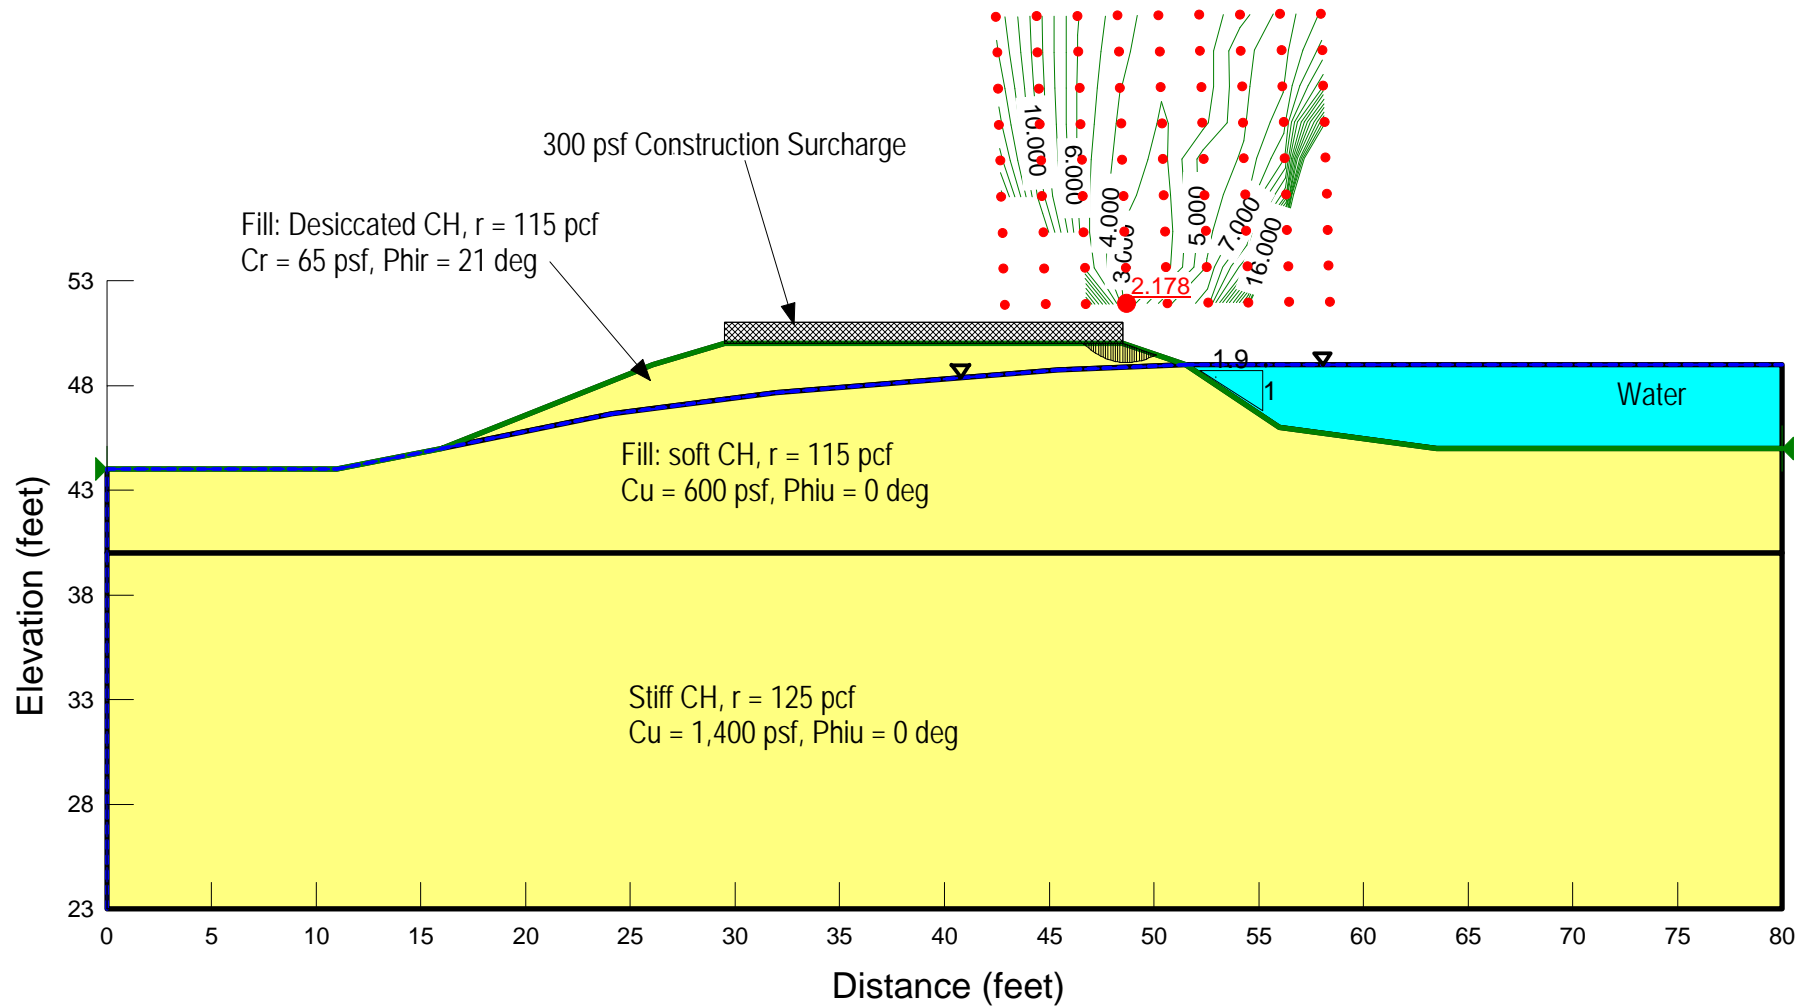
G134-15 SJRA MAIN CANAL SIPHON NO. 7
 CROSS SECTION C-C - SLOPE STABILITY ANALYSIS
 EXISTING WATERSIDE SLOPE, UPPER SLOPE H:V = 1.9:1, LOCAL SLIDE FOR NORTH EMBANKMENT
 BASED ON BORING B-1, SHORT TERM CONDITION

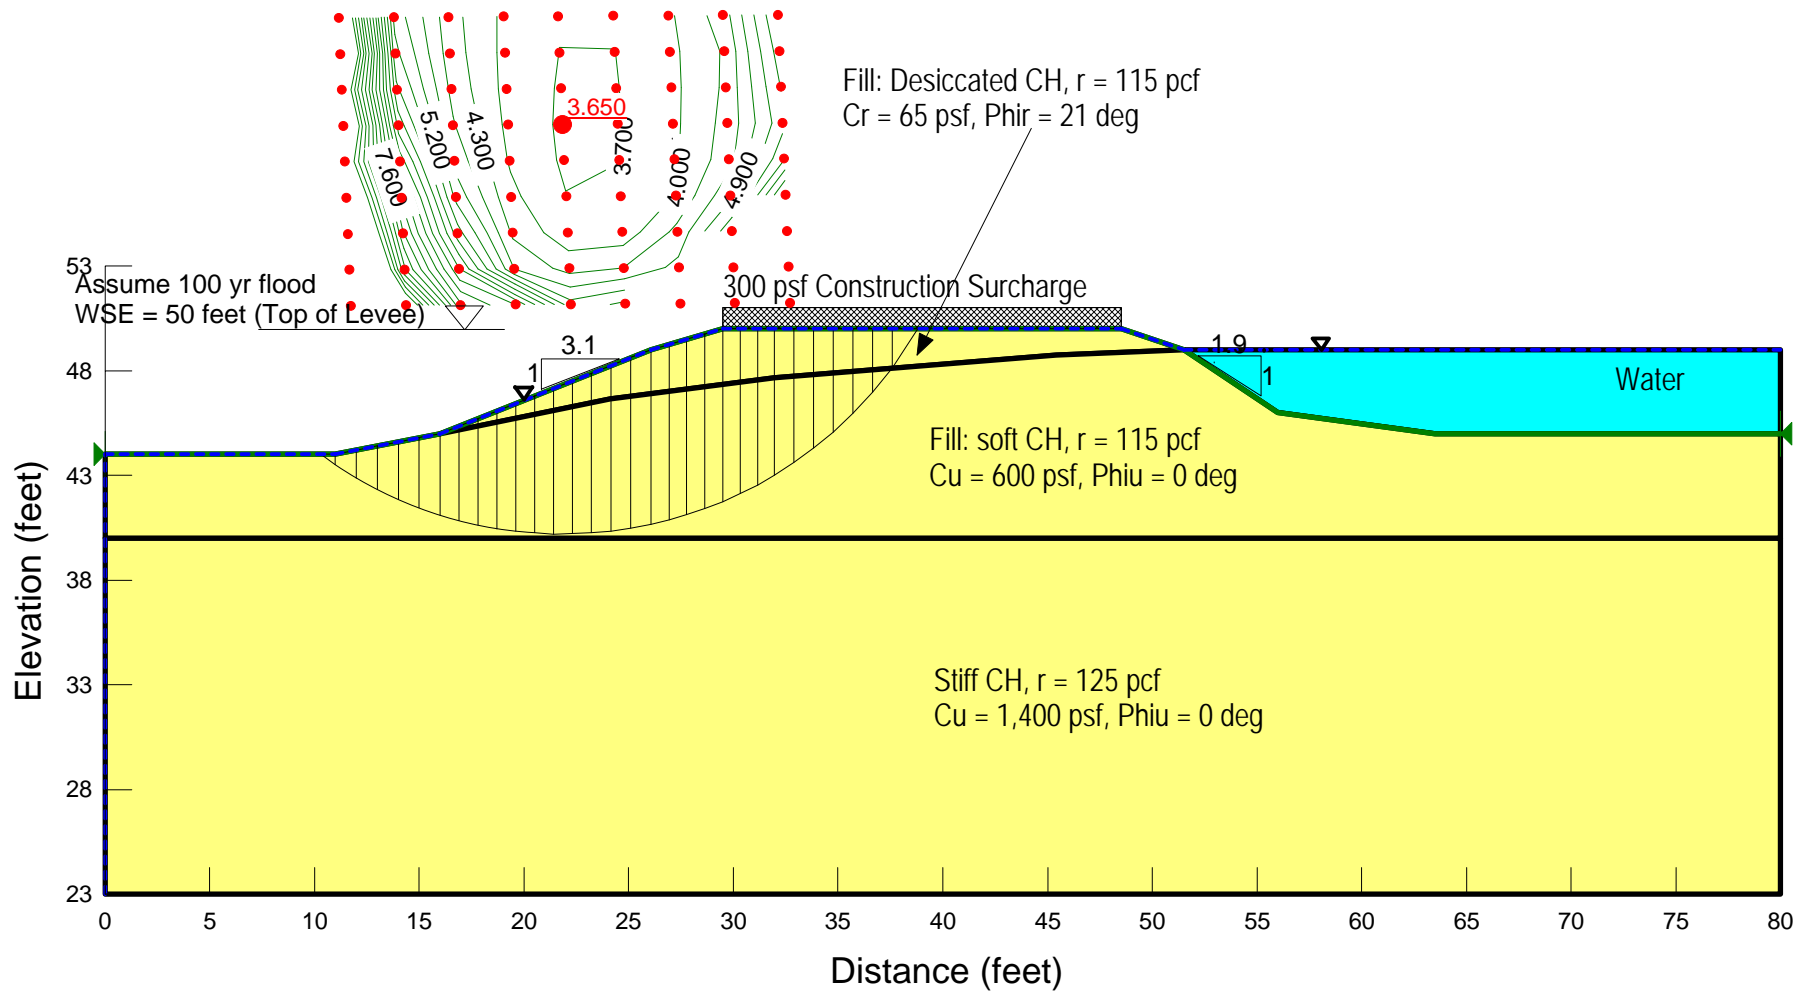
G134-15 SJRA MAIN CANAL SIPHON NO. 7
 CROSS SECTION C-C - SLOPE STABILITY ANALYSIS
 EXISTING LANDSIDE SLOPE, UPPER SLOPE H:V = 3.1:1, GLOBAL SLIDE FOR NORTH EMBANKMENT
 BASED ON BORING B-1, SHORT TERM CONDITION

Plate E-11a	Slope Stability Analysis on CS-CC Existing Landside Slope (Global Slide for North Embankment), H:V=3.1:1, Short Term Condition, Based on Boring B-1
Plate E-11b	Slope Stability Analysis on CS-CC Existing Landside Slope (Local Slide for North Embankment), H:V=3.1:1, Short Term Condition, Based on Boring B-1
Plate E-12a	Slope Stability Analysis on CS-CC Existing Landside Slope (Global Slide for North Embankment), H:V=3.1:1, Long Term Condition, Based on Boring B-1
Plate E-12b	Slope Stability Analysis on CS-CC Existing Landside Slope (Local Slide for North Embankment), H:V=3.1:1, Long Term Condition, Based on Boring B-1
Plate E-13a	Slope Stability Analysis on CS-CC Existing Landside Slope (Global Slide for North Embankment), H:V=3.1:1, Rapid Drawdown Condition, Based on Boring B-1
Plate E-13b	Slope Stability Analysis on CS-CC Existing Landside Slope (Local Slide for North Embankment), H:V=3.1:1, Rapid Drawdown Condition, Based on Boring B-1

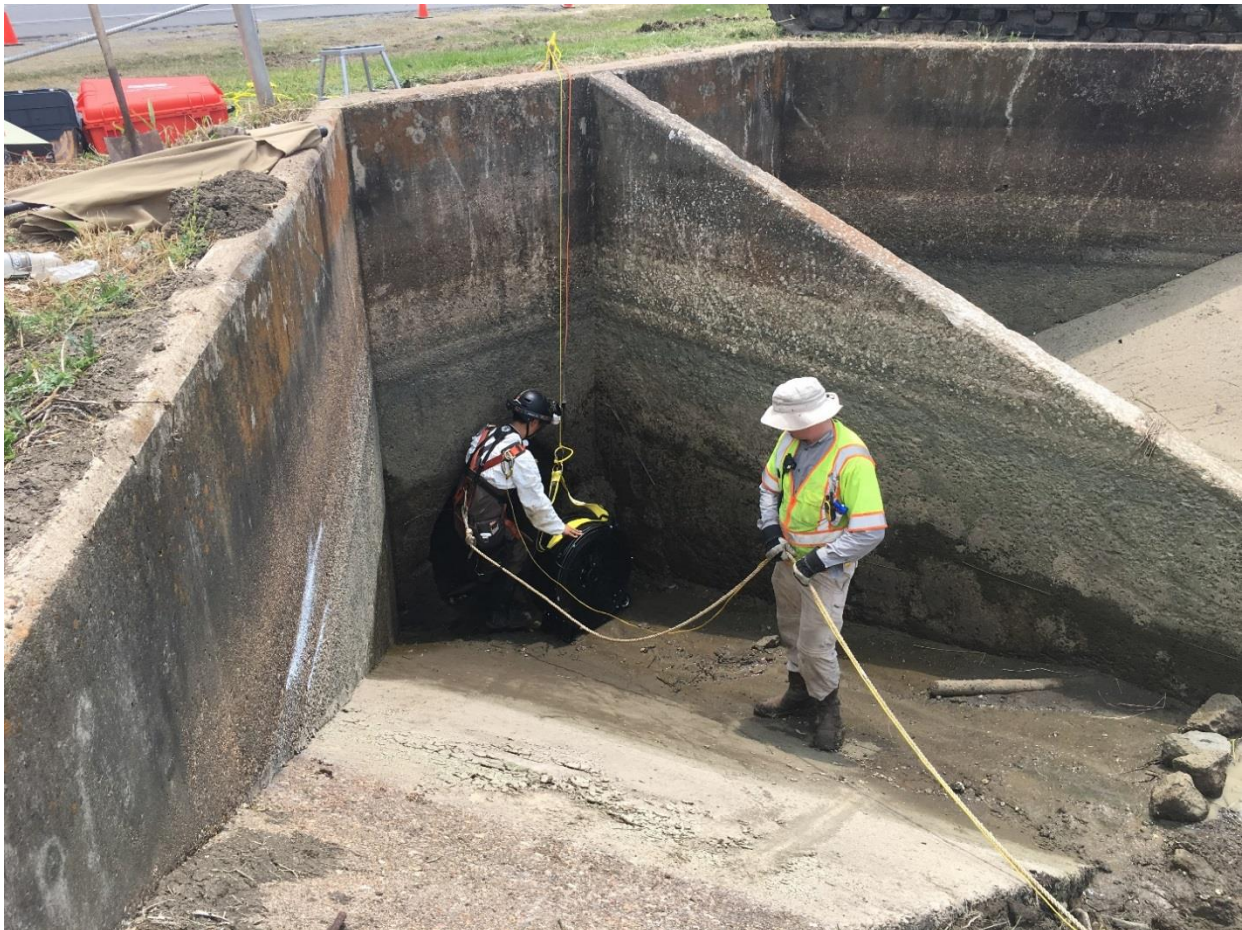
The siphon pipes were treated as permit-required confined spaces (PRCS) due to the difficulty of ingress and egress to the structures and the potential atmospheric and engulfment hazards that may exist. A health and safety plan was prepared and a pre-entry tailgate meeting was conducted immediately prior to the entry. For the assessment of the siphon pipes, the entrant made access to each pipe from the upstream/west side and exited on the downstream/east side. All entries were performed using rope and harness assembly (Photo 2-1). Entrants remained connected to a safety line while performing condition assessment activities within the confined space and maintained 2-way radio communication throughout the assessment.

Photo 2-1. Confined Space Entry at SJRA Siphon 7 48-inch North

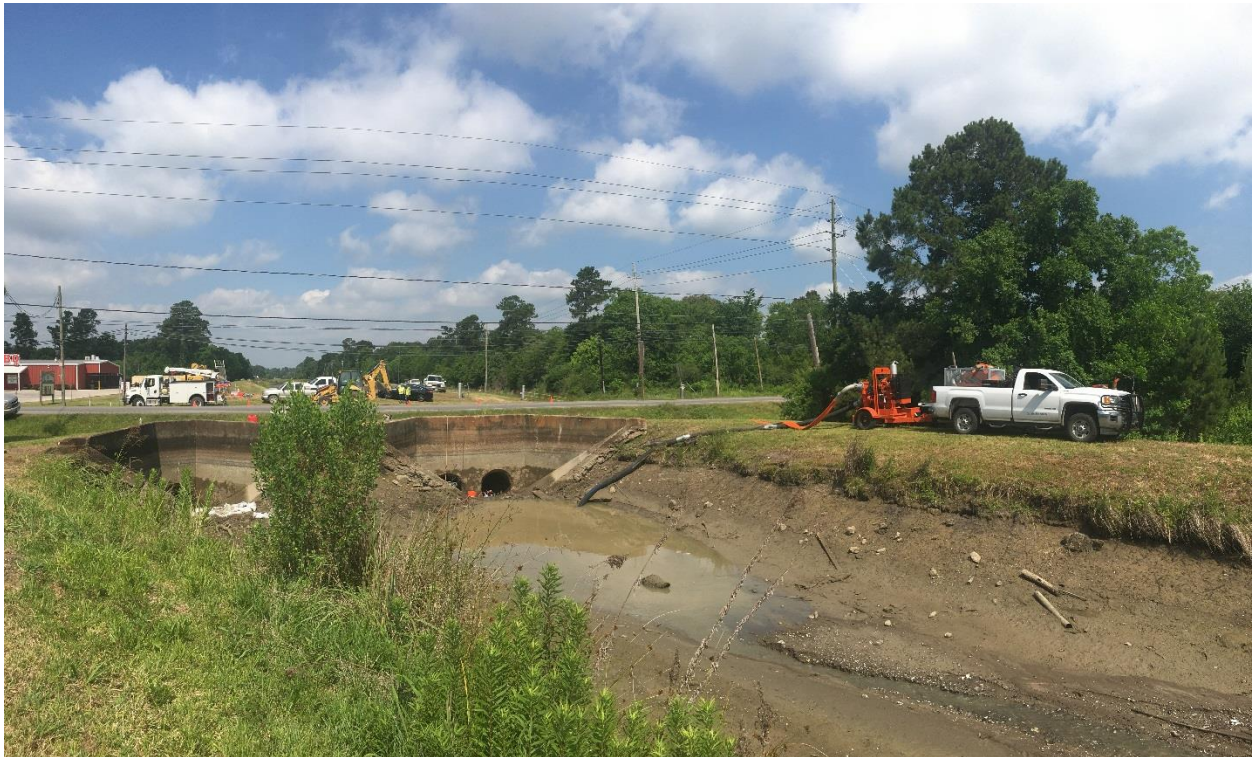
One V&A staff entered the siphon pipe, and two V&A staff provided supporting roles as attendants on each end of the siphon. SJRA provided dewatering of the inlet/outlet structures and the majority of the siphon pipes. Sand bags and a bypass pump were used to prevent backwatering from the downstream side of the canal into the siphon. V&A dewatered the remaining water within the pipes using transfer pumps. V&A followed local, state, federal, and industry standard health and safety guidelines.

Photo 2-2. Dewatering at Downstream End of Siphon 7

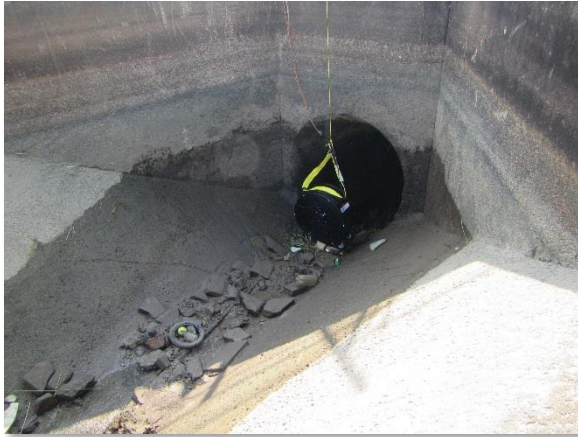
Photo 3-1. 60-inch Inlet Structure

of 1-inch or less were observed at 20 ft and 80 ft. A 0.5-inch pipe joint offset was observed near 75 ft. Small areas of surface delamination were observed in various locations (Photo 3-6). Small debris (rocks and bottles) were observed at the inlet structure (Photo 3-1), invert of the pipe (Photo 3-3), and outlet structure.

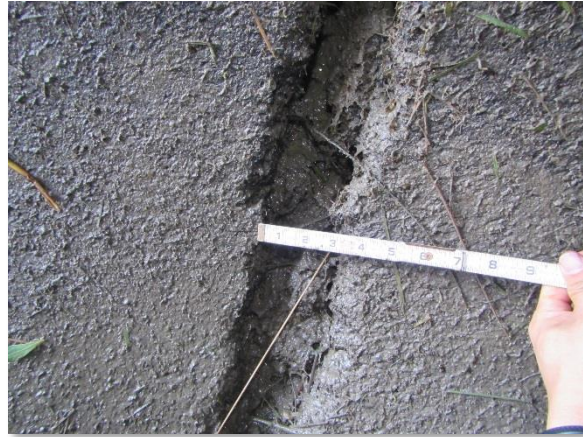
Photo 3-2. Pipe Joint Gap (15 ft)

Photos 3-1 to 3-6 show observations within the 60-inch pipe. Water infiltration was observed at multiple joints at approximately 15 ft (runner), 20 ft (runner), 25 ft (dripper and runner), and 125 ft (dripper). At the first joint, a 3-inch wide gap was observed at the 5 o'clock position and a 7-inch wide gap was observed at the 7 o'clock position. The joint gap was varied between 2 to 3-inches in depth. A 3.5-inch wide gap with 2 to 3-inches of joint depth was observed at the 3rd joint (approximately 15 ft) from the 12 to 5 o'clock positions, near the change in direction (Photo 3-2). A similar 3-inch wide gap, and 1-inch joint depth was observed at the change in direction near the outlet (approximately 125 ft). Smaller gaps

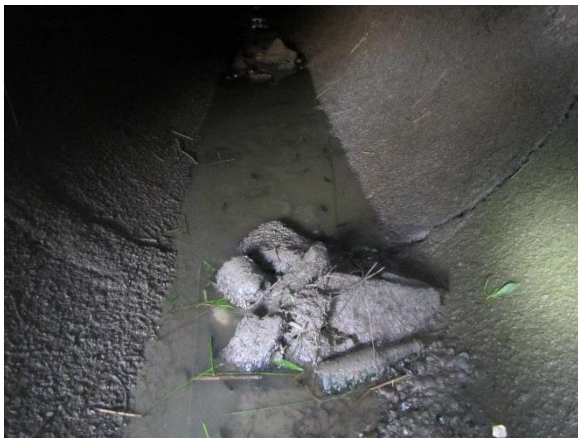
Photo 3-3. Debris (Typ.)

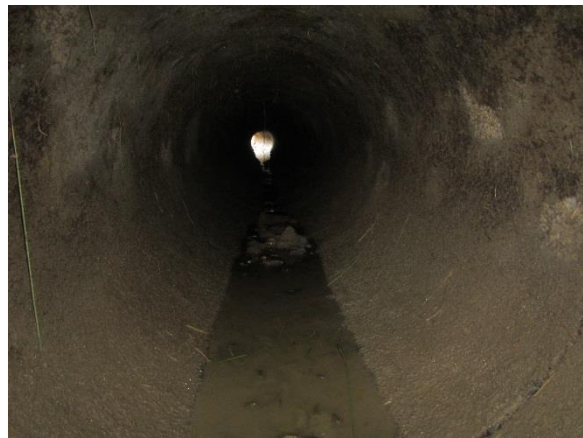
Photo 3-4. 60-inch Pipe Condition (Typ.)

The 60-inch pipe was observed to have an internal diameter of 60 inches (59 inches at 10 ft). The pipe wall was observed to have a VANDA concrete rating of level 1. The surface was generally smooth, was hard when subjected to penetration testing, and no observable voids were found during random concrete sounding. The surface had an observed pH of 6.

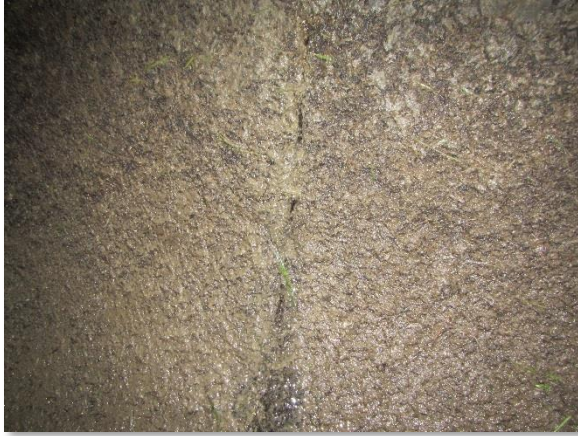
Photo 3-5. Surface Profile and Pipe Joint (Typ.)

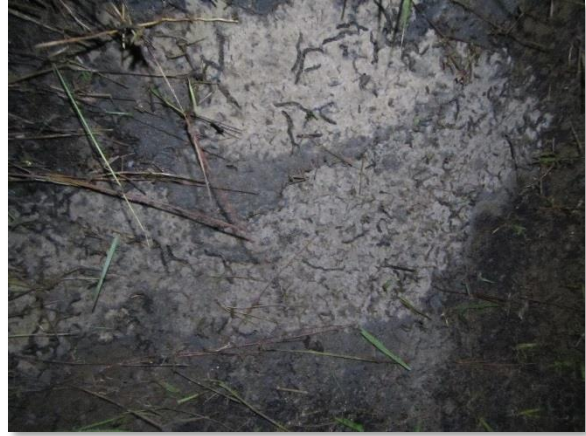
Photo 3-6. Surface Delamination (Typ.)

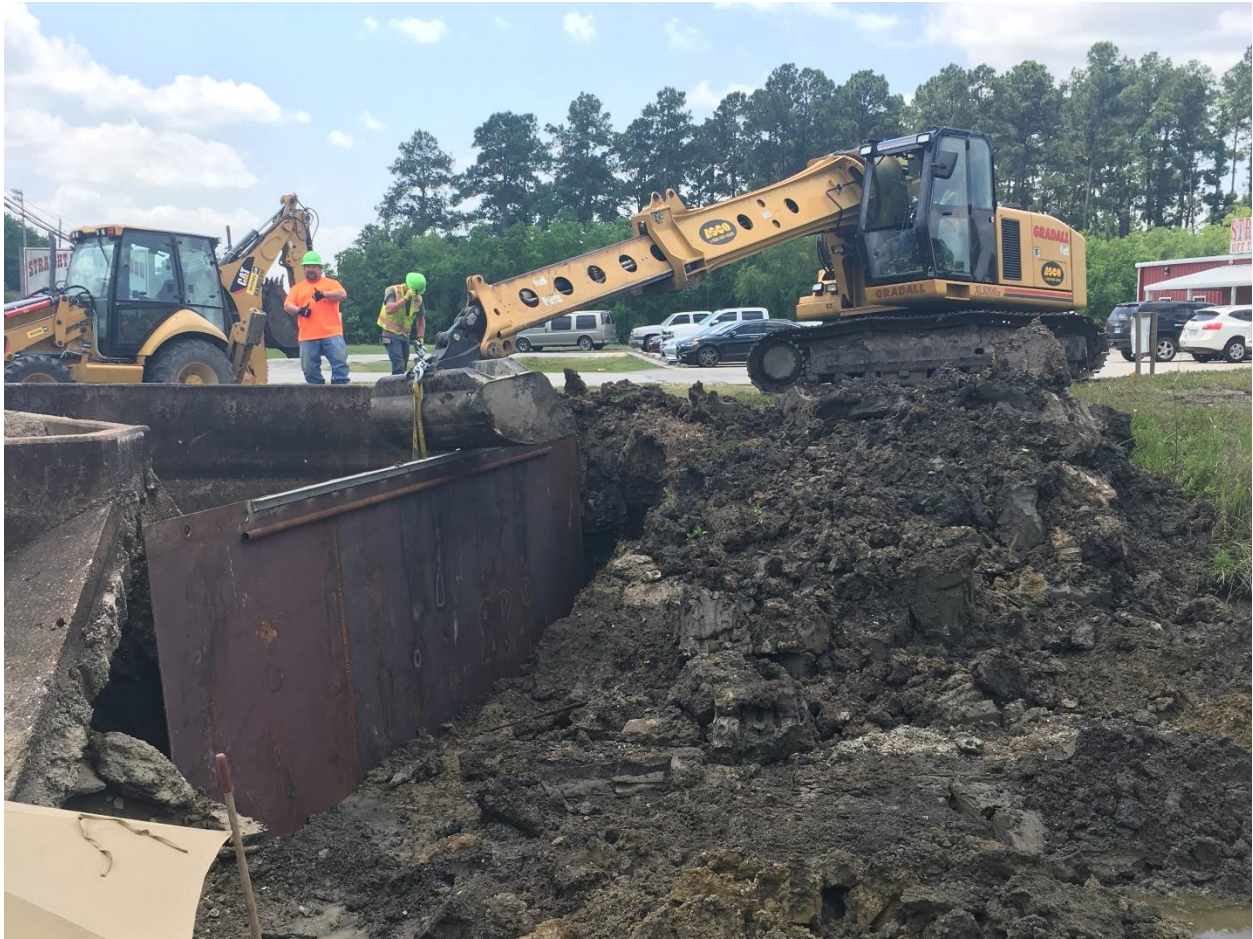
Following completion of the condition assessment, SJRA installed a steel plate across the inlet structure to facilitate a flow test through the two 48-inch pipes (Photo 3-7).

Photo 3-7. Steel Plate Installation at 60-inch Inlet Structure (Performed by SJRA)

Prior to May 18th, the SJRA fabricated a steel plate to be installed across the intake structure of the Siphon 7 60-inch bypass pipe. Photograph 4 of Appendix A shows a picture of the fabricated steel plate. The SJRA used the Gradall to remove earthen material approximately 6 to 8-inches below the bottom slab of the intake structure and approximately 3 to 4 feet into the south levee to accommodate the plate (see photograph 3 of Appendix A). Once the earth material was removed, the Gradall was used to lift the steel plate into position in front of the headwall (see photographs 5 through 7 of Appendix A). Once the plate was in place, the staff used the Gradall to install and compact backfill material along the sides and bottom of the plate (see photographs 8 through 10 of Appendix A) with the intent of providing a watertight installation. Once V&A completed the inspection of both 48-inch pipes, the SJRA performed final grading upstream of Siphon 7 prior to placing the canal back in service.

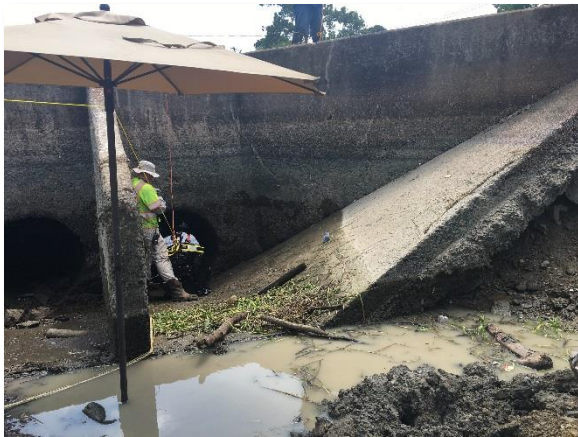
Photo 3-8. 48-inch South Inlet Structure

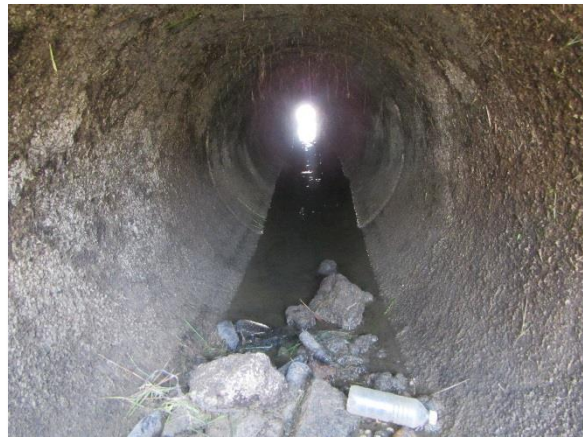
Photo 3-9. Pipe Profile and Debris (Typ.)

A 1.5-inch wide gap and 1" joint depth was observed at the 2nd joint (approximately 10 ft) with missing mortar (Photo 3-11). A similar 1-inch wide gap and 0.5" joint depth was observed at the last pipe joint between the 1 and 10 o'clock positions. A 4-inch by 8-inch area and 1-inch depth of surface spalling (VANDA level 2) was observed at approximately 100 ft at the 7 o'clock position (Photo 3-14 and Photo 3-15). At the deepest point, the defect was 1-inch deep relative to the adjacent pipe surface. Other smaller areas of surface delamination near pipe joints were also observed (Photo 3-10). Small debris (rocks, boards, and bottles) were observed at the inlet structure, invert of the pipe (Photo 3-9), and outlet structure.

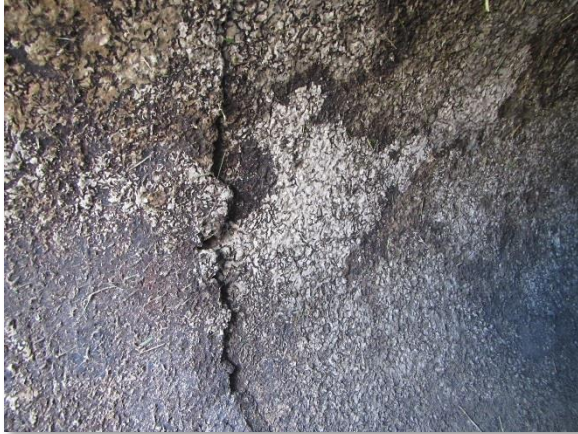
Photo 3-10. Surface Delamination at Joint (Typ.)

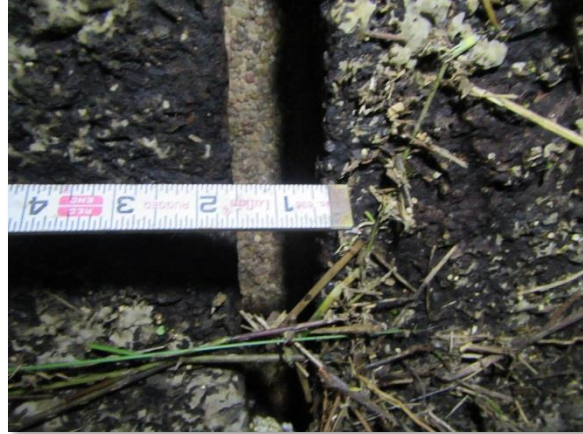
Photo 3-11. 1.5-inch Joint Gap at 10 ft

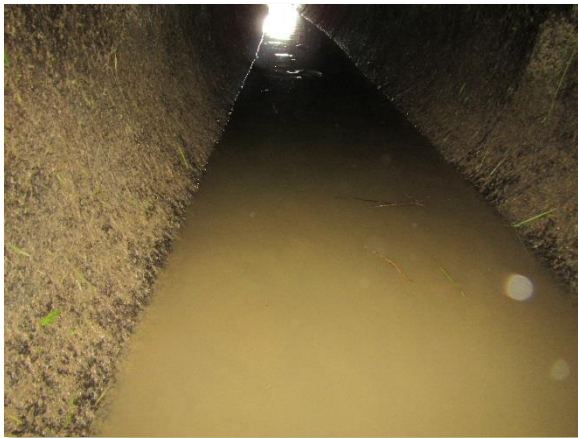
Photo 3-12. Possible Pipe Sag

Photos 3-8 to 3-15 show observations within the 48-inch South pipe. A possible sag in the pipe was observed near 50 ft (Photo 3-12), indicated by increased water depth at this location (9 inches). A an inconsistency in the pipe surface similar to diagonal cold joint was observed on each side of the pipe (3 and 9 o'clock) at approximately 60 ft (Photo 3-13), typical of cast-in-place construction. The surface inconsistency did not appear to be a crack, did not appear to have any obvious repair materials present, and appeared to be an inherent part of concrete matrix. The profile of the pipe itself was consistent on either side. Assuming the pipe is precast as reported, it is possible this surface inconsistency occurred at the manufacturing facility.

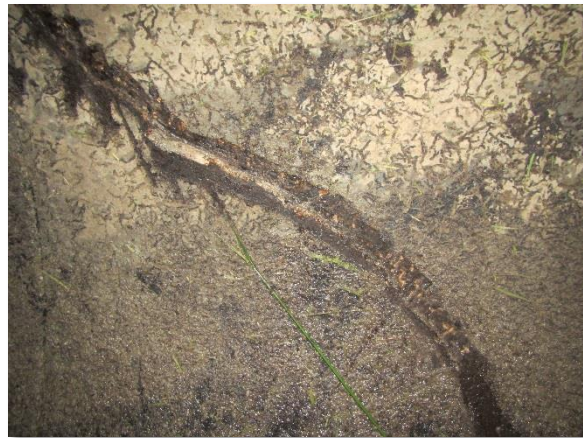
Photo 3-13. Possible Diagonal Cold Joint

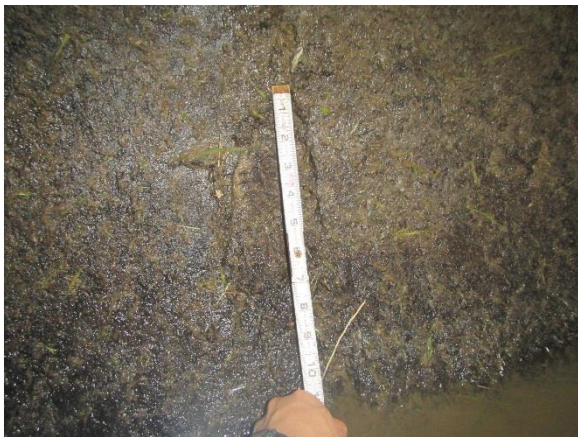
Photo 3-14. Surface Spalling at 100 ft (A)

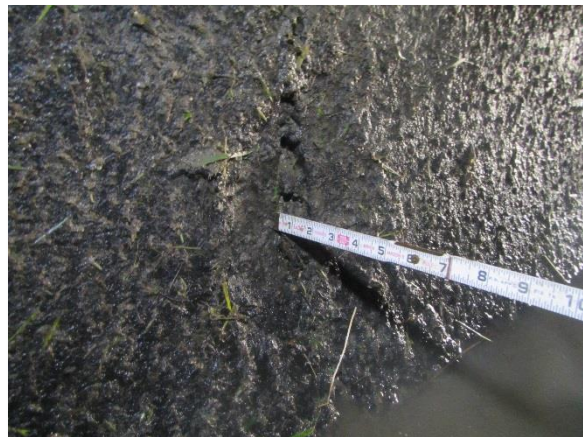
Photo 3-15. Surface Spalling at 100 ft (B)

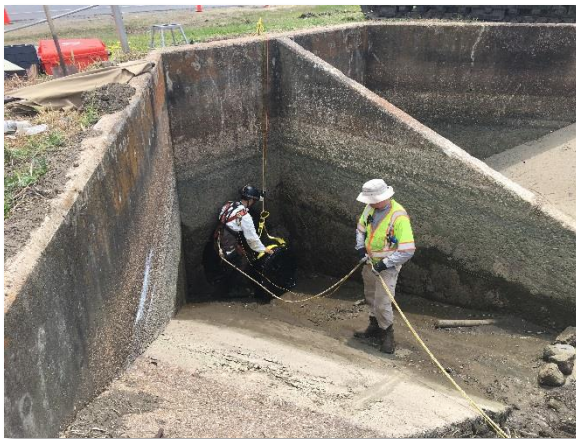
Photo 3-16. 48-inch North Inlet Structure

Photos 3-16 to 3-20 show observations within the 48-inch North pipe. A $\frac{3}{4}$ -inch wide gap with $\frac{1}{4}$ -inch depth and 1-inch wide gap with 3.5-inch depth were observed at the 1st and last joints, respectively, with missing mortar. Joint gaps of 1-inch or less and missing mortar were also observed at 30, 40, 100, and 110 ft (Photo 3-18). Small debris (rocks, boards, and bottles) were observed at the inlet structure, invert of the pipe, and outlet structure (Photo 3-20). A piece of debris approximately 18-inches long located near the inlet structure appeared to be cast into the pipe invert and could not be removed (Photo 3-19).

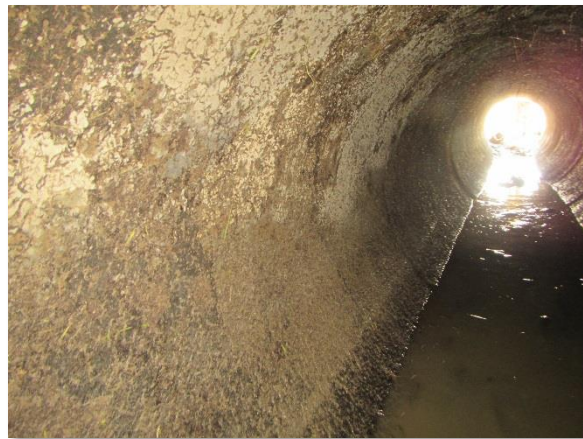
Photo 3-17. Pipe Surface (Typ.)

The 48-inch North pipe was observed to have an internal diameter of 48 inches. The pipe wall was observed to have a VANDA concrete rating of level 1. The surface was generally smooth, was hard when subjected to penetration testing, and no observable voids were found during random concrete sounding. The surface had an observed pH between 7 and 8.

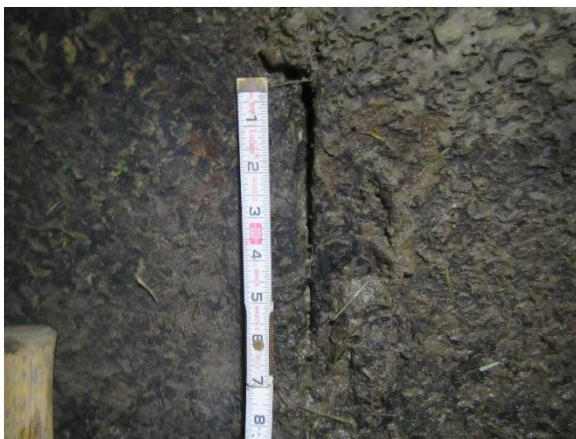
Photo 3-18. Small Joint Gap (Typ.)

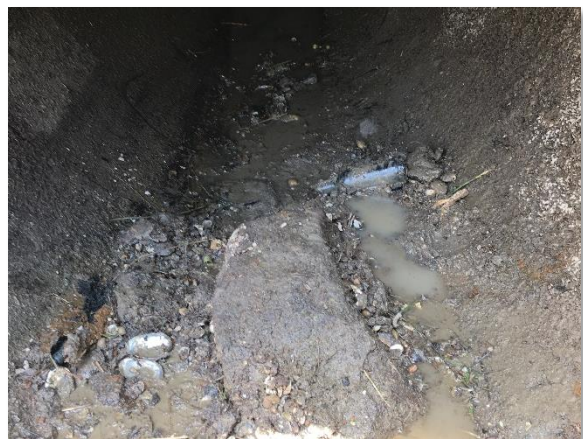
Photo 3-19. Debris Cast in Pipe Invert

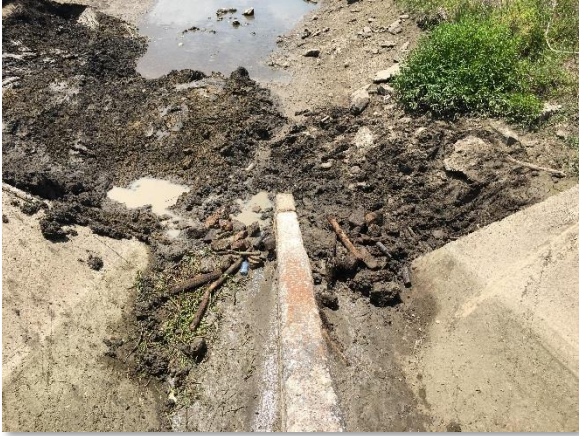
Photo 3-20. Removed Debris (Typ.)

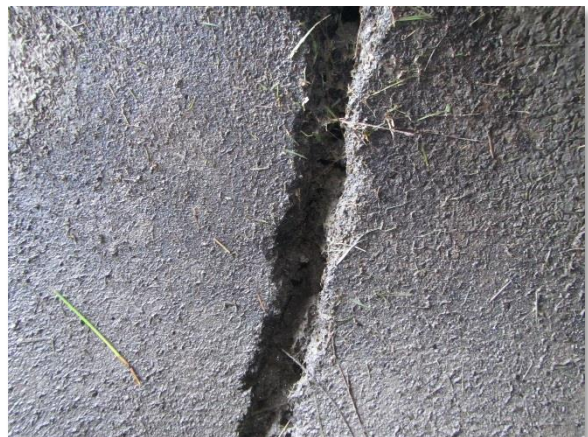
IMG_3956. Pipe Joint Missing Mortar @ 10ft

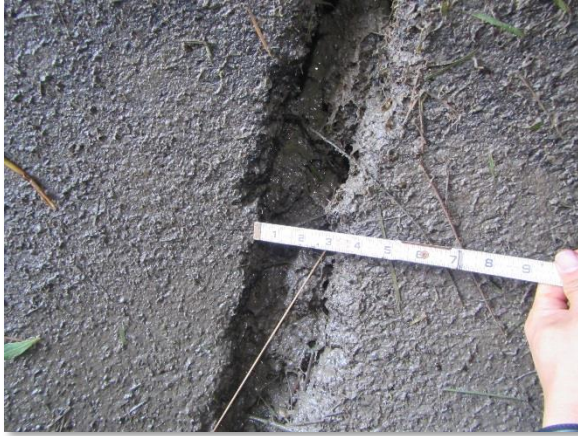
IMG_3957. 3.5-Inch Joint Gap at Inlet Change in Direction (A)

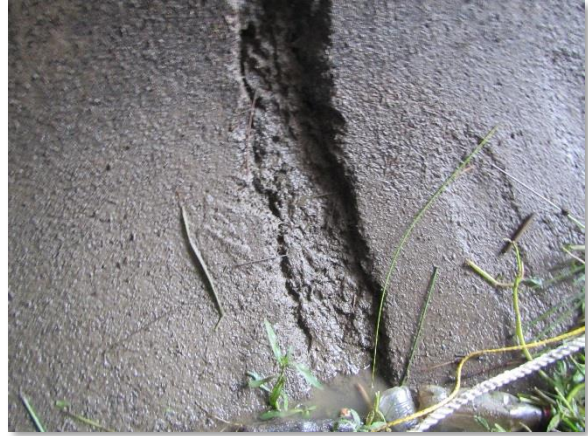
IMG_3958. 3.5-Inch Joint Gap at Inlet Change in Direction (B)

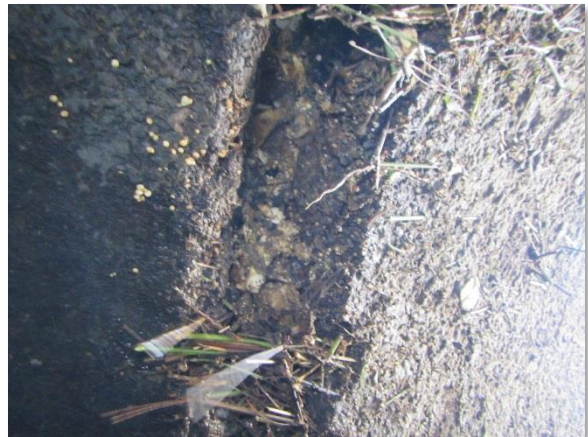
IMG_3960. 3.5-Inch Joint Gap at Inlet Change in Direction (D)

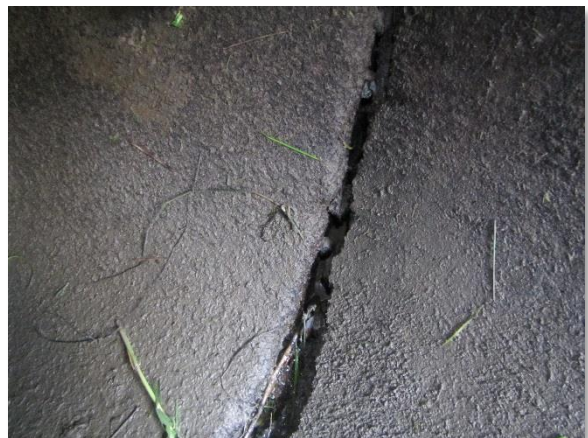
IMG_3962. Pipe Joint Missing Mortar @ 80 ft

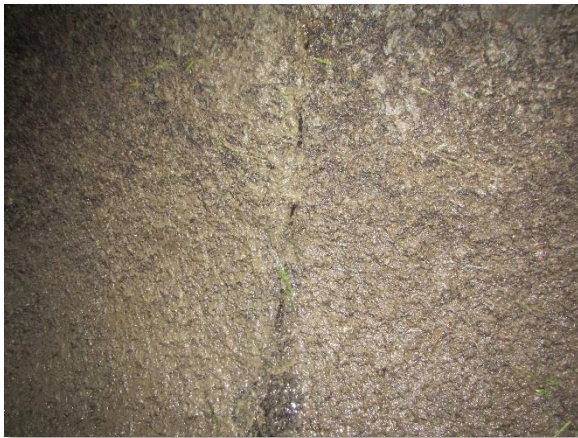
IMG_3966. Pipe Joint (Typ.)

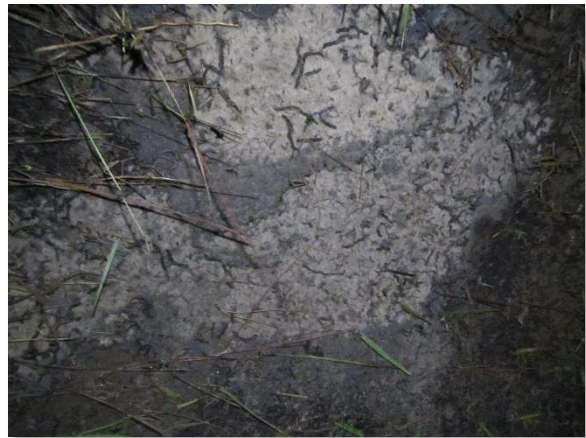
IMG_3978. Surface Delamination (Typ.)

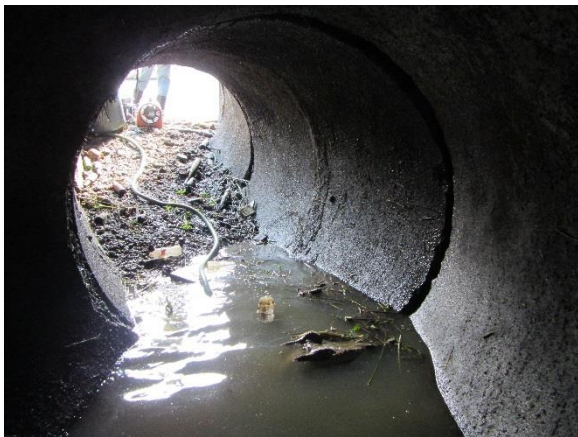
IMG_3979. 60-inch Pipe Outlet and 3.5-inch Joint Gap at Change in Direction

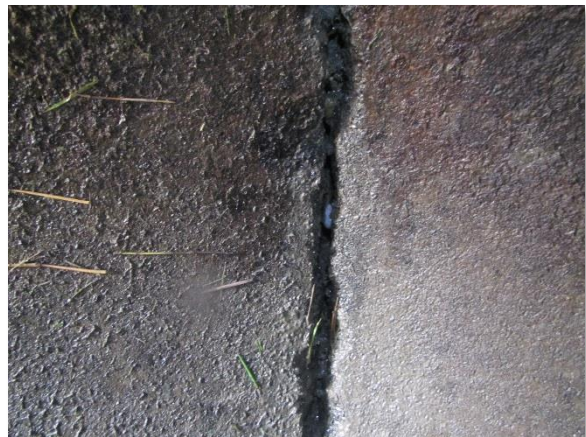
IMG_3980. Pipe Joint Missing Mortar at Last Joint

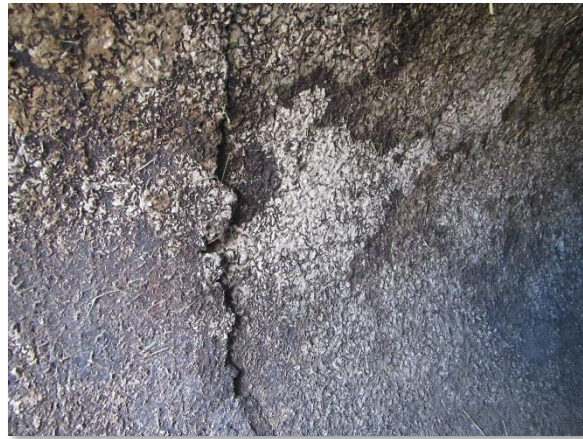
IMG_4005. Delamination at Pipe Joint (Typ.)

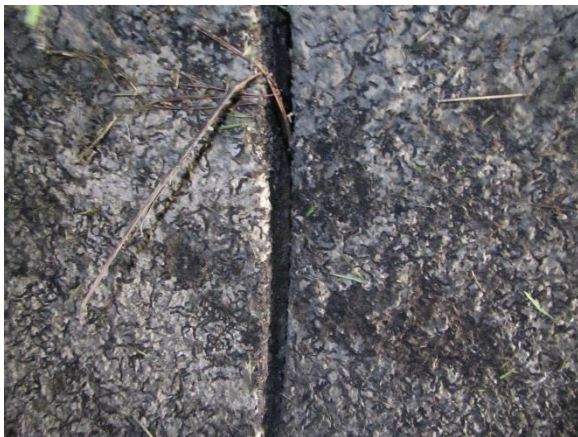
IMG_4007. Joint Gap (Typ.)

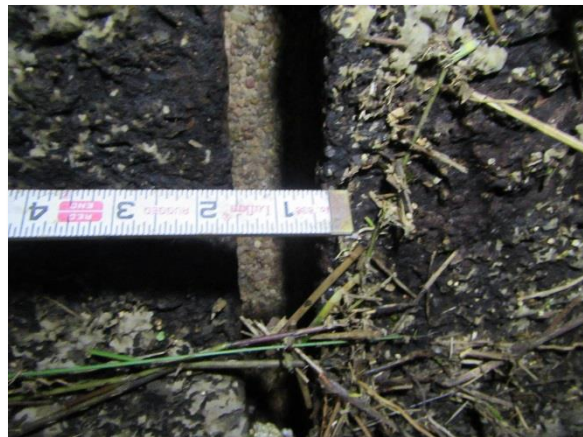
IMG_4009. Pipe Joint Missing Mortar @ 10ft

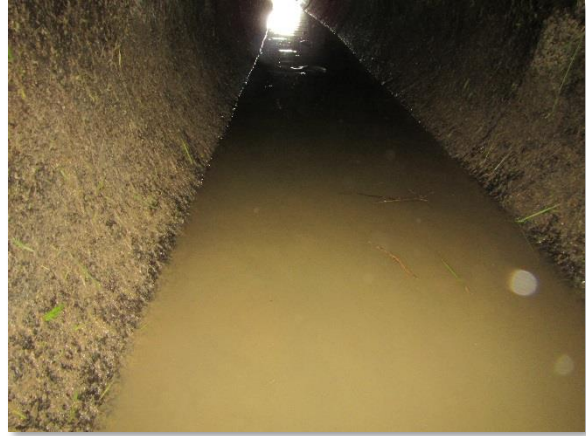
IMG_4017. Pipe Invert @ 50 ft

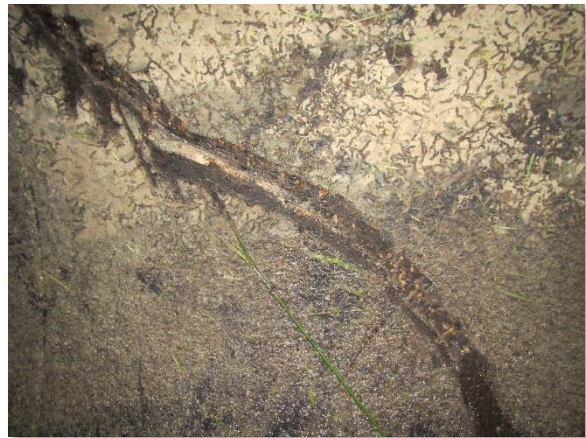
IMG_4019. Diagonal Cold Joint at 60 ft

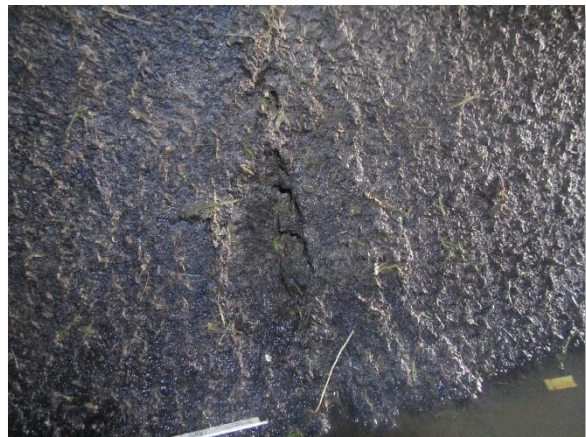
IMG_4024. Surface Spalling @ 100 ft (A)

in both 48-inch pipes. The southern 48-inch pipe was observed to have standing water and a sag in the pipe approximately 50 feet from the upstream end. The southern pipe was also observed to have some delamination of the pipe 100 feet from the upstream end. There was no indication of large debris present in the pipes.

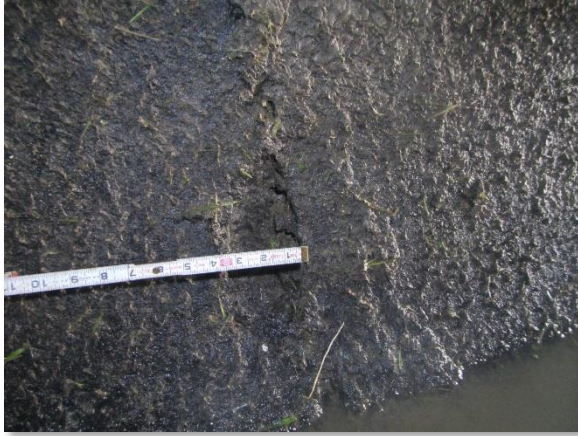
IMG_4025. Surface Spalling @ 100 ft (A)
