**ADDENDUM NO. 1
RFCSP # 18-0036**

Re: **RFCSP No. 18-0036 Siphon 7 Improvements – Phase 1**

VICINITY MAP
 SJRA HIGHLANDS CAPACITY IMPROVEMENTS PROGRAM
 PROPOSED SIPHON NO. 7 IMPROVEMENTS
 HARRIS COUNTY, TEXAS

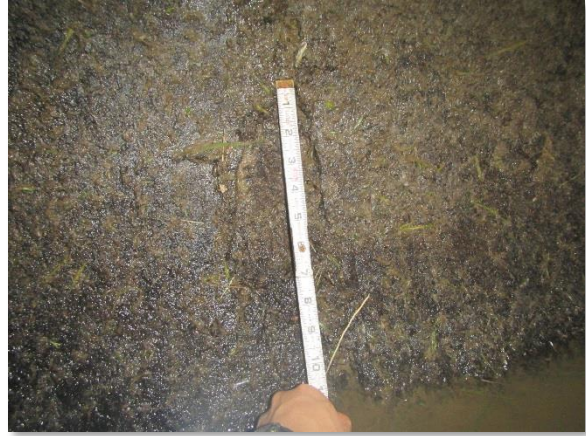
IMG_4026. Surface Spalling @ 100 ft (A)

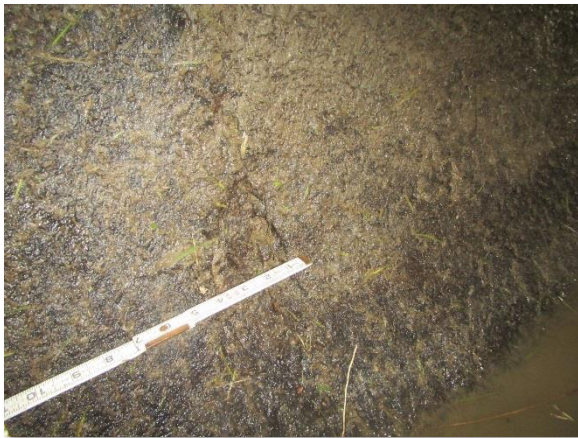
IMG_4027. Surface Spalling @ 100 ft (A)

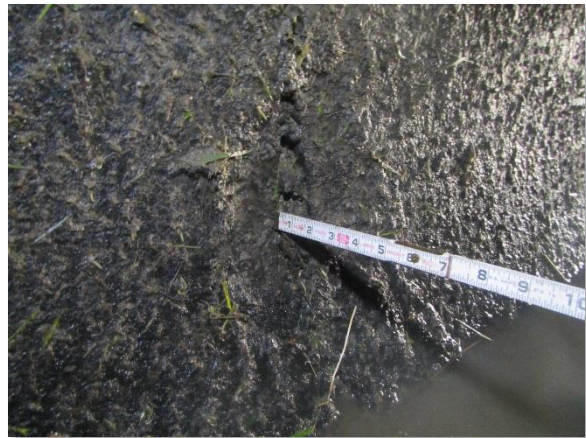
IMG_4028. Surface Spalling @ 100 ft (A)

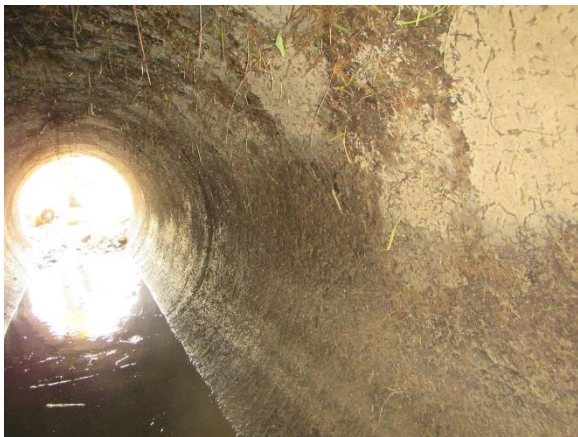
IMG_4029. 48-inch South Pipe Wall (A)

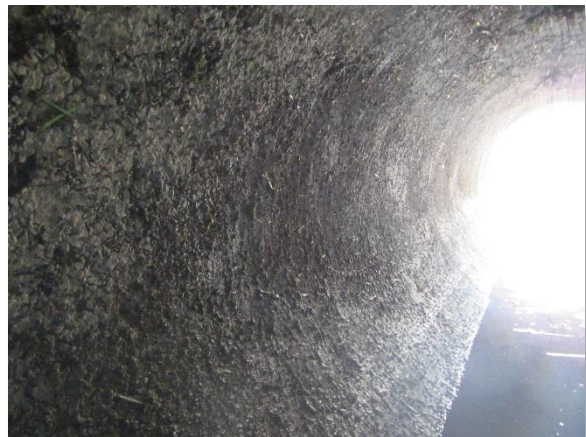
IMG_4030. 48-Inch South Pipe Wall (B)

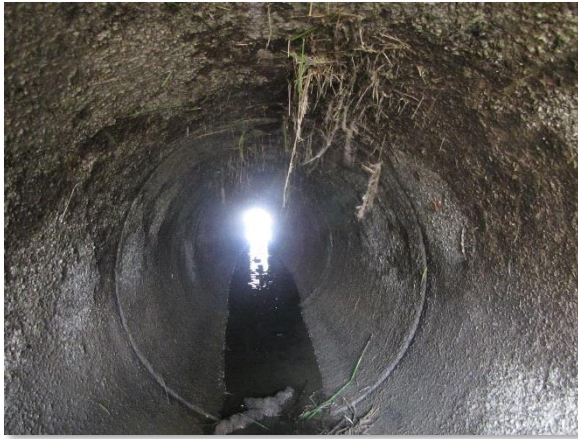
IMG_4037. 48-inch North Pipe

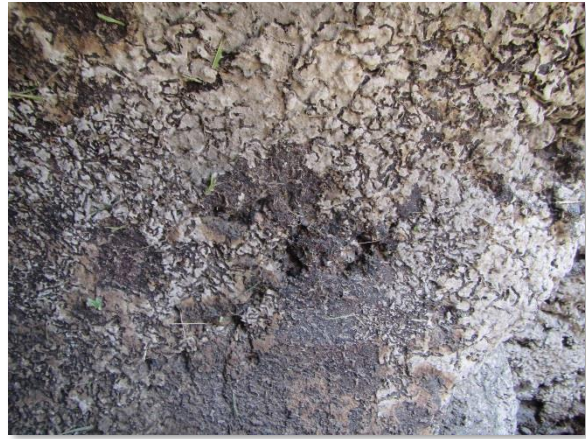
IMG_4038. 48-inch North Pipe Wall (A)

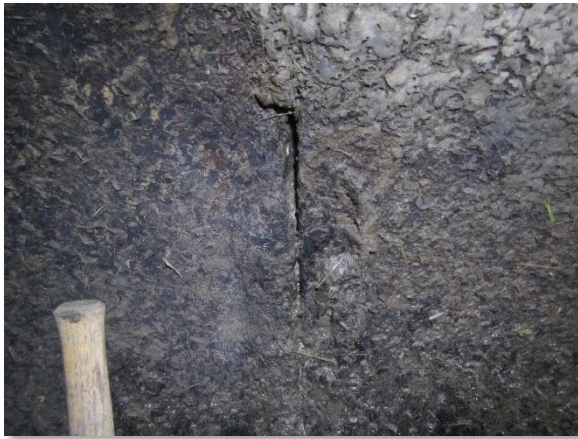
IMG_4044. Joint Gap (Typ.)

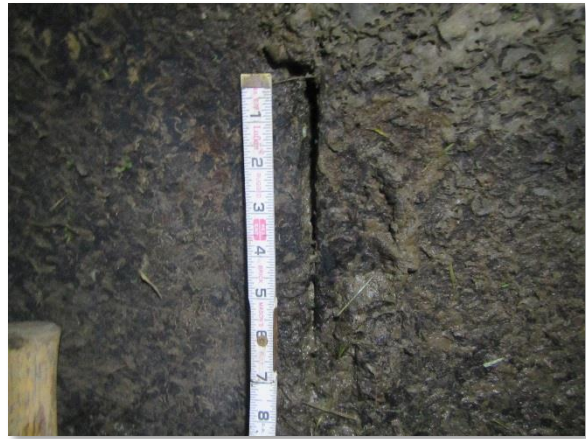
IMG_4045. Joint Gap (Typ.)

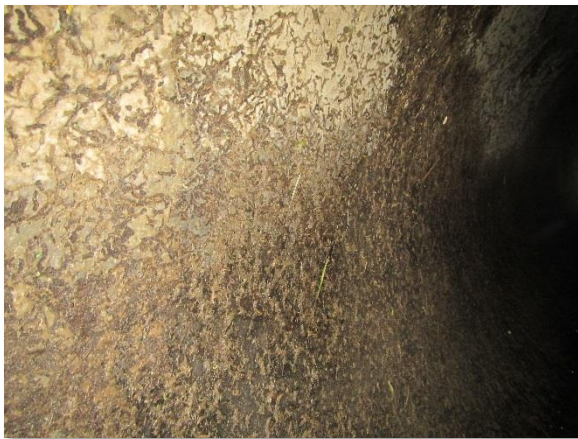
IMG_4051. 48-inch North Pipe Wall (B)

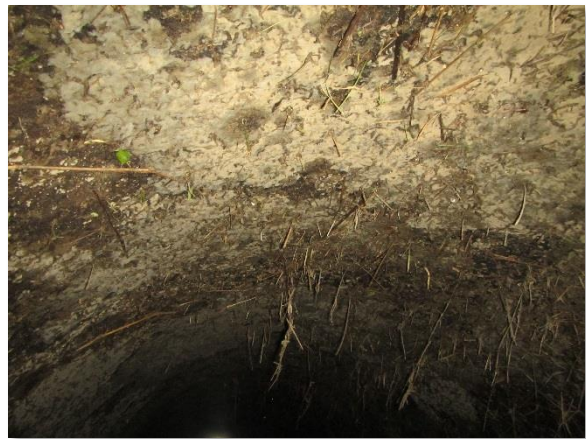
IMG_4052. Pipe Crown (A)

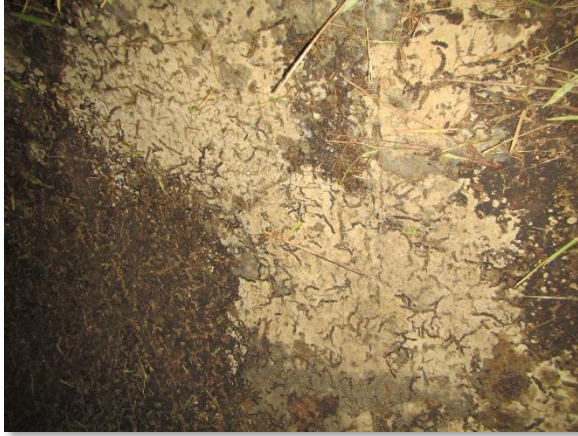
IMG_4053. 48-inch North Pipe Surface

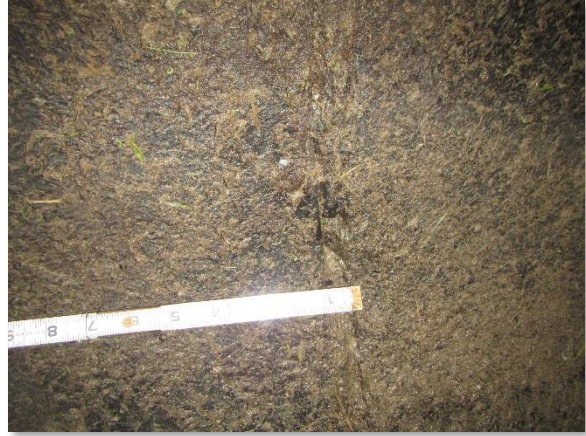
IMG_4054. Pipe Joint (Typ.)

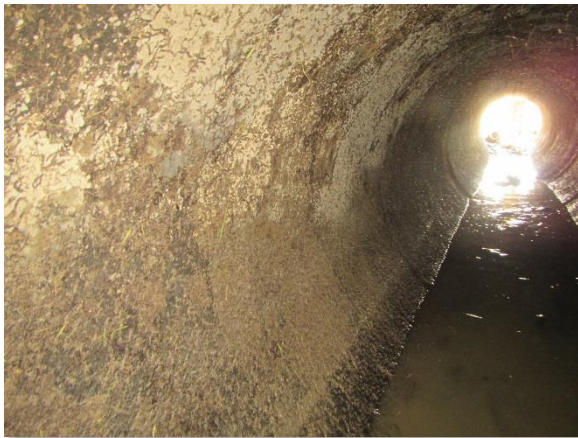
IMG_4057. 48-inch North Pipe Wall (C)

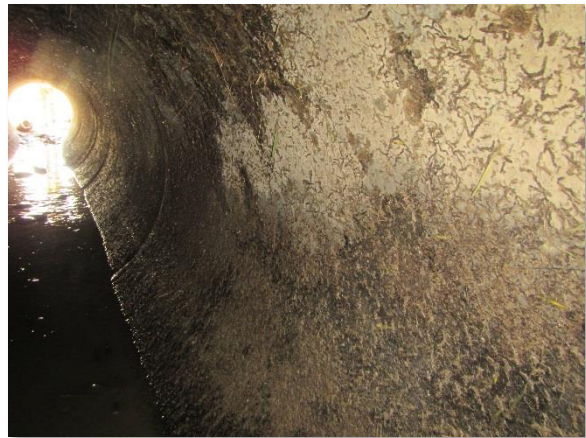
IMG_4059. 48-inch North Pipe Wall (D)

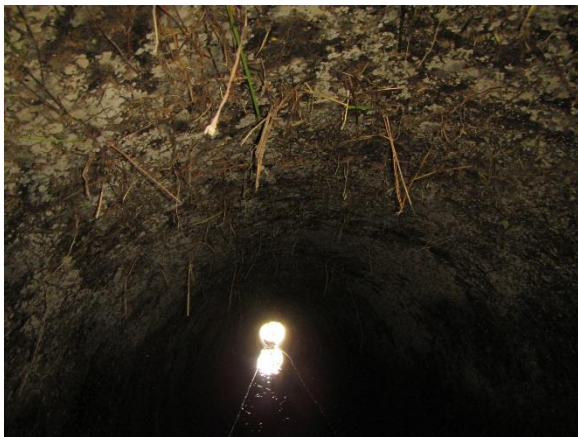
IMG_4061. Pipe Crown (B)

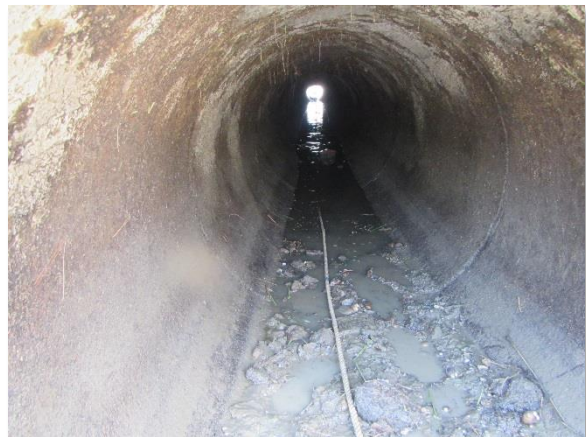
IMG_4069. 48-inch North Pipe Looking Upstream

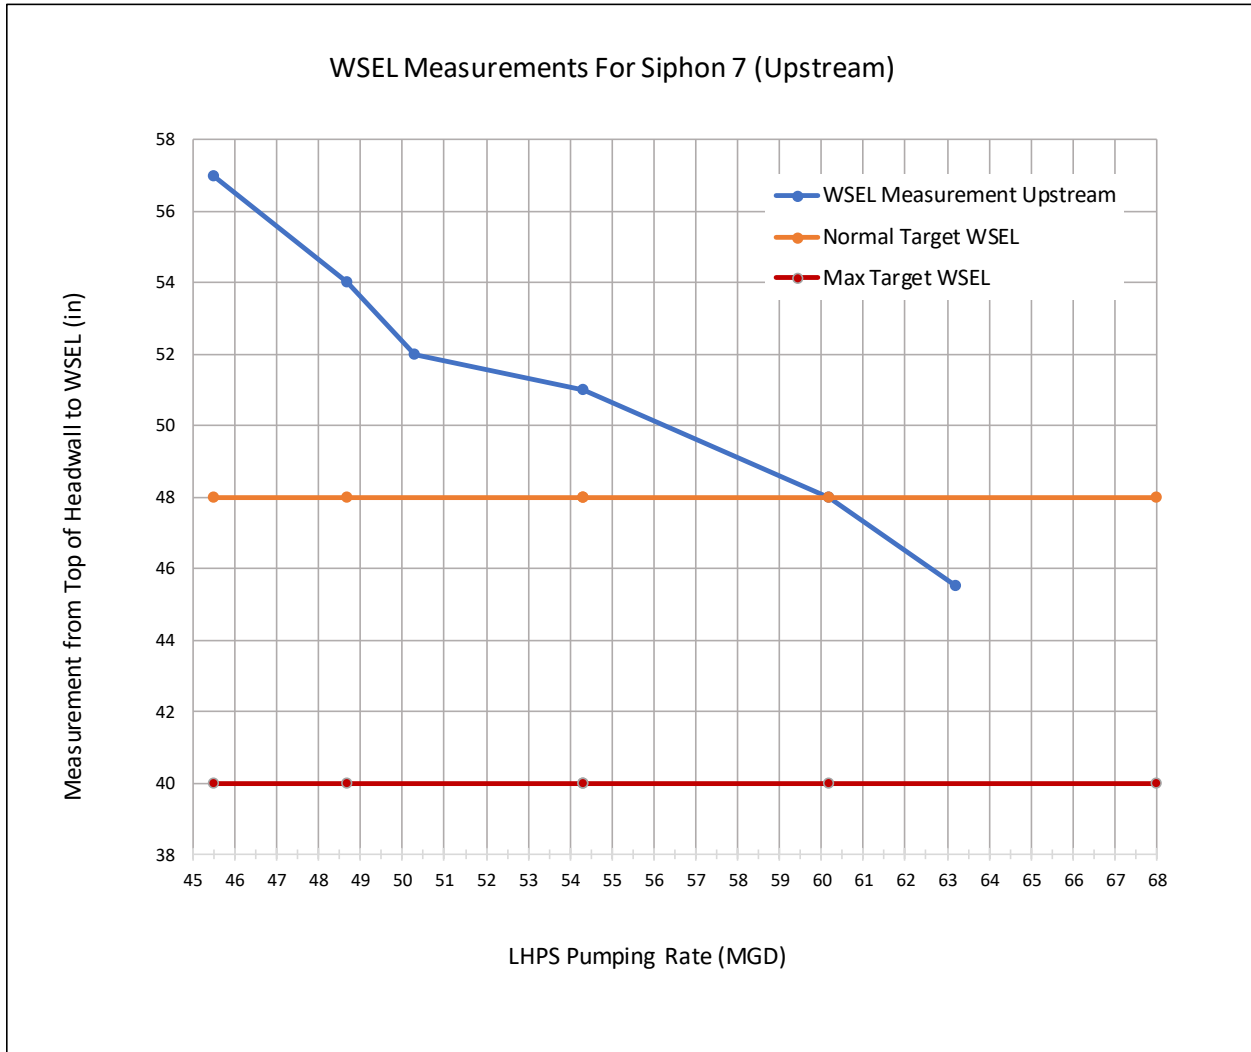
Figure 4 – Results from Flow Test

Data was collected during the flow test from May 21st to June 7th and recorded in an Excel spreadsheet. The raw data collection spreadsheet is shown in Appendix B of this memorandum. It was observed during the testing period, that the WSELs at the collection points took about 24 hours to stabilize and reach steady state. It was also observed that only at flows higher than 60 MGD during the testing period did the canal WSEL upstream of Siphon 7 reach higher than the target normal operating range. Figure 4 below provides a graphical representation of the flow test results.

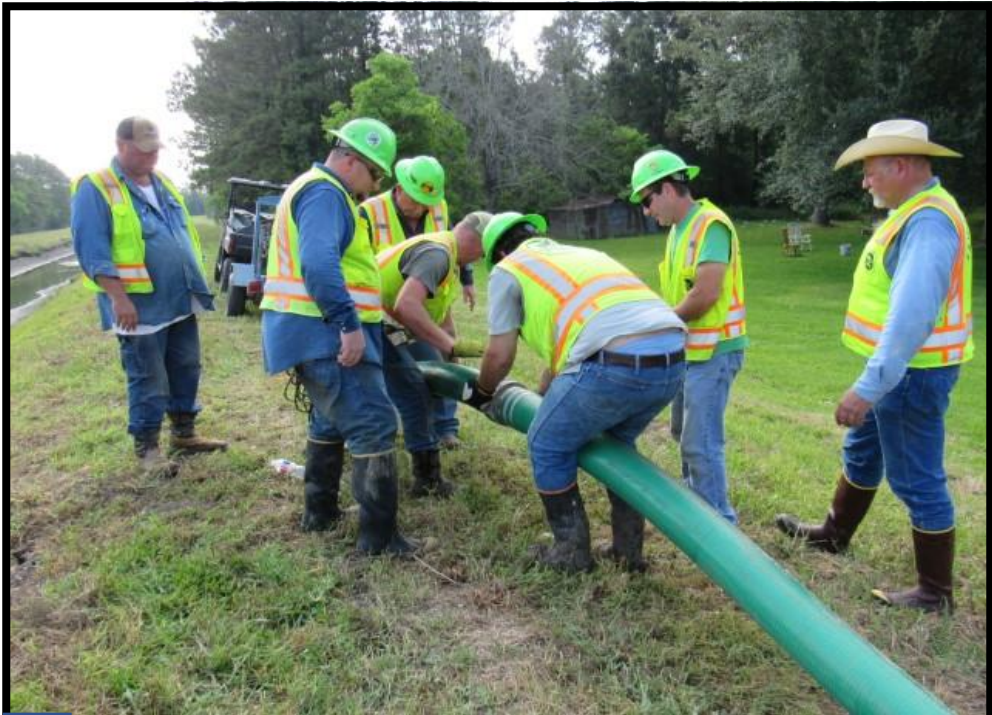
Dewatering pump suction line installation.

At 6:00 AM on May 18th, the SJRA mobilized pumps to the downstream area of Siphon 7 to begin dewatering the pipes in preparation for the manned inspections (refer to photographs 1 and 2 of Appendix A). The pipe inspections were performed by V&A Consulting Engineers under Contract 18-0063, Work Order No. 1. Detailed results from the inspections are summarized under a separate report developed by V&A. The SJRA staff completed the dewatering of the 60-inch bypass around 8:00 AM and the V&A inspector entered the pipe at the upstream end around 9:35 AM. TWE was on-site during the inspection and was able to listen to the inspector (via radio communication) narrate what he observed. TWE was able to communicate with the inspector during the inspection to ask questions and obtain additional information as needed. The inspector noted the concrete to be in good overall condition. However, several joints were observed to have some separation. A few joints were also observed to be missing joint material and had water infiltration from the surrounding soils. There was no indication of large debris present in the bypass. Once the inspector exited the pipe at the downstream end, the SJRA staff began the installation of the steel plate to temporarily block off the bypass for the flow test. While the SJRA was installing the steel plate at the bypass, the V&A inspector entered the southern-most 48-inch pipe for inspection. Victoria Foss with TWE was observing the steel plate installation and Abby Crockett with TWE was listening to and communicating with the V&A inspector in the 48-inch pipes. The two 48-inch pipes were noted to be in good overall condition. Some joint separation and missing joint material was noted

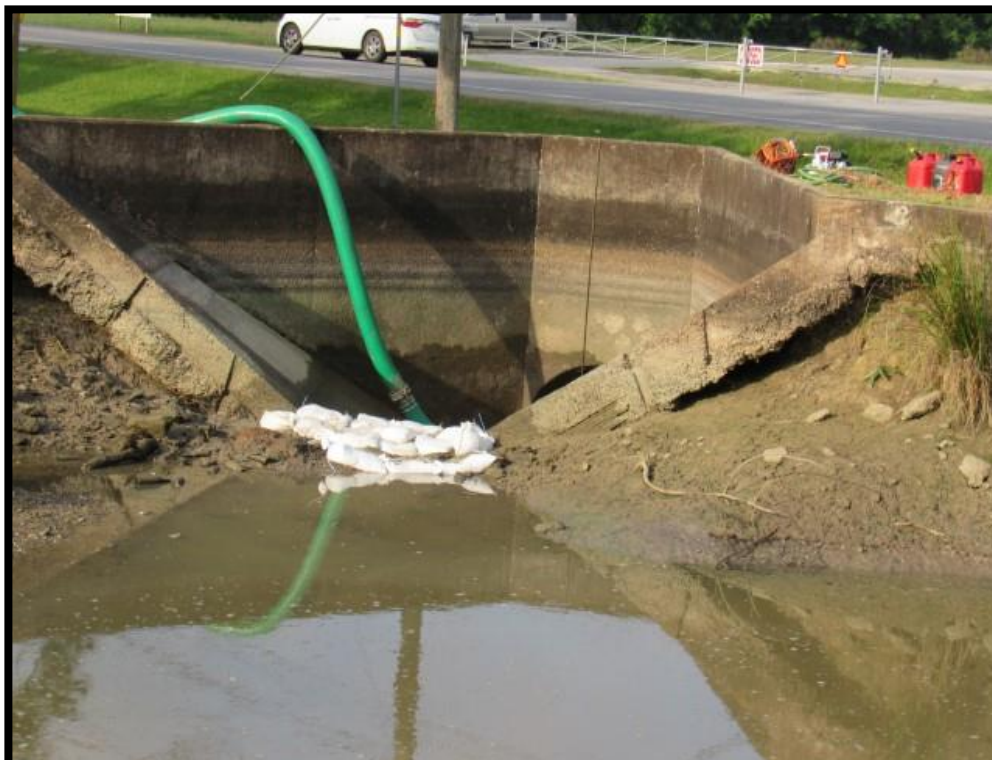
2

Cofferdam and pump suction at 60-inch downstream structure (looking upstream).

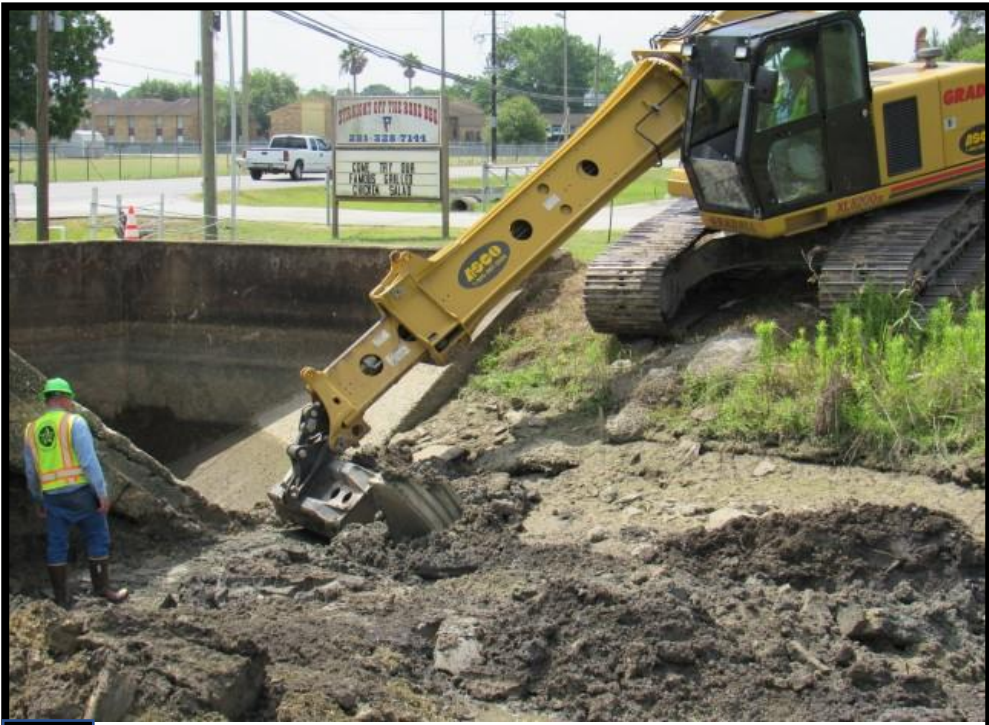
3

Grading for plate installation at the upstream of 60-in bypass.
(looking downstream/southeast)

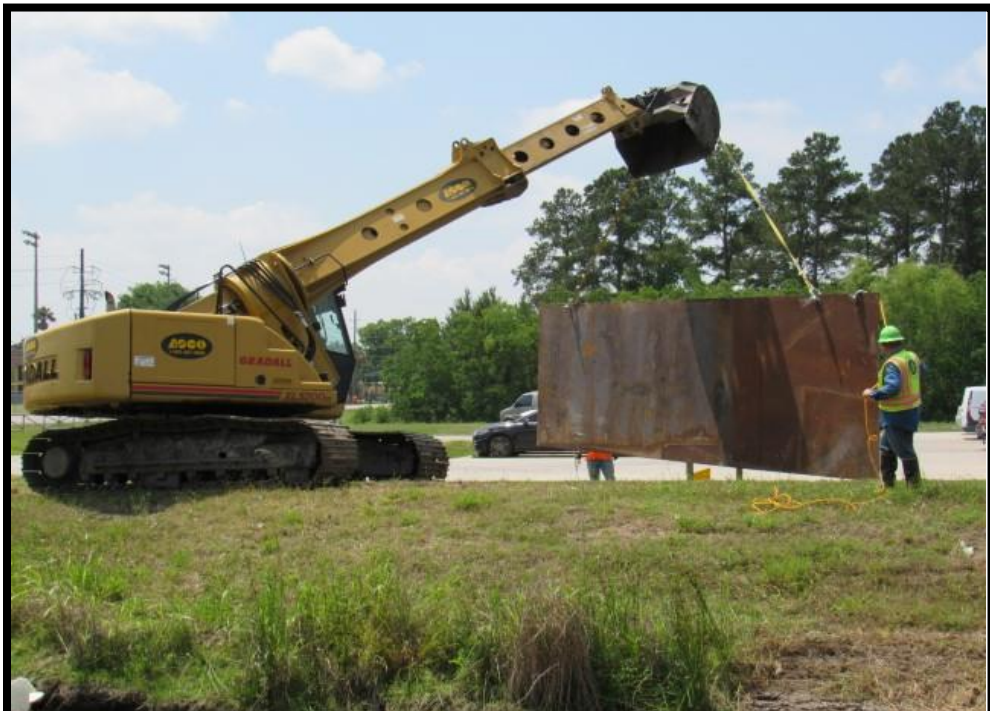
Mobilization of steel plate.

Prior to May 18th, the SJRA fabricated a steel plate to be installed across the intake structure of the Siphon 7 60-inch bypass pipe. Photograph 4 of Appendix A shows a picture of the fabricated steel plate. The SJRA used the Gradall to remove earthen material approximately 6 to 8-inches below the bottom slab of the intake structure and approximately 3 to 4 feet into the south levee to accommodate the plate (see photograph 3 of Appendix A). Once the earth material was removed, the Gradall was used to lift the steel plate into position in front of the headwall (see photographs 5 through 7 of Appendix A). Once the plate was in place, the staff used the Gradall to install and compact backfill material along the sides and bottom of the plate (see photographs 8 through 10 of Appendix A) with the intent of providing a watertight installation. Once V&A completed the inspection of both 48-inch pipes, the SJRA performed final grading upstream of Siphon 7 prior to placing the canal back in service.

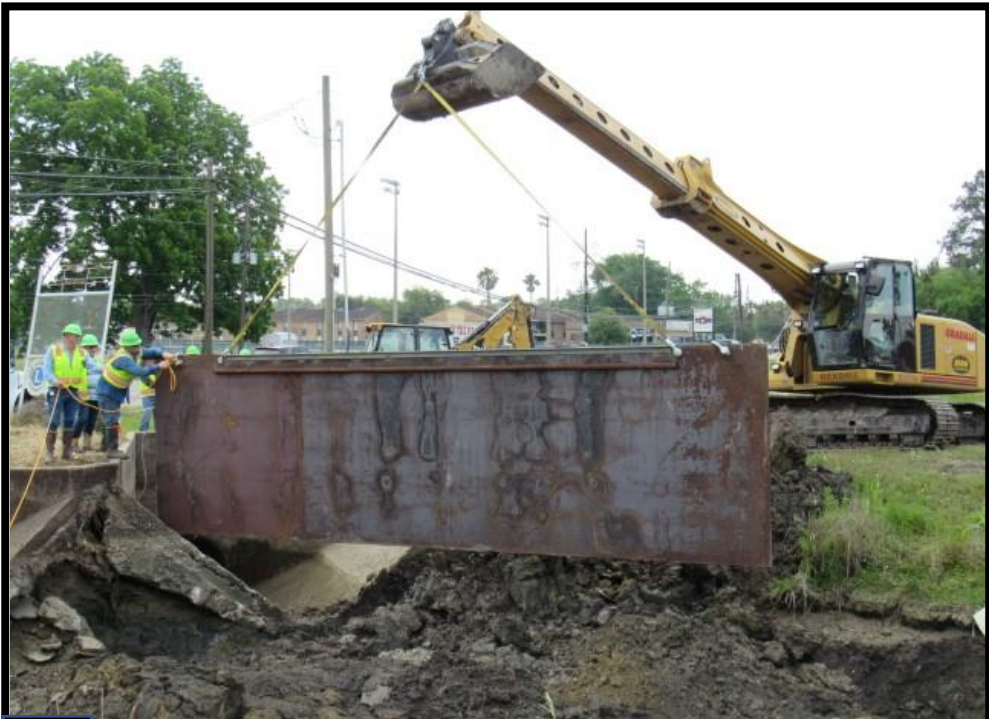
5

Steel plate installation at 60-inch bypass intake structure.
(looking downstream/southeast)

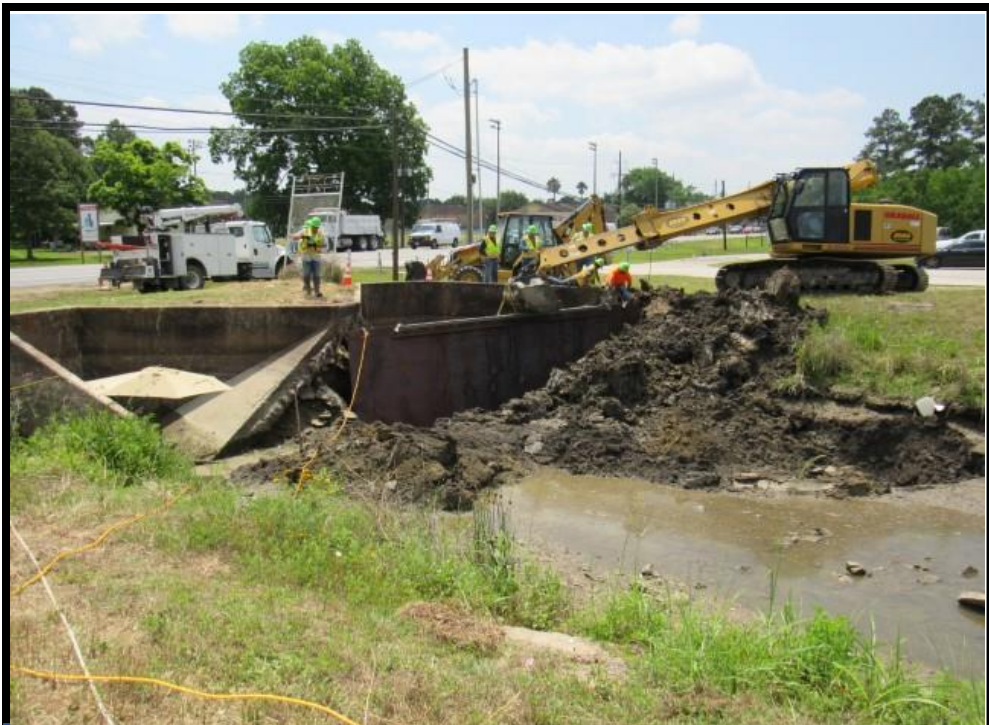
6

Steel plate installation at 60-inch bypass intake structure.
(looking downstream/southeast)

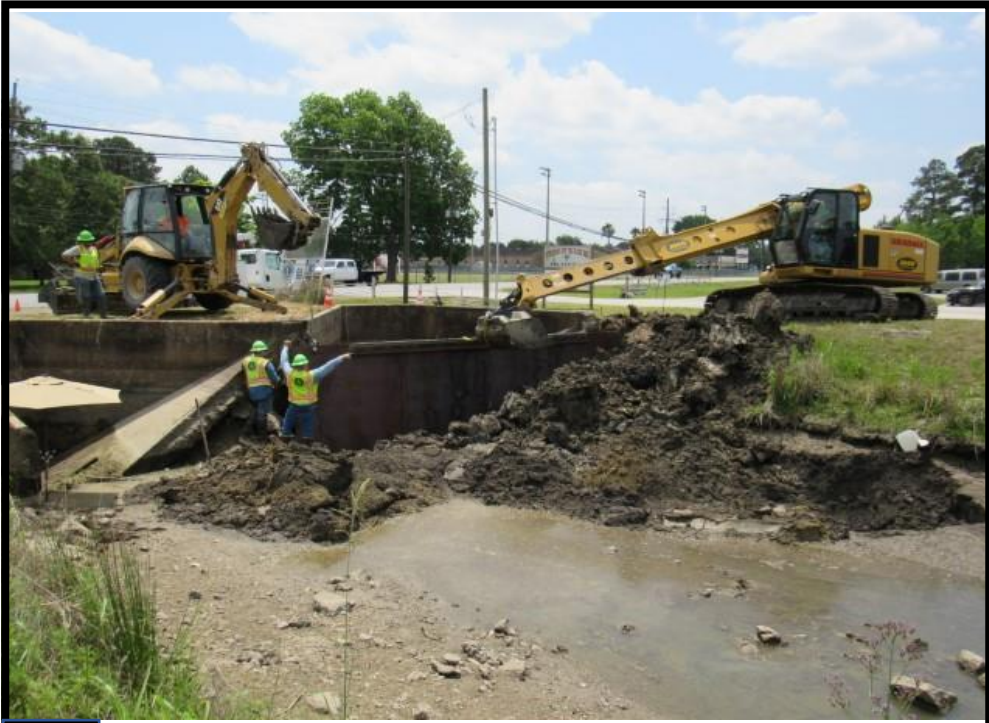
7

Steel plate installation at 60-inch bypass intake structure.
(looking downstream/southeast)

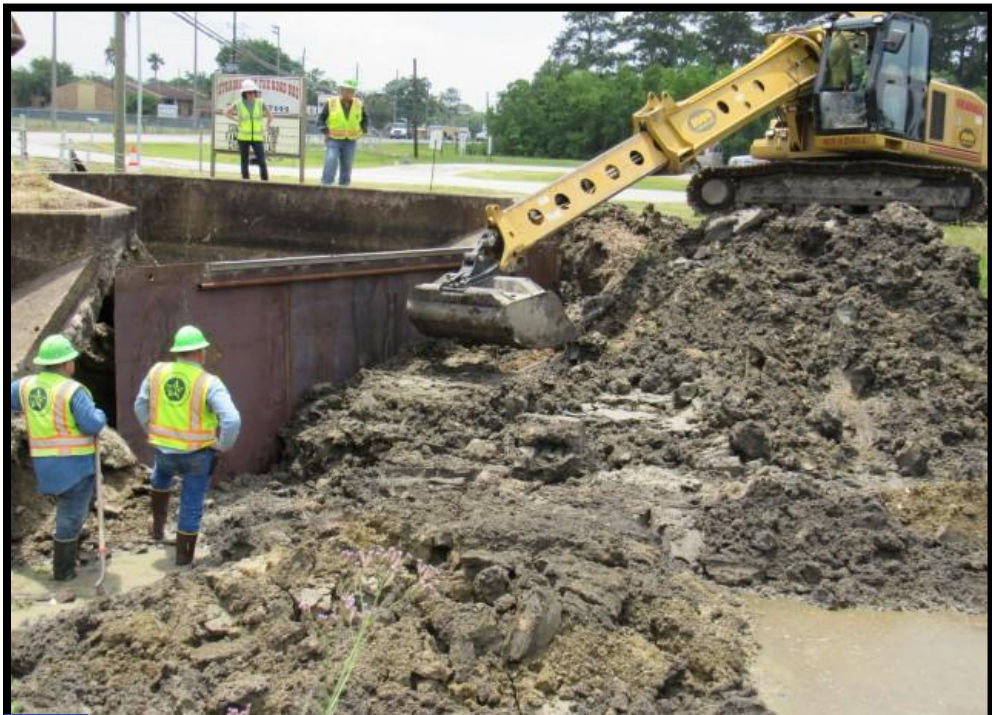
8

Backfilling behind steel plate.
(looking downstream/southeast)

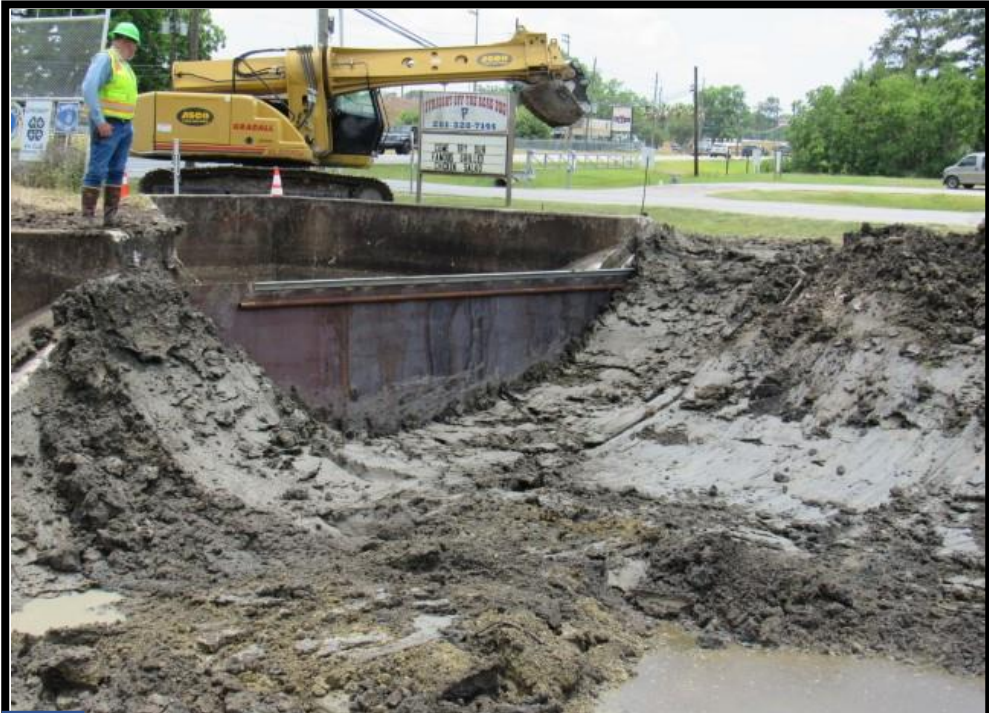
9

Backfill and re-grading behind steel plate.
(looking downstream/southeast)

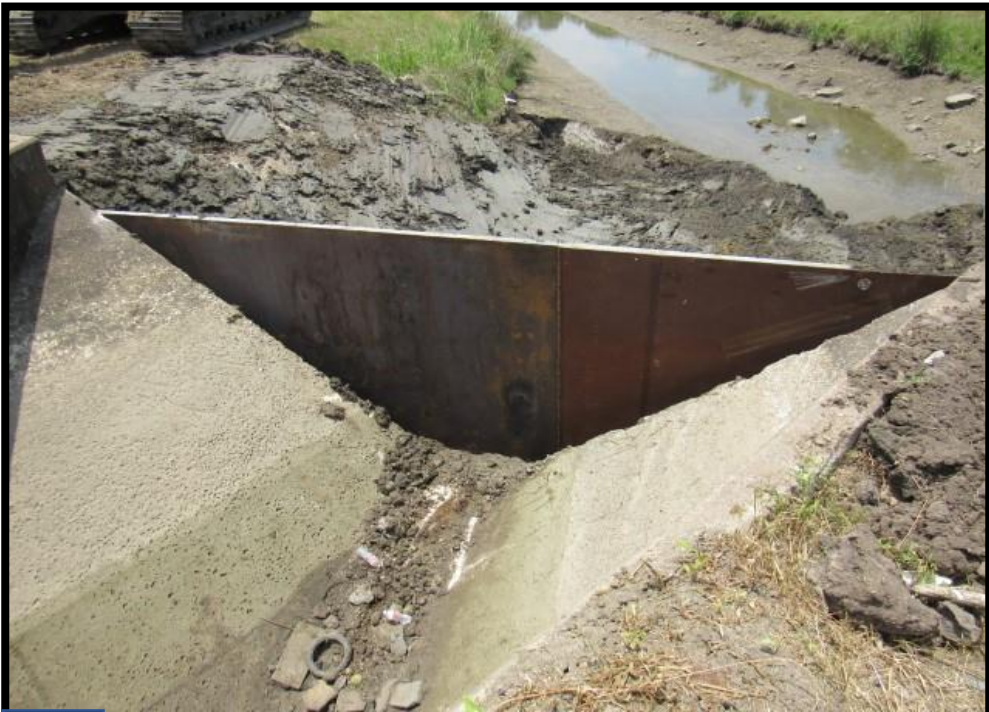
10

Final installation of steel plate at 60-inch bypass intake structure.
(looking upstream)
